Heavy Rain Influence on Airplane Accidents

J. Luers* and P. Haines†

University of Dayton Research Institute, Dayton, Ohio

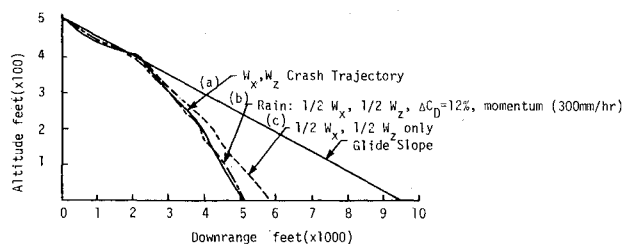
Fixed stick digital landing simulations were performed to estimate the contribution that drag and momentum penalties associated with heavy rain may have made. Figure 1 shows a fixed stick landing simulation for a 727 aircraft trimmed to the glide slope at 500 ft. Trajectory A is the trajectory that the aircraft would have taken with no additional pilot input and with the aircraft influenced only by the vertical and horizontal windfield derived in the accident reconstruction. For comparison purposes, this will be called the crash trajectory even though it only represents the trajectory the aircraft would have taken had there been no pilot response. To assess how much the windshear profiles could have been influenced by rain penalties, yet provide the crash trajectory, curves B and C were generated. Curve B is that trajectory resulting from a combined heavy rain drag penalty of 12%, a momentum

penalty for 300-mm/h rainrate and windshear values of 50% of those calculated in the accident reconstruction. Curve C results from 50% wind shear values with no rain penalties. Note that in these fixed stick simulations the crash trajectory can be effectively reproduced with only half the original magnitude of the wind if rain is also taken into account. Thus we conclude that the derived Eastern 066 wind profiles could have been overestimated by a factor of 2.

Fig. 1 Fixed stick landing simulations with rain and modified wind input from Eastern 066 accident environment.

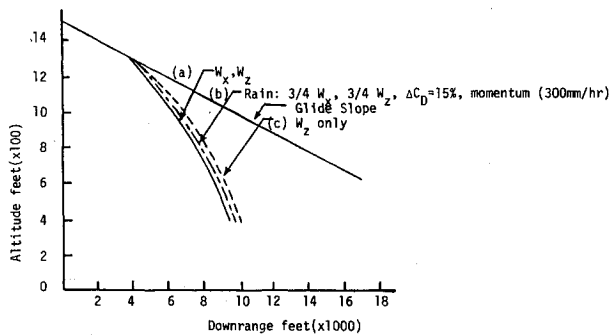
Fig. 2 Fixed stick landing simulations with wind and rain inputs from Eastern 693 incidents.

In our study, the vertical and horizontal wind profiles derived from the NTSB analysis and the time of the heavy rain encounter were used in a simulation analysis similar to that performed for the Kennedy crash. Figure 2 shows the resultant fixed stick trajectories. Note that in this incident, nearly the entire glide slope deviation must be attributed to the vertical windshear, curve C, as compared to curve A. This result would tend to rule out any engine underperformance due to ingestion of large amounts of water, since engine underperformance would largely be reflected in airspeed loss and thus be interpreted as a horizontal wind. Curve B was derived by introducing into the simulation a rain-induced momentum penalty for 300-mm/h rainrate and a drag penalty of $\Delta C_D = 15\%$ as well as horizontal and vertical wind components that were 75% of those derived in the accident investigation. Note that by taking the rain-induced drag and momentum into account, over 75% of the windshear is still required to approximate the windshear trajectory alone. Thus the drag and momentum penalties associated with the rain were not a primary factor in this analysis.
