# Composite Material Repairs to Metallic Airframe Components

T. F. Christian Jr.\* and D. O. Hammond†

The repair of metal structures by using composite materials is a technology that was pioneered in Australia, and excellent results have been obtained in over 500 repairs of corrosion and fatigue cracking. This paper will present details of the first in-service composite material repair applied to metal structure on USAF C-141B operational aircraft. This engineering study evaluated five locations representing both fatigue and corrosion cracking susceptible areas on the C-141B strategic airlift transport aircraft. Repairs using either boron/epoxy or graphite/epoxy are beneficial for crack retardation, end fastener effect relief, and field stress reduction. The most obvious time saving feature of these repairs is that no fastener removal or installation is involved. Extensive structural analysis utilizing finite element modeling was done to ensure that the repair design not only would have the requisite strength and durability but also would reduce the inspection burden after the aircraft was returned to service. A test program was also undertaken to substantiate the analytical inve

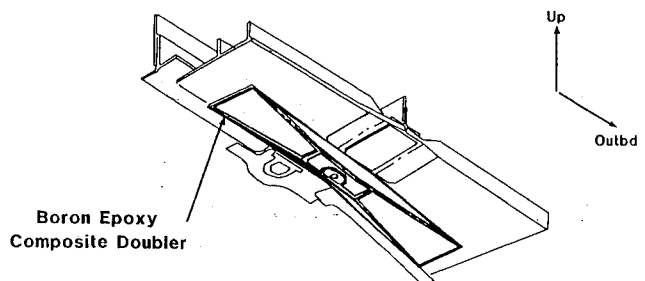
Fig. 2 C-141 WS 405 rear beam splice composite repair.

The complex geometry and surrounding structure are major constraints in the repair of the lower WS 405 area. In addition, the aircraft must retain its present tiedown and jacking capability in this area. The repair of a damaged WS 405 splice fitting to restore the capability to transfer loads from the outer wing beam cap, wing panel, and web to the inner wing is a complex matter, so several repair configurations were evaluated. The configuration finally selected was an external doubler bonded to the inner and outer wing panels, located below the beam caps. Since no fasteners or sharp radii are involved, the advantage of higher stiffness of boron/epoxy material can be taken. The doubler will not cover the tie down fitting and will permit standard mooring of the aircraft. Due to the vertical jacking load imposed on the WS 405 fitting, a metallic insert is required, as the epoxy matrix will not be able to withstand these high concentrated loads. A load carrying metallic insert having composite legs was considered, but splicing it effectively to the composite doubler proved too difficult. The resulting composite requires 48 plies of unidirectional AVCO 5505/4 boron/epoxy tape with a titanium insert for the WS 405 jacking loads. Each leg is parallel with its respective rear beam datum, forming a "bow tie" shape. The general shape is shown in Fig. 2.

The doubler is bonded using an American Cyanamid FM 73 film adhesive. Ultrasonic inspections are performed to check for voids in the doubler and in the adhesive bond line. The doubler is then covered with one layer of aluminum foil and sealed around the edges. This provides environmental protection by keeping moisture away from the doubler and the adhesive. The rework area is then painted to match the aircraft. The WS 405 doubler was the first part to be designed, fabricated, and installed. Actual WS 405 joint area was not available on the static test article (Aircraft S/N 6000) for trial installation, so a similar compound contour area on a pylon was used. The fabrication and installation experience gained from this location was applied in the repair design of the other areas.

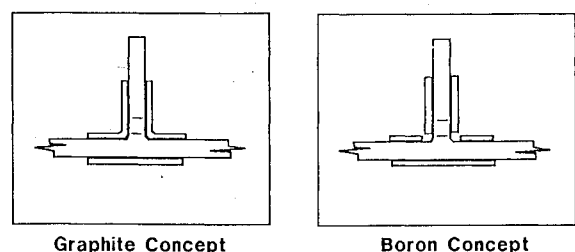
Fig. 3 C-141 weep hole composite repair concept.

The weep holes are nominally 0.25-in.-diam. holes drilled through the panel risers and approximately 0.25 in. above the inner surface of the wing panel. They help increase usable fuel by allowing fuel to flow between the riser bays. Approximately 30 weep holes are in each inner wing lower surface riser. The stress concentration caused by the weep holes adversely affect the aircraft service life.

The optimum solution was to use a five-piece boron/epoxy doubler arrangement. The internal doublers are placed as close to the radius as possible, as shown in Fig. 3. Since the surfaces are basically flat, the boron/epoxy tape can be cured at 350°F, utilizing an autoclave process. The material is an AVCO 5505/4 boron/epoxy prepreg tape. Each piece is 6 in. long and consists of 14 plies (total thickness 0.074 in.). The cracked weep hole is fitted with an aluminum plug to prevent future deformation of the hole under applied loading. At weep hole locations where 0.020-in.-high by 1.0-in.-wide raised pad exists, additional plies of the film adhesive can be used as shims. After bonding and ultrasonic inspection for voids, the internal doublers are overcoated with sealant. The internal doublers will receive a coat of flexible polyurethane, and the outside doublers will receive the aluminum foil/paint treatment.

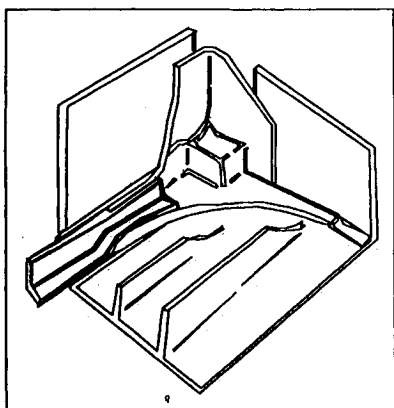
Fig. 4 C-141 corner fitting.

The wing station (WS)77 inner wing lower corner fitting is a large aluminum fitting inside the inner wing at the rear beam WS 77.7/FS 958 intersection. This fitting transfers the inner wing beam cap loads to the center wing beam caps via large tension bolts. The problem caused by this fitting results from the abrupt drop off in thickness at the outboard end of the horizontal leg. This abrupt ending of the fitting causes large shifts in the load path and induces high bending stresses (i.e., end fastener effect) in the rear beam caps. The fitting is shown in Fig. 4.

chosen. This would provide the loads in the horizontal leg of the beam cap an alternate load path, thus lowering the beam cap stress levels and retarding the onset of cracking. The final design consists of a rectangular doubler fabricated from 32 0 plies of AVCO 5521/4 250°F curing boron/epoxy tape. A gentle taper is provided in the inboard-outboard direction. The doubler is cured and bonded at the same time to the wing panel. Based on ARL experience, the laminate made from all 0-ply orientations is used. Since all plies are of the same orientation, ply drop off about the center line is not necessary to maintain symmetry. After bonding, the composite doubler is inspected for voids, covered with aluminum foil, sealed, and painted.

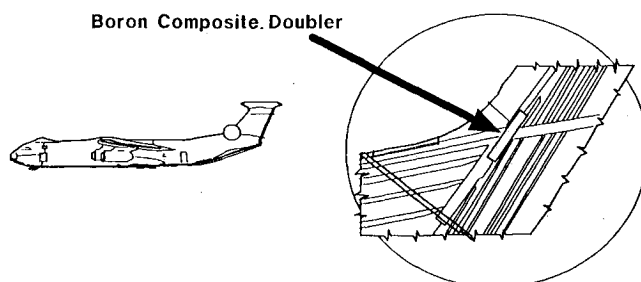
Fig. 5 C-141 dorsal/vertical stabilizer composite repair.

The low-level missions usage of C-141B aircraft imposes higher stresses than originally anticipated on the dorsal longeron and vertical stabilizer front spar area. This fact and the complex contour of the area led to the selection of this area for development of a composite repair. The basic structure is shown in Fig. 5. The dorsal longeron, located near the crown of the fuselage, is a large "T" shaped extrusion and intersects the center spar of the vertical stabilizer. The vertical stabilizer front spar consists primarily of two aluminum extruded "T"-shaped spar caps, one on the left and right sides with a connecting web. The front spar is discontinuous at the dorsal longeron and is spliced through by bath tub fittings and tension bolts. In-service aircraft have experienced fatigue failures of the front spar splice fittings, splice plates, and spar caps.

The doubler is approximately 30 in. long, 0.168 in. thick, and composed of 32 plies of boron tape. The AVCO 5521/4 tape cures at 250°F, so the compound contour can be permanently shaped into the doubler at the same time it is being bonded in place. The same doubler can be used on either the left or the right side of the front spar. The tapers on the top and bottom of the doubler are different due to the stiffness differences of the front spar cap above and below the dorsal longeron. After bonding, the doubler is checked for voids, covered with aluminum foil, sealed, and painted to match the aircraft.

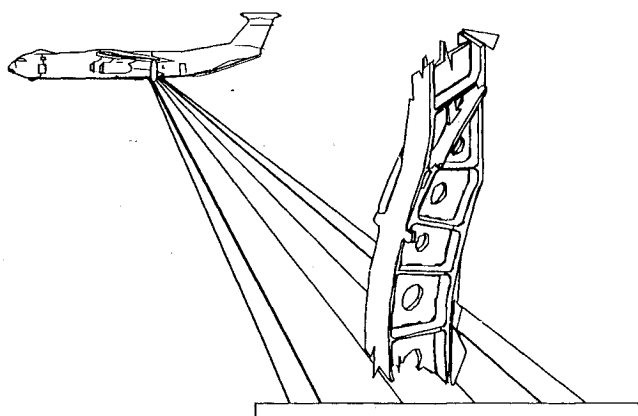
Fig. 6 C-141 FS 998 mainframe composite repair.

connected by an integral web and supported by integral stiffening members, forming many "pockets" in the frame. Figure 6 shows the frame. The primary mode of cracking experienced in service aircraft is stress corrosion and is in the pocket area. This stress corrosion is due to the residual stresses caused by the extensive machining as well as the low stress corrosion threshold level of the 7075-T6 forged material.

The repair concept consists of two graphite/epoxy angles positioned on each side of the frame. Graphite/epoxy is required due to the 0.50-in. fillet radius.

The angle is approximately 7.5 in. long, 3.5 in. high, 2.7 in. wide, and 0.170 in. thick. It consists of 34 plies of 250°F curing SP-377 (3M) graphite/epoxy tape. The plies are dropped in sets of four about the center line of the laminate. One layer of dry type 120 fiberglass is used as a galvanic barrier between the aluminum frame and graphite/epoxy angle, with a 0.5-in. overlap of the frame. This composite repair member also has rounded corners. It was found that rounding the corner helps to reduce the peeling stresses at the corners. The angles are co-cured and bonded to the frame. The angles are checked for voids, sealed, and painted.

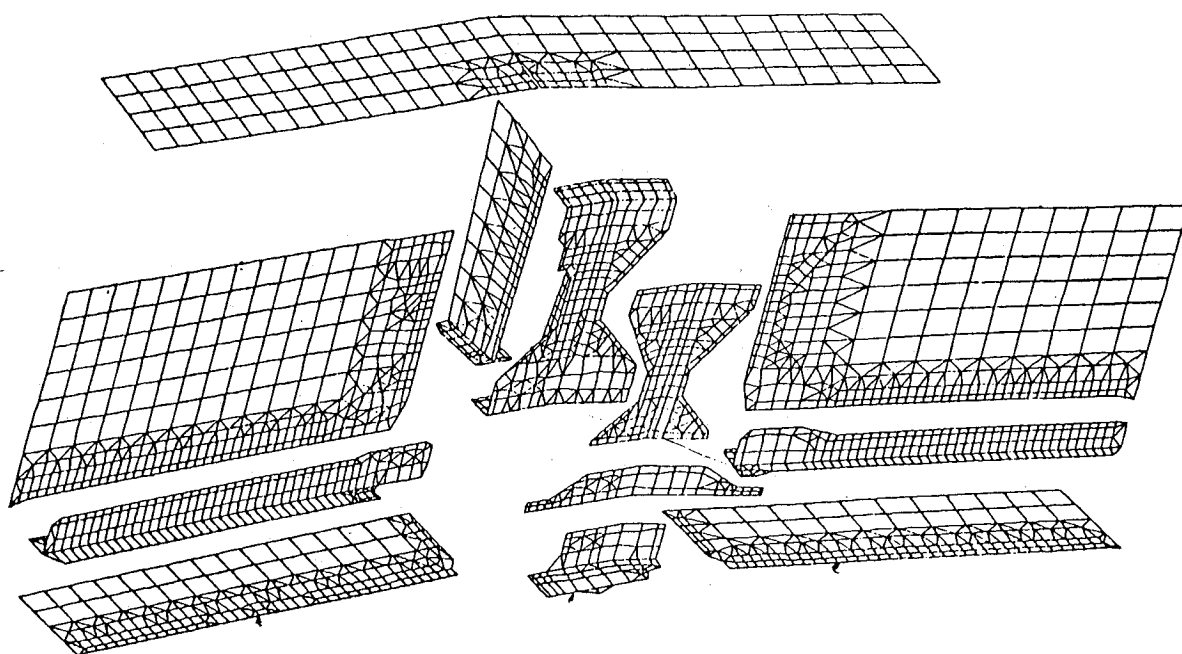
Fig. 7 C-141 WS 405 joint finite element model.

The WS 405 repair FEM is a modification to the wing substructure of the C-141B general airframe FEM. Substantial detail is included in the rear beam, lower surface, and WS 405 area. Individual components in the model are upper and lower surface, spar webs, and caps, WS 405 fitting, failsafe strap, tiedown fitting, splices, and IWBR 374 web. Fastener elements are included in this area to investigate load transfer distribution and their magnitude. Structural elements used in the detail model are three and four node membrane (CTRMEM and CQDMEM), semi-monocoque membranes (CSMTRM and CSMQDM), axial elements (CRODS), beam element (CBAR), and fastener elements (CFAST). The FEM results indicated that the benefit due to the addition of a boron/epoxy doubler gave a fatigue improvement ratio for the various elements of the joint conservatively calculated to be 2.4, including the effects of residual stresses due to differential thermal expansion between the doubler and the structure during curing. Figure 7 shows the FEM that was used.
