Behavior of Compression-Loaded Composite Panels with Stringer Terminations and Impact Damage

Dawn C. Jegley*

NASA Langley Research Center, Hampton, Virginia 23681-2199

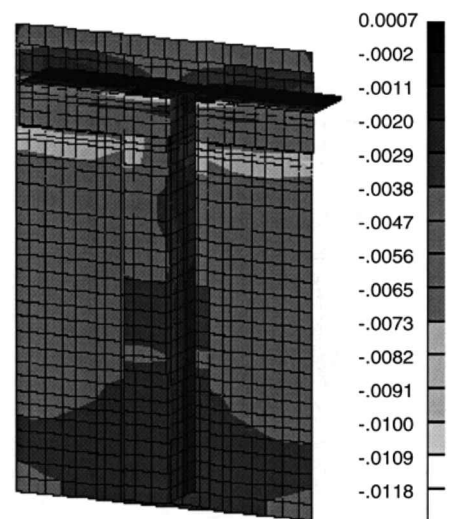
**Fig. 8 Axial surface strain for a load of 100,000 lb for panel U-1.**

Analytically determined axial surface strains for a load of 100,000 lb are shown in Fig. 8 for panel U-1. The maximum compressive axial surface strain occurs in the region of highest bending, which is in the intercostal flange near the intercostal. In this region the blade is only two stacks thick and it passes over the intercostal flange without connecting to it. As can be seen in Fig. 3, the stringer flange terminates at the edge of the intercostal flange, allowing more bending to occur. The maximum axial strain at the laminate midplane is less effected by bending behavior and occurs in the stringer flange near the intercostal. Based on an allowable axial strain value at the laminate midplane for an undamaged structure of 0.0093 in./in., failure should not occur because of axial strain for a load less than 108,500 lb. Lateral strains were small enough to have little effect on failure. However, the shear strain in the intercostal flange is predicted to exceed the shear strain allowable of 0.0126 in./in. for loads greater than 91,200 lb. Shear strain in the intercostal flange causes or contributes to failure of the panel because the panel failed at 98,200 lb.

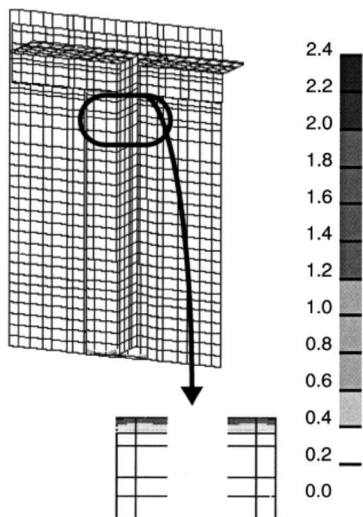
Fig. 9 Normalized interlaminar stresses at skin-to-stringer flange interface for a load of 100,000 lb for panel U-1.

The values of the interlaminar failure parameter is shown in Fig. 9 for the interface between the skin and the stringer flange of panel U-1. The maximum interlaminar stress in the stringer flange occurs at the end of the flange, where it terminates at the intercostal flange. At this location the interlaminar failure parameter is approximately equal to 2.0 for a load of 100,000 lb. The maximum axial strain, shear strain, and interlaminar shear strain occur in close proximity, and failure could result from a combination of strains.

Test results indicate that failure in panel U-1 initiates at the interface between the skin and stringer flange. The separation of the stringer flange from the skin occurs immediately beneath the blade of the stringer near the termination of the stringer flange. As load increases, separation between the stringer flange and skin progresses down the panel, away from the intercostal. The analytical prediction of the location of the initial failure agrees with the experimental results. The panel failed at 99,200 lb of load.

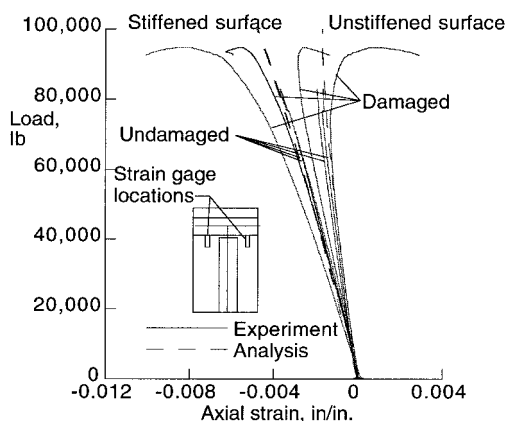
Fig. 11 Axial strains near the intercostal flange in panel U-2.

far-field behavior, or on the global behavior, of the panel. The local effect of the impact damage can be seen in Fig. 11, where results are shown for strain gauges within 1 in. of the impact sites. Surface damage closer than 1 in. from the impact site was too severe to allow strain measurements.

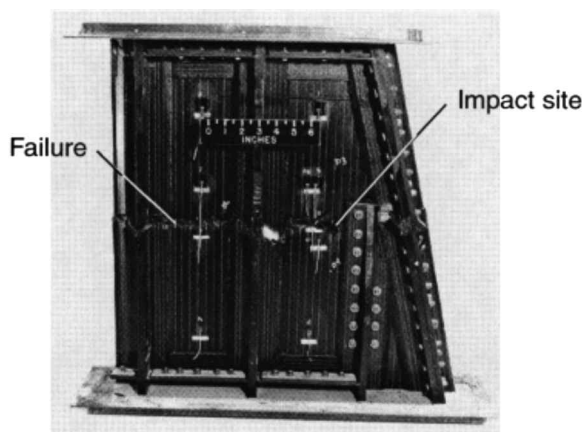
Fig. 14 Failed panel L-2.

The panel was subjected to impact damage resulting in an indentation with a depth of 0.11 in. The allowable strain of 0.0053 in./in. at the impact site is exceeded for loads greater than $580,000$ lb. Applying the method of Ref. 5 results in a predicted failure load of $570,000$ lb. The panel failed through the impact site for a load that is $\sim 85\%$ of that predicted by analysis. The panel failed with a stress at the impact site of 44.6 ksi, which is 113% of the design stress. A photograph of panel L-2 after failure is shown in Fig. 14.

Test data indicate that the maximum midplane strain (based on the surface strain gauges) near the impact site reached 0.0053 in./in. for a load equal to $397,000$ lb. The panel failed at a load of $484,000$ lb. The maximum midplane strain in the region of the impact site was 0.0062 in./in., which is 1.16 times the allowable strain value. The predicted maximum strain in the panel away from the impact site is 0.0058 in./in., which is significantly less than the allowable strain value in an undamaged structure, so that failure was caused by the strain in the region of the impact.
