Observations from the Inspection of an Aged Fuselage Panel

An aged aluminum 7075-T6 fuselage panel was inspected for evidence of time-based degradation. Although corrosion pitting and intergranular attack (IGA) were the focus of the investigation, evidence of cracking and fretting wear were documented as well. The investigation was performed at several levels of magnification through the use of magnifying glasses and stereoscopic, metallurgical, and scanning electron microscopy. Comparisons were made for the various levels of investigation. Significant levels of corrosion or cracking damage were discovered in approximately 40% of the fastener holes during the initial low-magnification inspection. Several fastener holes were investigated via sectioning. These specimens were examined with metallurgical and scanning electron microscopes. This investigation revealed tunneling pits, pitting in the countersink region, IGA, cracking and pitting in and away from fastener holes, as well as fretting within the fastener holes and on the faying surface of the panel. This work is significant and applicable to the structural integrity of aging aircraft; it lends credence to the multitude of pas

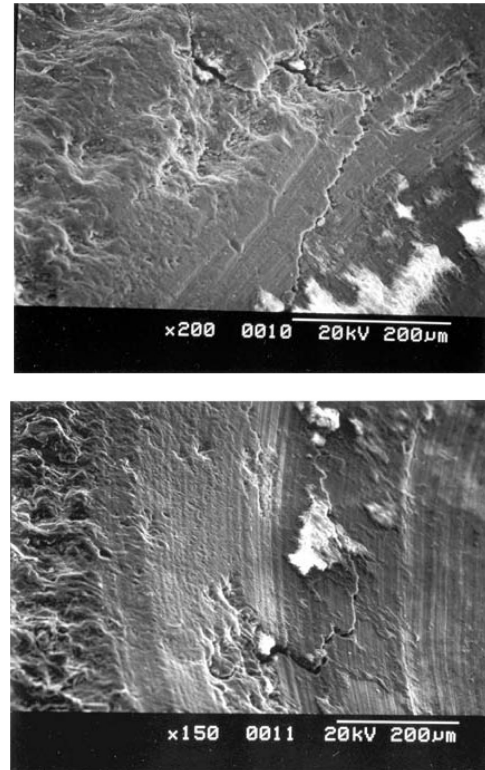
Fig. 6 Examples of pitting with cracking in fastener holes.

Figure 6 reveals discovered examples of pitting and cracking on the surface of countersunk fastener holes. (Note tool marks on the faying surface of the countersinks.)

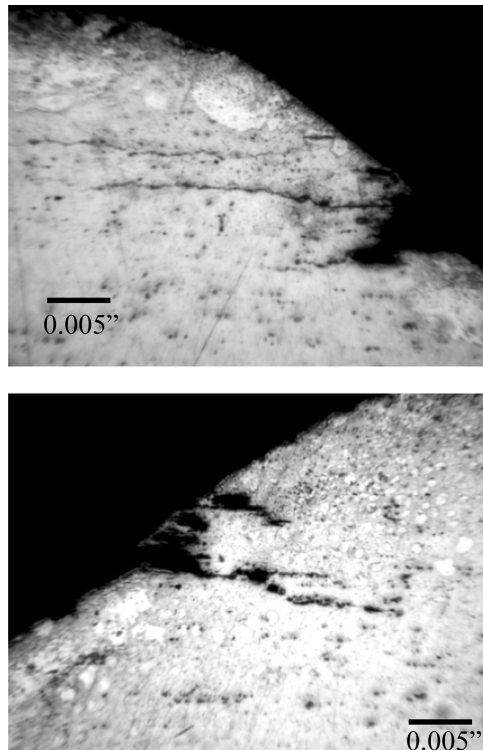
IGA and pitting are highlighted in the metallurgical microscope images depicted in Fig. 7. Note the tunneling behavior of the captured pitting as well as the significant penetration of the IGA into the material.

Fields of pitting among the faying surfaces in and around the fastener holes was common; this is typically associated with fretting. The tunneling behavior of the pitting is also noteworthy; this behavior is common in aluminum alloys.^{5,8} Tunneling pits hide the true extent of damage from surface investigations.

Fig. 7 Examples of pitting with associated IGA (specimen sectioned and polished prior to metallurgical microscope investigation).

Several of the sectioned specimens revealed tunneling/undercutting of pits on both top and bottom of the panel. This tunneling behavior has been documented in pitting growth studies on pristine aluminum alloys.^{5,8}
