# New Ground Deicing Hazard Associated with Freezing Drizzle Ingestion by Jet Engines

DOI: 10.2514/1.20799

A new ground deicing hazard is described, consisting of the accretion of freezing drizzle onto jet engine fan blades and cowlings, and subsequent shedding of the accreted ice during takeoff leading to damage to jet engine fan blades. Cases of damage to aircraft from hazardous surface icing conditions at Denver, Colorado and Oslo, Norway are described. The two cases at Denver cost United Airlines over \$2 million in damage to 12 B737-300 engines. The hazard is identified as heavy freezing drizzle through examination of National Weather Service observations of upper level temperature and humidity, satellite, radar, and freezing rain sensor data. The official National Weather Service observation during these cases, however, was either light snow and mist or light freezing drizzle. The reason for this misreport and underestimate of intensity lies in the current reporting rules for determining freezing drizzle intensity by visibility and not by precipitation rate. Theoretical relationships are presented that show that the variation in drizzle size distribution and the difference

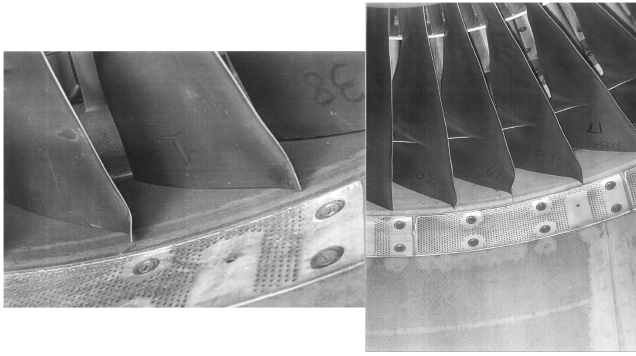
ON 31 October 2002, 12 United Airlines B737 aircraft incurred jet engine damage during a winter storm at Denver, Colorado. The damage was primarily bent fan blade tips, and was consistent with ice being ingested into the engines at normal flight engine

speeds (Fig. 1, photo of bent fan blades). Total damage was reported by United Airlines as being over \$2 million, with one engine requiring total replacement. The damage was noted after the aircraft landed at their destination airports. The aircraft incurring damage departed Denver between 5:00 and 8:00 p.m. Mountain Standard Time (MST) [(1 November, 0000-0300 Coordinated Universal Time (UTC)]. The weather observer at Denver reported mist and light snow during this time period, and also unseasonably cold temperatures ( $-8^\circ\text{C}$ ). While inbound to Denver these aircraft encountered light to moderate icing aloft as given by pilot reports. After landing, the aircraft were deiced at the gate to remove ice buildup that occurred via in-flight ice accretion. The deicing included the removal of any ice from the jet engine fan blades. Once deiced and loaded, the aircraft taxied to deicing pad B (located just west of Concourse B at Denver International Airport, see Fig. 2), and were further examined for ice accumulation due to the reported snow conditions. During this period ground personnel reported the presence of freezing drizzle despite the METAR report of mist and light snow. Denver is a category A airport and therefore had an observer present who augmented the METAR in this case to report snow and mist. An interesting observation for this case was that only the right engines were damaged.

Fig. 1 Photograph of bent fan blades from the damaged B737-300 engines.

Braathens engineers believe that the engine damage occurred due to the liberation of ice from the back side of the fan blades during engine run-up. Ice, so liberated, is centrifuged to the outer portions of the engine where it can damage the blade tips when ingested into the engine. United engineers also suggested the same scenario for their engine damage.

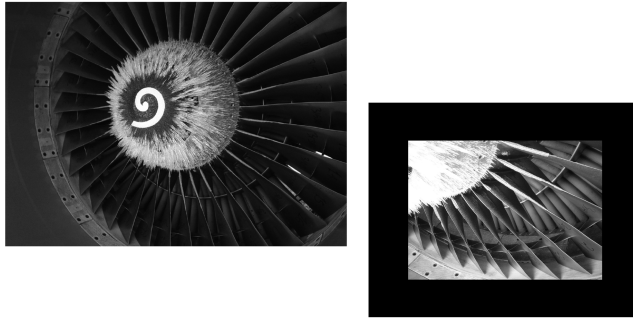
Photographs of the actual ice accretion on the spinner and fan blades during this event are shown in Fig. 14. Note the formation of

Fig. 14 Photograph of ice accretion on spinner and fan blades, 30 October 2003.

ice spikes on the spinner, which could easily shed during takeoff rotation. The temperature at the surface during this event, however, was  $-3^{\circ}\text{C}$ , significantly warmer than the 31 October 2002 event and the Gardermoen Airport events, which occurred near  $-8^{\circ}\text{C}$ . Thus, engine damage is not only limited to the cold freezing drizzle events.

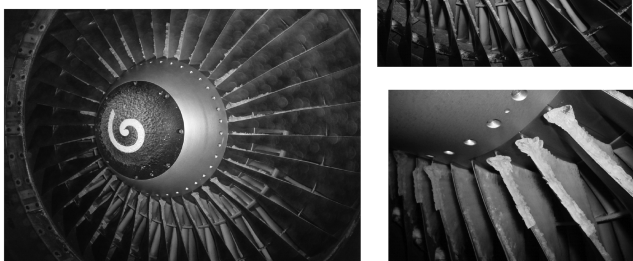
Following this event, United Airlines staff conducted tests of the ice accretion into engines during a freezing fog event on 6 November. The results showed rapid accretion of ice on both the spinner and on the sides of the engine blades (Fig. 15). However, no ice spikes formed in this case. 1/4 in of ice was observed to build up on the blades within 15 min of taxi, and 1/2 in of ice within 30 min of taxi. Ice accretions were observed to occur on a variety of jet engine types, not just the B737s. Thus, taxi during freezing fog may also be of concern. More research is needed to verify this suggestion.

United taxi tests with a 737 in freezing fog on 6 November 2003 showed 1/4" ice build up on the fan blades in 15 minutes and 1/2" ice build up in 30 minutes.

Fig. 15 Ice accumulation on spinner and fan blades during Denver freezing fog event.
