# Corrosion Pillowing in Aircraft Fuselage Lap Joints

Nicholas C. Bellinger,\* Jerzy P. Komorowski,† and Ronald W. Gould‡  
*National Research Council Canada, Institute for Aerospace Research,  
Ottawa, Ontario K1A 0R6, Canada*

DOI: 10.2514/1.18589

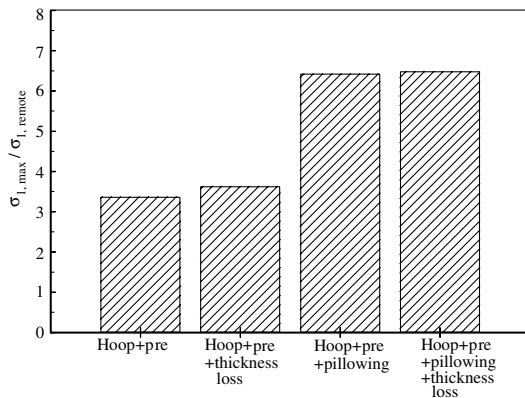
A comparison was also made between the increase in stress caused by an equivalent thinning of the outer skin and that caused by pillowing (Fig. 5). The results showed that pillowing had a greater influence on the stress in a joint, as compared with the effective thickness loss alone. This larger influence is a significant finding because it has been previously assumed that by reducing the skin

Fig. 5 Effect on stress caused by reduction of outer skin thickness as compared with pillowing (10% thickness loss) [4].

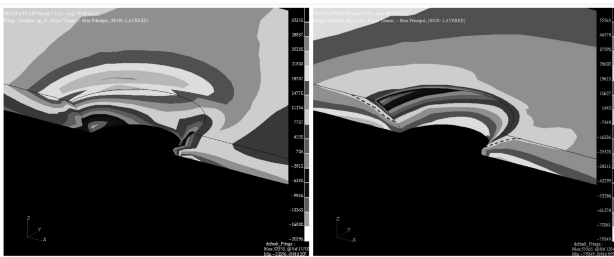
The finite element analysis showed that the stress along the outer surface of the outer skin, in the vicinity of the critical rivet row, could become compressive at the holes when the thickness loss in a corroded lap joint increased to above 10% [10] (Fig. 6). This smaller stress, along the outer surface, raised concerns about the nucleation and growth of cracks in the presence of corrosion pillowing. To examine this effect, a fracture mechanics analysis was carried out

Fig. 6 Stress plot from finite element analysis for lap joints; a) includes hoop stress and rivet interference, and b) shows approximate location of neutral axis (dashed line) for 10% thickness loss. Loading includes hoop stress, rivet interferences, and corrosion pillowing [10].

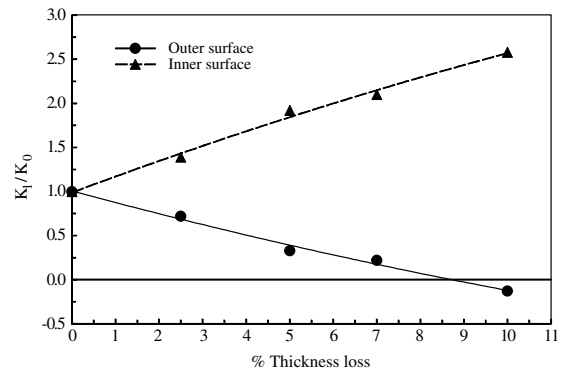
Fig. 7 Nondimensional stress intensity plot of outer surface ( $z = 0.000$ ) and inner surface (1.14 mm) of outer skin for single crack length of 3.84 mm, where  $K_0$  is the stress intensity factor of a through crack without corrosion ( $K_0 = \sigma \sqrt{\pi a}$  [11]).

thickness loss increased (Fig. 7). As can be seen from this figure, the stress intensity factor for the crack edge along the faying (inner) surface increased as the pillowing increased, whereas the crack edge along the outer surface decreased. This difference in the two surfaces suggests that the crack edge located along the faying surface would grow more rapidly in the direction of the row of rivets than through the thickness, resulting in a semi-elliptical crack front with a high aspect ratio as shown in Fig. 8.

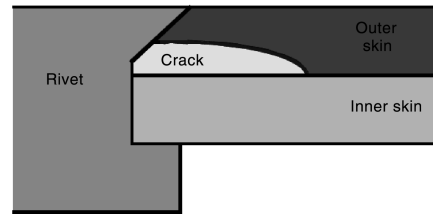
Fig. 8 Suggested shape of cracks in the presence of pillowing [11].

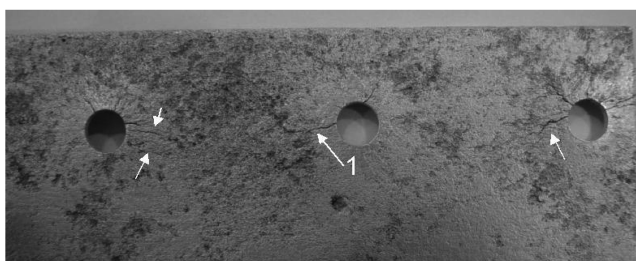
shows the characteristic star-shape cracking pattern that occurs in the presence of corrosion in lap joints. A few of the cracks had grown in the direction parallel to the rivet pitch at approximately 90 deg to the hoop stress. The location of these particular cracks could indicate that some may have propagated under cyclic loading. One of the cracks, which had a length of 3.94 mm (0.155 in.) and a maximum depth of 1 mm (0.039 in.), labeled “1” in Fig. 10, was pried open. A scanning electron micrograph of the fracture surface is shown in Fig. 11. As can be seen from Fig. 11a, there are at least four distinctive nucleation sites, as well as a large secondary crack present on this fracture surface. The exact locations for these sites could not be determined due to the presence of corrosion products on the fracture surfaces. Fatigue striations were also found near the crack tip indicating that this crack was growing under cyclic loading (Fig. 11b and 11c). A cavity was also present on the fracture face (Fig. 11e), which appeared to have intergranular cracks originating from it. This cavity may have formed as a result of intergranular corrosion dissolving a constituent particle that was located at a grain boundary. This scenario was found during a study to determine the faying surface damage caused by corrosion in the vicinity of the rivet holes [14,15]. During this study, sections were taken from naturally corroded lap joints and progressively polished to document the damage present.

Fig. 10 Close-up of pillowing cracks present in second layer. Crack labeled “1” was pried open [14,15].

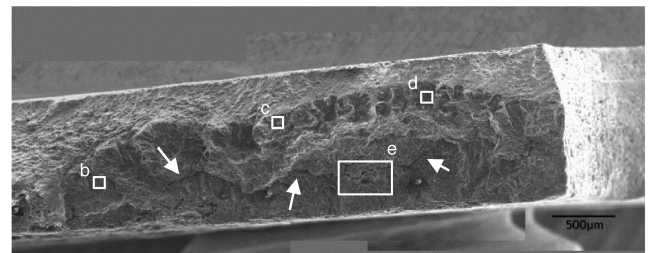
a) Overall view of fracture surface showing distinct fracture regions. Boxes indicate areas where close-ups were taken. Arrows show location of secondary cracks (intergranular cracks)

b) Fatigue striations were found near edge of crack indicating crack origin

c) Fatigue striations found on fracture surface indicating second fracture origin

d) Fatigue striations found indicating third crack origin

e) Close-up of cavity and intergranular cracks

Fig. 11 Scanning electron micrographs of fracture surface from crack “1” in Fig. 10 [14,15].

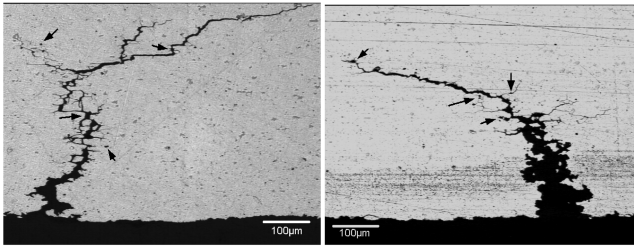
Some of these sections were taken from areas that contained pillowing cracks. An example of intergranular corrosion dissolving a constituent particle is shown in Fig. 12. As can be seen from this figure, extensive intergranular cracking was present.

**Fig. 12** Optical micrographs of environmentally assisted cracks found in cut sections of corroded lap joints. Arrows indicate constituent particles affected by intergranular corrosion (discoloration) [14,15].

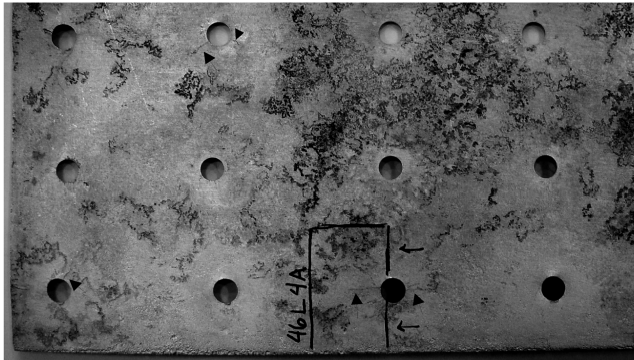
**Fig. 13** Optical image of faying surface of artificially corroded lap joint containing pillow cracks (arrows).

At the start of this study, lap joints were subjected to an artificial accelerated corrosion protocol that was developed at NRC to simulate corrosion pillowing. One of these lap joints was stored at NRC for four years after which it was disassembled and the corrosion products removed. Pillow cracks were discovered that were similar to those found in service-exposed lap joints (Fig. 13). Because these cracks formed only in the presence of the sustained stress caused by corrosion pillowing, it strongly suggests that they nucleated and grew due to environmentally assisted cracking. However, the presence of striations found along the crack front of the pillowing crack pried open from several service-exposed joints suggests that once these cracks form, they may grow further under fatigue loading.
