Failure Analysis of Cracks in the Upper Shaft of Torque Arm

DOI: 10.2514/1.C031169

In the periodic inspection of a plane having flown for 300 h, cracks were found in the upper shaft of the torque arm of the landing gear. In addition to visual examination, other experimental investigation techniques were 1) crack morphology and fracture characteristics by scanning electron microscopy, 2) metallographic observation of cracks, 3) chemical constituents and hydrogen-content testing, 4) hardness testing, 5) impact and bending simulation test, and 6) comparison of wear condition for the crack-free upper shafts with other batches. The results were obtained through the analysis of processing and experimental data. Because of higher surface frictional shear stress and tensile stress, the cracks propagated in the form of stress corrosion after the initiation, which was unrelated to the coating, matrix material, and hydrogen content.

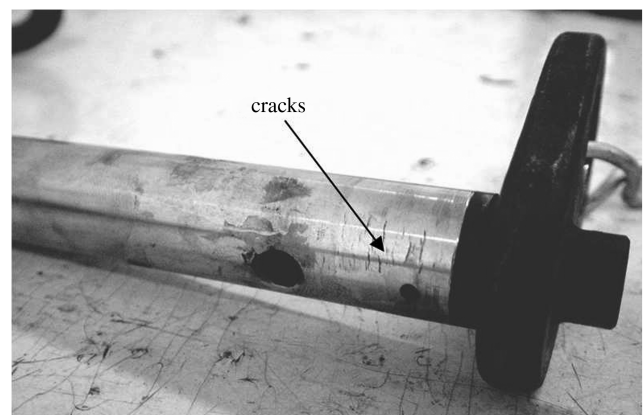
THE landing gear, as one of the main components of the plane, is a necessary support system of the plane for takeoff, landing, taxiing, moving, and parking on the ground. Since no direct transmission of torque exists between the inner rod and outer cylinder of the shock structure, the torque arm is used to transmit the torque by way of moment [1]. In every five planes having a 300 h periodic inspection, cracks were found in the upper shaft of the main landing gear torque arm, as shown in Fig. 1. The upper shaft is made of 30CrMnSiNi2A.

Fig. 1 Upper-shaft cracks.

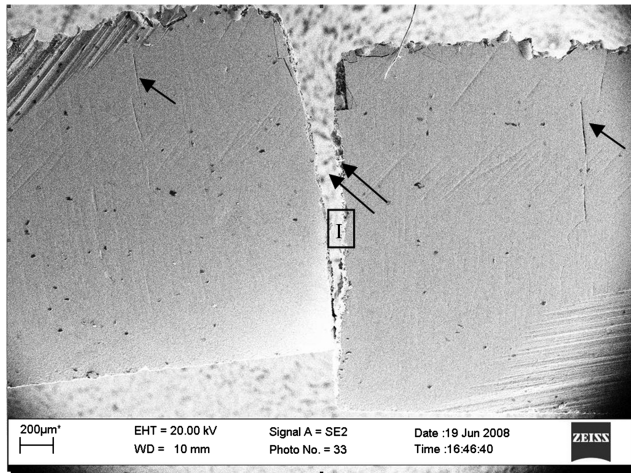
The morphology of crack area is shown in Fig. 2. Region I is the fracture of cracks with circumferential distribution formed. Many circumferential cracks were found to be parallel with the fracture on both sides, and circumferential frictional traces were found as well. In some areas the crack direction is consistent with the circumferential frictional traces, while in other areas a certain angle existed between them. Unlike the circumferential ploughing wear traces, it wore seriously in the 45° direction and obvious spallings could be found in some areas, as shown in Fig. 3. It can be judged that the surface of the upper shaft was subjected to higher torsion (shear stress) during the process of wearing.

Fig. 2 Morphology of cracks.

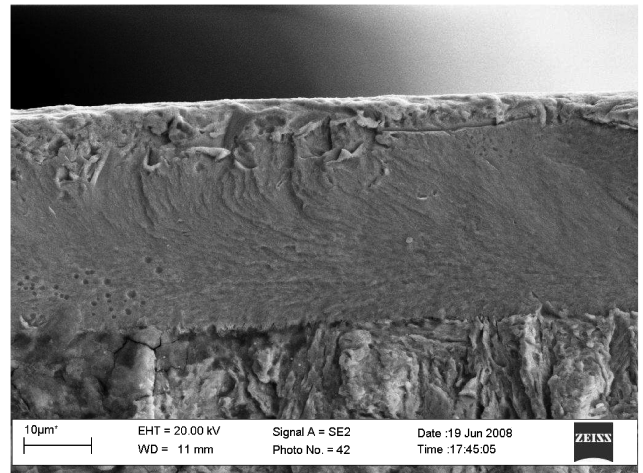
Opened along the crack, the fracture can be obviously divided into four regions with different morphology (see Fig. 4). It contains the coating crack region (region I), quasi-cleavage fracture region (region II), intergranular fracture region (region III), and open-formation region (region IV). The surface of the crack belongs to the coating crack region, from which obvious radiation fracture can be found. As shown in Fig. 5, from the convergence direction of the radiation pattern, it can be observed that the crack was initiated from the coating surface and propagated into the matrix. The depth of regions I and II were measured to be 33 and 30–50 μm , respectively. Between the quasi-cleavage fracture region and the open-formation region was the intergranular fracture region (see Fig. 6), which took up a higher proportion (about 80%) of the fracture. The open-

Fig. 5 Fracture morphology of the chromium coating.

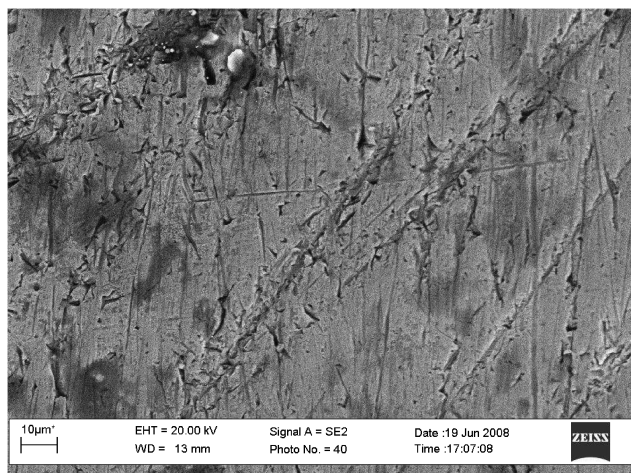
Fig. 3 Worn morphology at 45°.

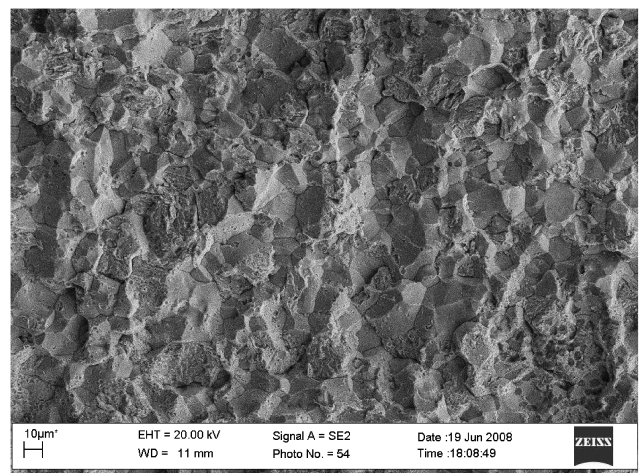
Fig. 6 Fracture morphology of the intergranular fracture region.

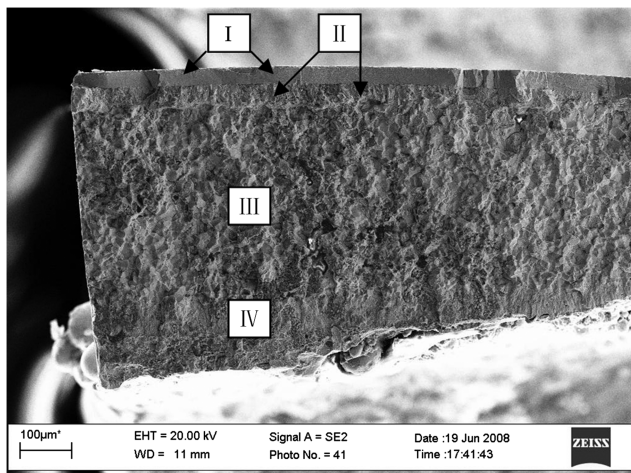
Fig. 4 Morphology of fracture.

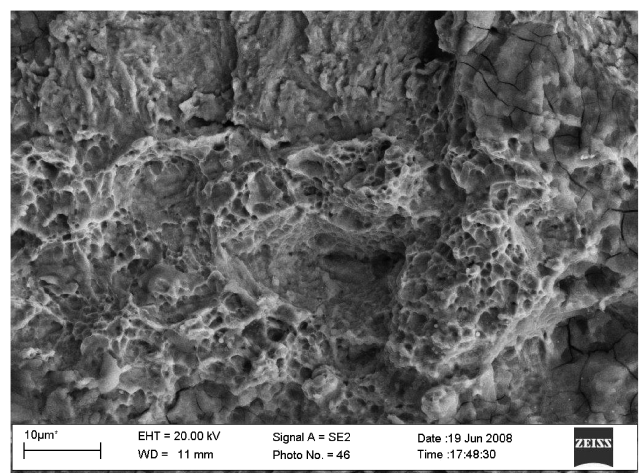
formation region was characterized by a thin dimple fracture (see Fig. 7) [2].

Fig. 7 Fracture morphology of the open-formation region.

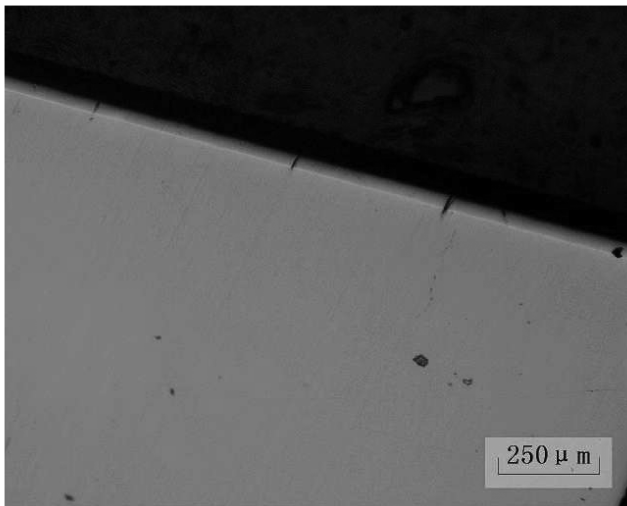
Many cracks were found when the crack area was sampled for metallographic observation (see Fig. 8). Some existed within the coating and did not propagate into the matrix, while others propagated into the matrix at different depths; the deeper one might be about 0.6–0.7 mm. The cracks in the matrix propagated along the crystal boundary and furcated at the local position (see Figs. 8 and 9). No decarbonizes and evident material defects were found. The metallurgical structure consisted of tempered martensite, lower bainite, and little residual austenite, with nothing abnormal detected.

**Fig. 8** Metallographic structure of cracks in coating area.

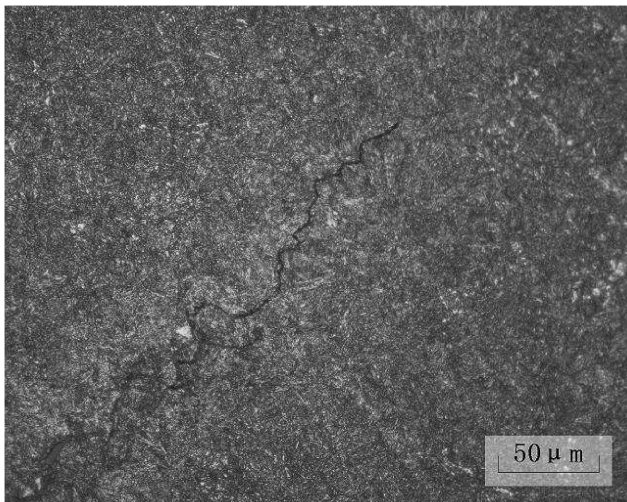
**Fig. 9** Crack branching in the matrix.

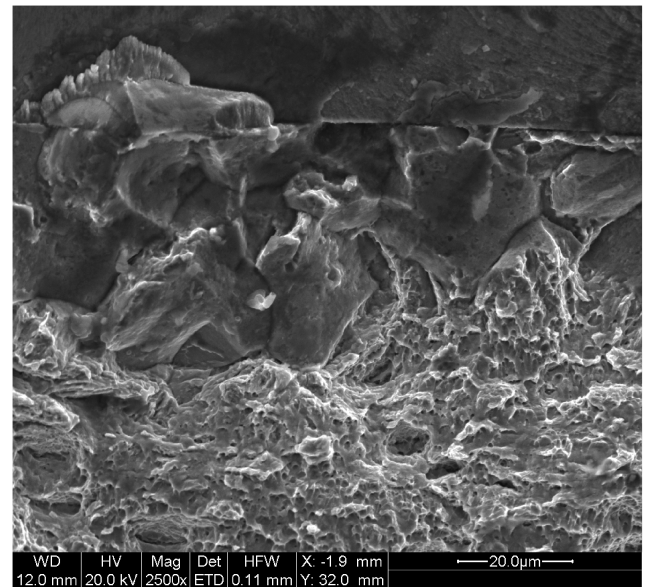
Impact and three-point bending simulation were conducted, and the morphology of fractures is shown in Figs. 10 and 11. The coating fracture is characterized by brittle cracking, near which the matrix is

the interconnection of quasi-cleavage and thin dimple. The fracture morphology of the local area near to the coating is intergranular (Fig. 11), and the extending area of the fracture morphology is equiaxed dimple (Fig. 10).

**Fig. 10** Morphology of the coating brittleness fracture and nearby area of the bending sample.

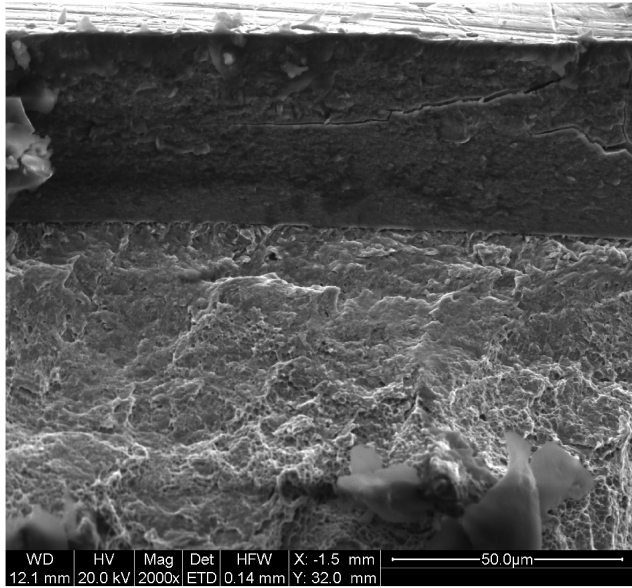
Fig. 11 Morphology of intergranular fracture nearby coating of the bending sample.

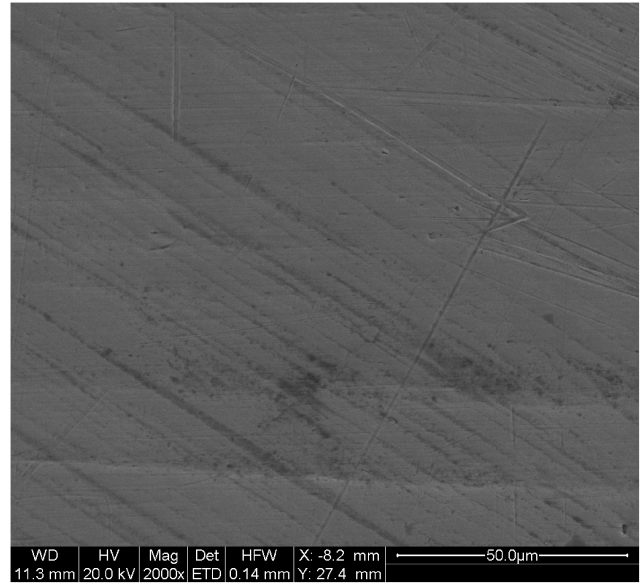
equivalent-use time. The enlargement of worn morphology in the same batches is shown in Fig. 12), and other batches are shown in Fig. 13. It can be seen that circumferential and 45° tangential-direction wear scars appeared in both after a certain use time.

Fig. 13 Worn morphology of other batches.

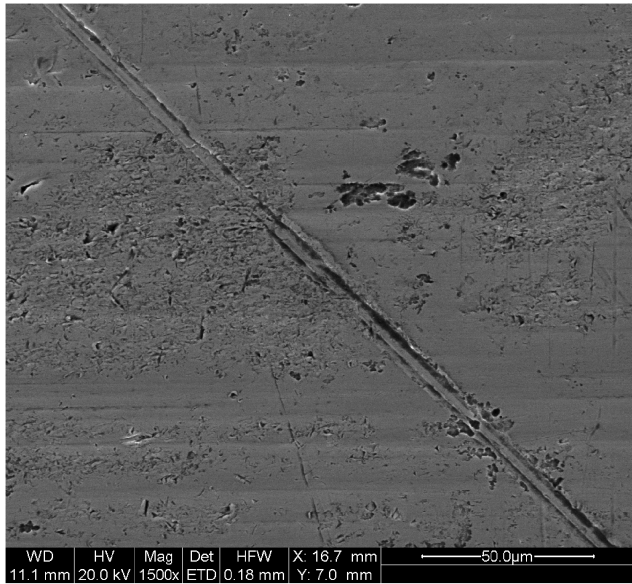
Fig. 12 Worn morphology of the same batch.

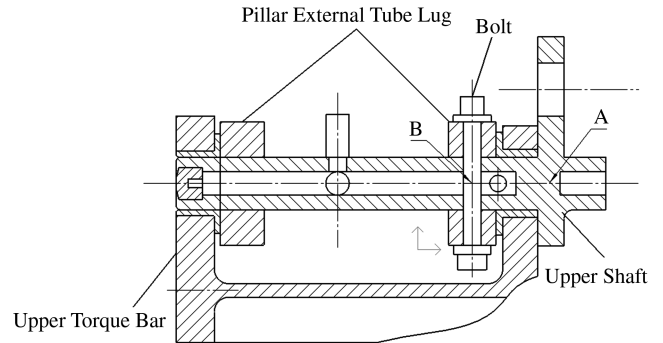
Judging from the assembly condition of the upper shafts, torsion bars, and pillar external tube lugs, the upper shaft is fixed, connected with the lugs by pins, and it can rotate in the copper bush if clearance fit exists (see Fig. 14) [1]. The AB part bears torsion stress when the upper-shaft lugs are forced by the steel rope. The cracks exist only in the AB part that bears torsion stress of the upper shaft. It can be seen from the cracks of the upper shaft and the surface wear condition that cracks are mainly circumferential and should be related to the torsion stress. An obvious abrasive wear in the furrow can be seen on the surface of the upper shafts, with or without cracks. The formation of the trace may have relation to the hard particles between the surfaces of the upper shaft and the copper bush, since there is no sealing that exists at either end of the bush. The hard particles scrape the surfaces when there is circumferential rotation between the upper shaft and the bush, creating some furrow wear traces. No high-contact friction shearing stress exists between the external surface of the upper shaft and the internal surface of the copper bush. Severe 45° tangential wear traces appear on the surface of the upper shaft with cracks, which are not caused only by the abrasive wear. Higher-friction shearing stress also exists on the surfaces of the upper shaft and the bush, contributing to the bad wear and even flaking.

Fig. 14 Assembly of the upper shafts, torsion bars, and pillar external tube lugs.
