Liquid Oxygen Cooling of Hydrocarbon Fueled Rocket Thrust Chambers

Elizabeth A. Roncace*

NASA Lewis Research Center, Cleveland, Ohio 44135

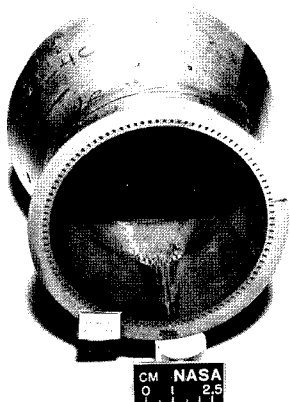
Fig. 7 Chamber 702 throat area.

ratio of 3.43. The chamber was inspected after the second run and there was indication of more melting in the same location, with nine coolant passages opened up (Fig. 7). The injector, injector 288, was not damaged, but in one area, the injector elements were discolored, indicating a hot spot. Chamber 702 was then taken off the test stand and sectioned. Figure 8 shows the slot closest to the melted region. As can be seen, there is no distinguishable effect from the leaking LOX in the region

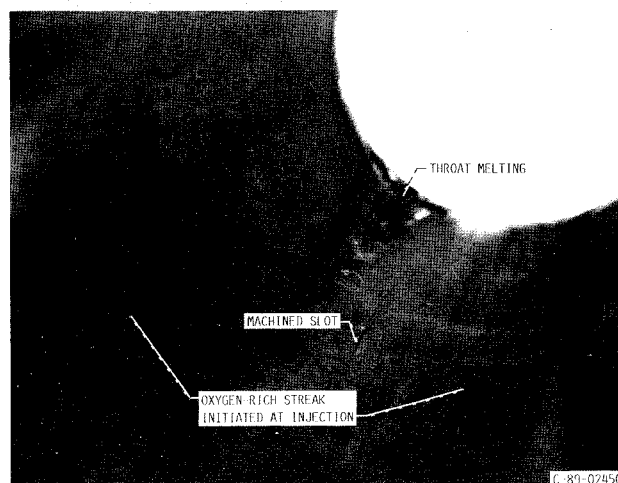
Fig. 9 Chamber 702 after testing.

of the slot. Figure 9 shows the damage to the throat area and upstream of the throat in relation to a machined slot and an oxygen-rich streak.

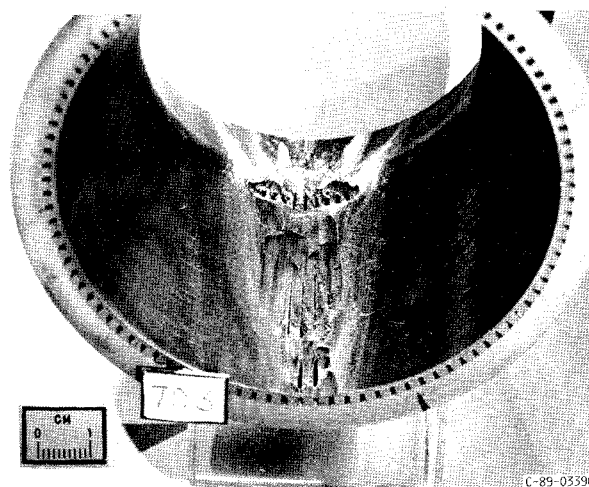
Fig. 10 Chamber 703 throat area.

Six complete runs and one partial run were conducted with chamber 703 and injector 288. After the first three runs, the chamber was inspected and no evidence of damage was detected on the liner surface. The chamber was fired four more times and then inspected again. A part of the chamber liner had melted at the throat and just upstream of the throat (Fig. 10) with 10 cooling channels opened. Several oxygen-rich streaks were also detected from discoloration of the copper wall. The streaks began at the injector face and continued past the throat. The melted region was in line circumferentially with an oxygen-rich streak from the injector but not with either machined slot (Fig. 11). Chamber 703 was then taken off the test stand and also sectioned. Again, there was no distinguishable effect on the chamber from the leaking LOX at the machined slots.

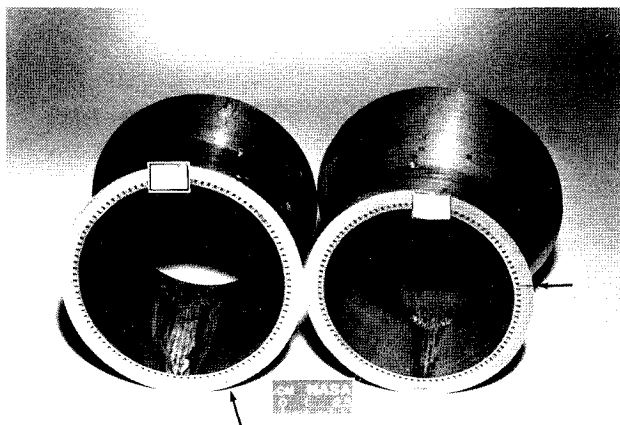
Fig. 12 Melted throat region of both chambers.

Figure 12 shows the melted region at the throat for the two chambers. The arrows denote the same circumferential location relative to the injector face. As can be seen, the melted regions were not in the same circumferential locations.

The melting could be from injector anomalies, resulting in an oxygen-rich zone, which appears as a streak, beginning at the injector face and continuing past the throat. The melted regions on both chambers were in line with streaks. The injector, injector 288, was water-flowed tested to detect any injector anomalies, which showed that several of the oxygen element streams did not flow at the proper angle. A new injector, injector 309, was also water-flow tested and all the elements were properly aligned. Chamber 704 was tested with injector 309 and no melting occurred after more than 20 firings.
