Deterioration of Stainless Steel Regeneratively Cooled Thrust Chambers

JAMES K. STANLEY*

The Aerospace Corporation, El Segundo, Calif.

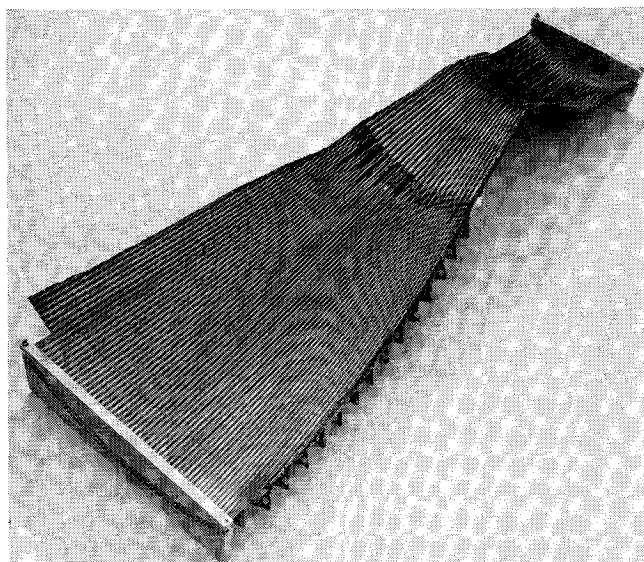
A section of brazed tubes from a chamber is shown in Fig. 1 to illustrate the type of structure that is produced. Heat marking occurs near the bifurcated joint. Terminal blocks were installed for flow measurements. Over-all length is about five feet. In chambers made with single tubes, heat marking also occurs. Gold-base and manganese-base brazing alloys are used for joining these stainless tubes into an integral, gas-tight chamber.

Fig. 1 Rocket engine section showing brazed tube construction and heat marking.

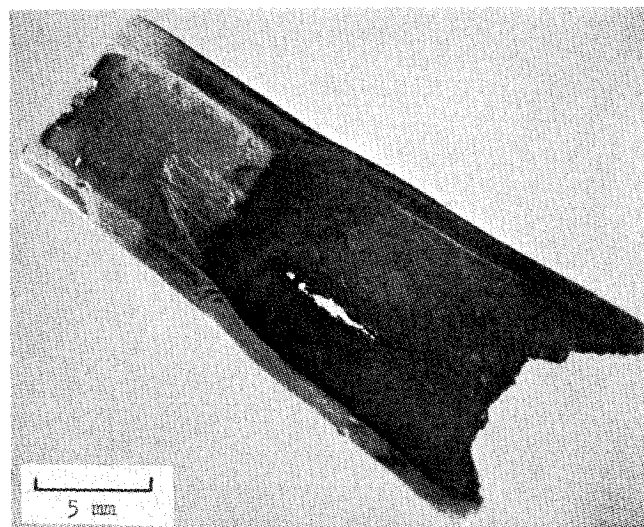
Figure 2 shows the nature of the failure of a type 347 stainless steel tube under high heat flux conditions (16.88 Btu/in.²-sec). Note slight flaring of tube and carbonaceous deposit in the region of failure. Flaring is caused by the biaxial stresses resulting from the internal pressure in the tube at the moment of rupture. The carbonaceous deposit results from the decomposition of the UDMH in the Aerozine-50.

Fig. 2 Failure of type 347 tubing under burn-out conditions.

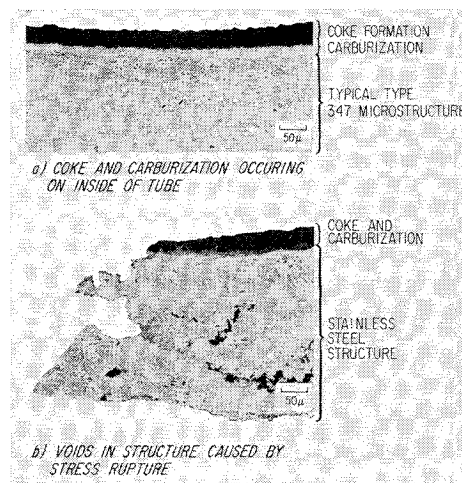
Fig. 3 Edge of fracture on burn-out failure.

Photomicrograph Fig. 3a shows the coke formation and some carburization beneath the coking on the inside of the tube in the vicinity of the failure (burn-out). Figure 3b shows the edge of the fracture and the voids show the metal was separating at the elevated temperature.

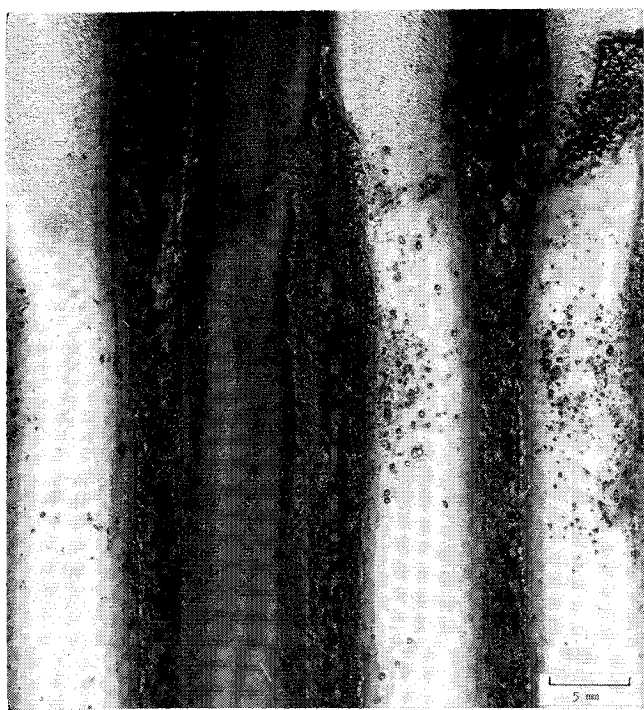
Heat-marking is defined as the discoloration of the type 347 stainless steel tubing that occurs in the thrust chamber and is usually located below the throat. In regeneratively cooled thrust chambers, only isolated tubes, generally up-tubes, will show heat-marking whereas adjacent tubes do not. However, by metallography, it is possible to show that in heat-marked tubes, the structure is carburized and not oxidized. A polished but unetched stainless steel will reveal oxidation if it is present, but carburization is only brought out by etching. Chemical analysis, of course, confirms the presence of carbon. Figure 4 shows the appearance of a section of a heat-marked tube. Note that on either side, the tubes are bright except for the splatter of braze metal removed from between the tubes. A heat-marked tube is a carburized tube. See Fig. 5, which shows a photomicrograph of such tube. The tube surface shows a thin layer of a carburized structure. The grain size is also coarse (ASTM grain size is 5.5, compared to an as-received ASTM grain size of about 10).

Fig. 4 Heat-marked (black) tube in vicinity of bright tubes.

Roughening of tube material is often observed. Roughening due to the resolidification of remelted braze material has been referred to before (see Fig. 4). Carbide deposits are shown in Fig. 6. Roughening, representing metal loss, is often found in association with pinholes and cracks.

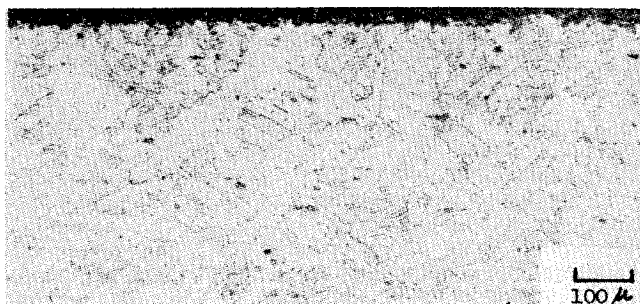
Because carburization of type 347 stainless steel only occurs above about 780°C (1530°F), the tubes must have experienced rather high temperatures.¹ Tube temperatures above 780°C are not unreasonable in the engines. The coarse grain size in Fig. 5 suggests temperatures as high as 1095°C (2000°F).³

Fig. 5 Microstructure of heat-marked tube shows carburized (mottled) layer and coarse grain size.

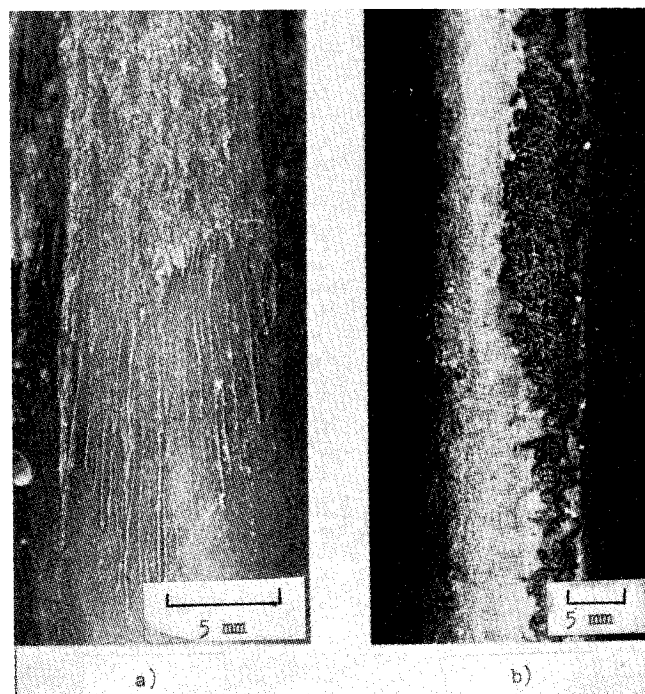
apparently melted from the tubes. Figure 6a shows a beaded spray and Fig. 6b shows the crystallized material. This material had been assumed to be molten metal, but x-ray analysis identified it as carbide, $\text{Fe-Cr}_7\text{C}_3$, that had formed, melted, and resolidified.

Various melting temperatures have been observed for this carbide, some as low as 1095°C (2000°F) and some as high as 1260°C (2300°F). Variation in melting temperature is probably due to different carbon contents in the carbide.

Fig. 6 Two types of resolidified carbide, $\text{Fe-Cr}_7\text{C}_3$: Beaded spray and crystallized.

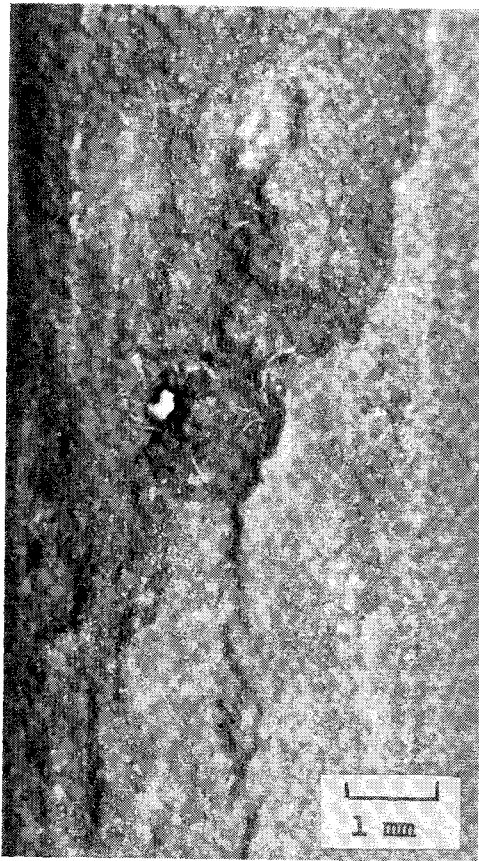
Pinholes, such as shown in Fig. 7, are perforations of the tube wall. The holes are always in a roughened area, often in association with cracks.

Fig. 7 Pinholing and associated roughening.

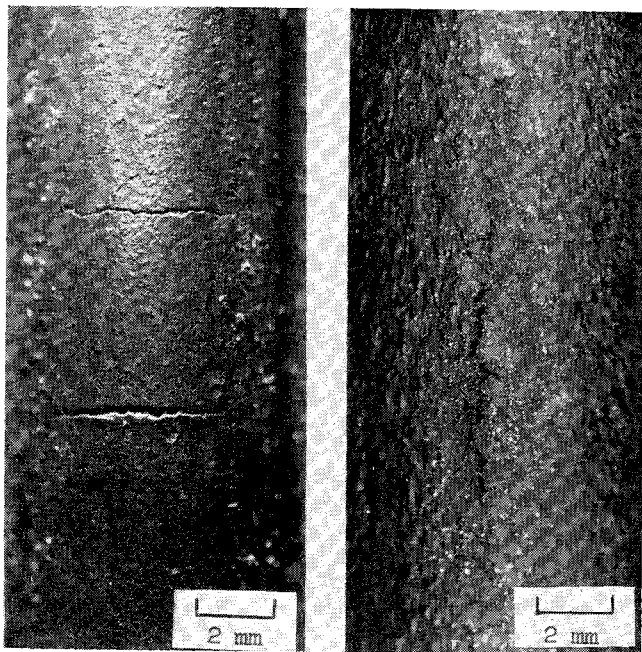
Tube cracking, sometimes transverse and sometimes longitudinal, is often observed on overheated tubes. These types of cracking are shown in Fig. 8. Longitudinal cracks, when they penetrate the wall, are called splits.

Fig. 8 Transverse and longitudinal cracking on distressed tubes.

One unfortunate consequence of the carburization is the loss of ductility of the carburized type 347.⁶ Figure 11 shows the loss of ductility (i.e., elongation) of the steel with carburization. Figure 8 shows the type of transverse cracking that also develops when a carburized steel is pulled in tension. The formation of a nitride case lowers the ductility of the type 347 even more than does the carburization,⁷ and similar cracking also occurs.

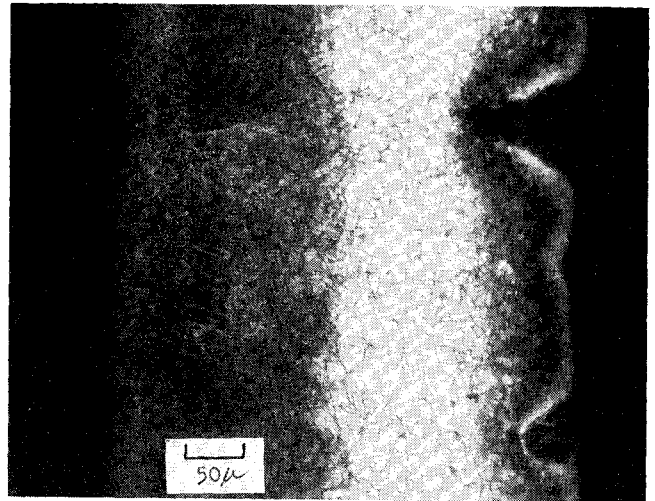
Figure 9 shows the microstructure in the vicinity of cracks. Note carburization (black areas) on the external surface. Note the carburized (black) and the nitrided (white) zones on the internal surface. Severe metal loss on the internal diameter and crown cracking are shown in Fig. 10. Carbu-

Fig. 9 Microstructure of distressed type 347 stainless steel tube.

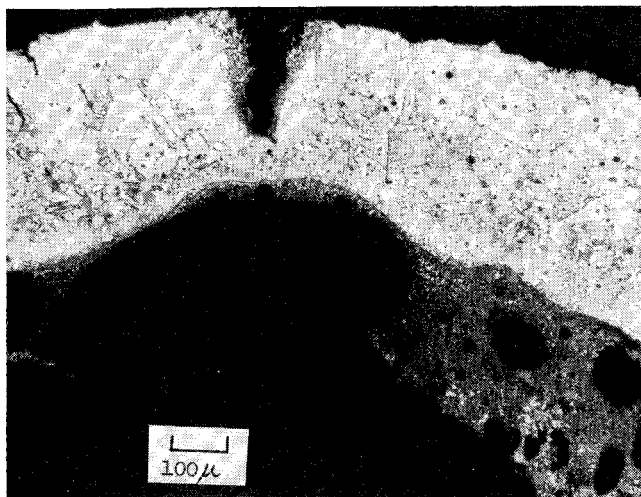
rization on the crown is absent, but it may have melted away. The internal surface shows a porous structure of carbide and nitride that apparently is readily detached.

Obviously, the carbide, because of its extensiveness, and probably to some extent the nitride, cause a reduction in ductility, and with dimensional changes resulting from thermal transients, cracks develop. However, in addition to the notches (cracks), there appear to be large areas internally where metal has been dislodged from the distressed areas (Fig. 10).

Fig. 10 Microstructure of another distressed area showing cracking and wall thinning.

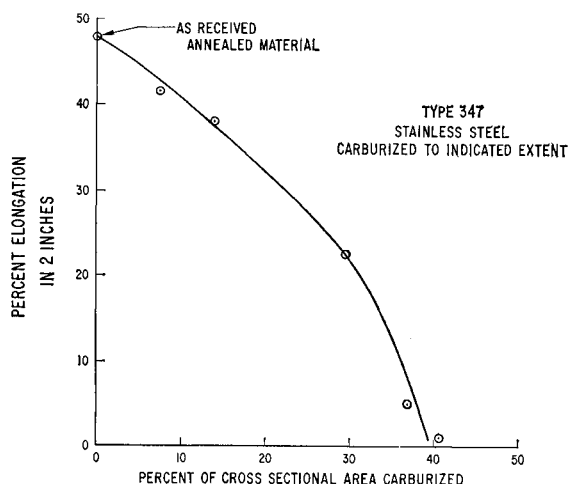
Fig. 11 Curve shows a decrease in ductility (elongation) when the stainless steel becomes carburized.

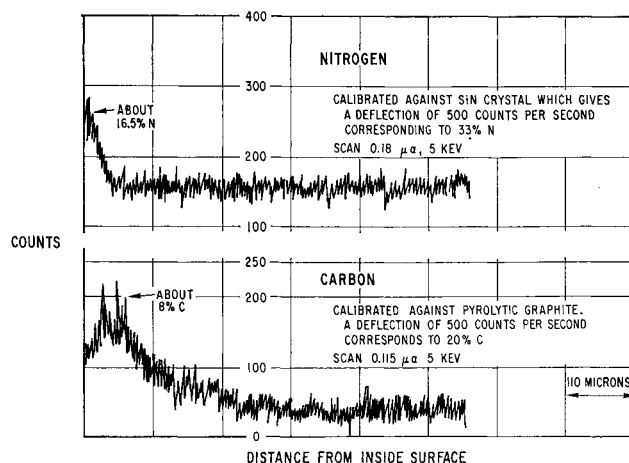
Microprobe traverses were made on the internal surface to identify the carbide and nitride zones (see Fig. 12). The traverse verifies the observation made in Fig. 9 that the nitrogen is on the immediate surface. The dark-etching zone is a carburized structure consisting of carbide ($\text{Fe} \cdot \text{Cr}_7\text{C}_3$) and austenite (face-centered cubic solid solution). The light etching constituent on the inside surface of the tube, superimposed on the carburized layer, is a nitride ($\text{Fe} \cdot \text{Cr})\text{N}$.

Fig. 12 Microprobe traverses on the inside of a distressed type 347 stainless steel tube.
