## Hypervelocity Impact Tests on Space Shuttle Orbiter RCC Thermal Protection Material

Donald H. Humes\*

NASA Langley Research Center, Hampton, Va.

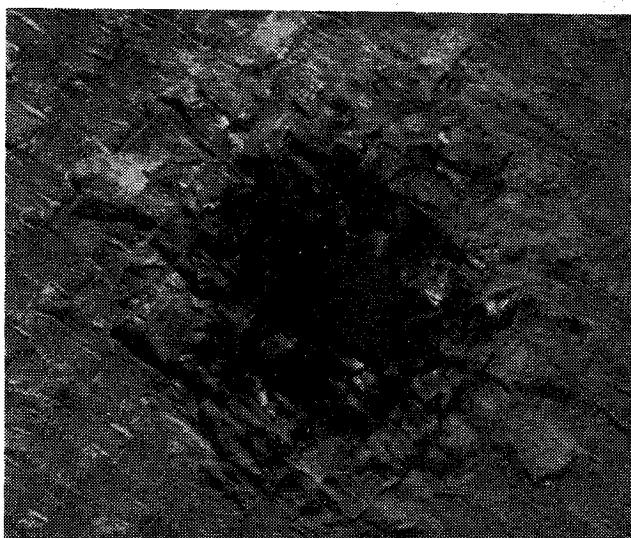
The specimens were completely penetrated when the impact energy was 34 J or greater. The size of the hole and the area damaged on the front and back surfaces are given in Table 1.

Fig. 1 Front surface of specimen 3-77 after impact by 37-J projectile.

Notice that the rear surface was damaged more extensively than the front surface. The shock wave originating at the impact site caused delamination near the back surface when it was reflected from that surface. Much of the delaminated material was lost as detached spall while some remained attached. A photograph of the front surface of a specimen which was completely penetrated is presented in Fig. 1.
