Aberrant halt of syringe pump motion: an improved system to prevent false setting of the syringe

Key words Syringe pump · Aberrant movement halt · False setting of syringe

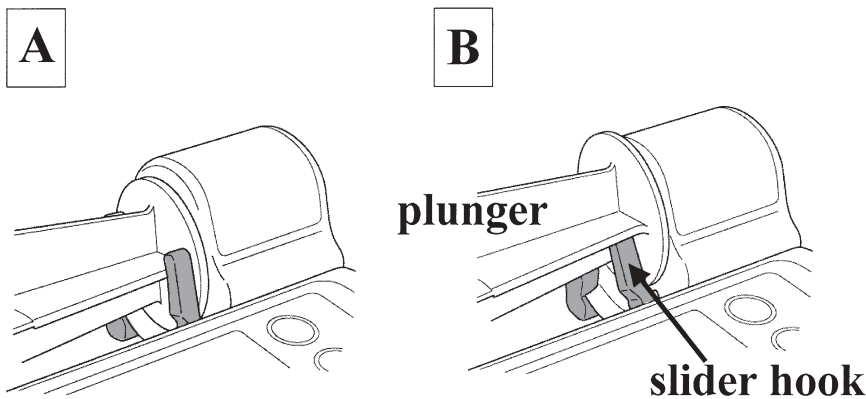
We therefore supposed that the aberrant halt of the syringe pump movement was caused by a false syringe setting, because (1) there was no detectable abnormality in the syringe pump, (2) the halt in the movement of the pump was accompanied by a syringe loss warning, and (3) the doctor observed that he felt the syringe rise when re-inserted. Taking these facts into account, we tried various kinds of false syringe settings and examined whether the situation could be reproduced. As a result, we found that the syringe false setting described here could reproduce the aberrant movement halt (Figs 1 and 2). When the plunger (called “pestle”) of the syringe was set on the slider hook (Fig. 1), the slider hook lifted the plunger of the syringe. This resulted in the syringe being gradually raised from the pump (Fig. 2), and this led to the pump sensing it as a syringe loss, and issuing the appropriate warning, followed by an aberrant movement halt. We therefore concluded that the false setting of the syringe was the cause of the problem.

Fig. 1. Setting of the syringe. **A** Correct setting; **B** false setting (the plunger of the syringe was lifted by the slider hook)

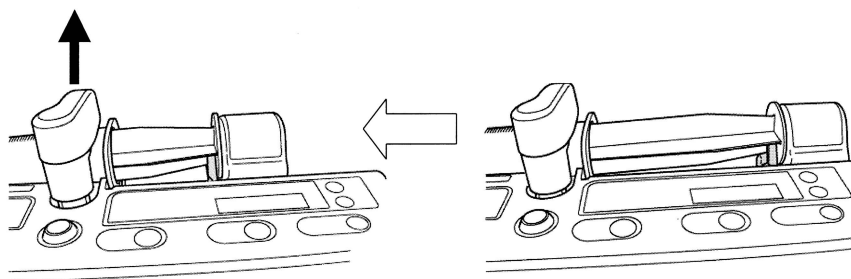
Fig. 2. Syringe loss warning. When the plunger is pushed, the syringe rises (vertical arrow), and a warning occurs

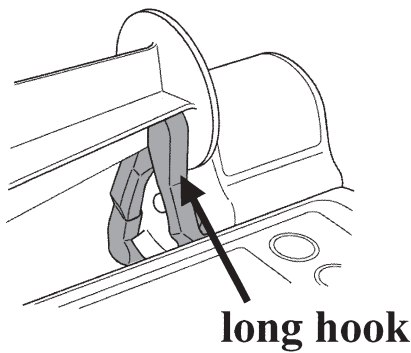
Fig. 3. Mechanism for preventing false setting of the syringe. We lengthened the slider hook. If the syringe is wrongly positioned, the pin for syringe detection comes off, and a warning occurs. Therefore, the syringe pump does not start

malpositioning. Therefore, we asked for the development of a system whereby a false setting itself could be impossible. As a result of much deliberation and discussion, we concluded that improvement of the slider hook was the simplest, easiest, and most effective way to overcome this problem. Keeping this in mind, the manufacturer set about to improve the slider hook. After some trials, they found that lengthening the slider hook resulted in an alarm sounding immediately the syringe was wrongly positioned (Fig. 3). This improvement made a false setting itself totally impossible, by virtue of the design of the hook.
