ESCA and Other Morphological Investigations of the Brittle Failure Caused by an Environmental Stress Cracking (ESC) of a HDPE Milk Crate*

A. K. KULSHRESHTHA, V. K. KAUSHIK, G. C. PANDEY,
S. CHAKRAPANI, and Y. N. SHARMA, *Research Centre, Indian
Petrochemicals Corporation Ltd., Baroda 391 346, India*

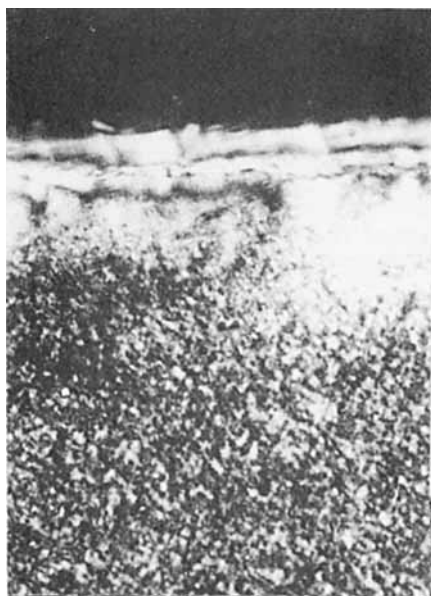
(a)

Figure 1 shows two polarized light photomicrographs of cross sections of the wall of the milk crate. The existence of a surface layer (termed the "oxidation skin") can be clearly distinguished from the bulk structure of HDPE crate [Fig. 1(a)]. This layer is nonspherulitic and is bestowed with a structure which is different from the structure of the bulk HDPE material. Formation of this layer very probably occurs as a result of the oxidative degradation of the milk crate surface.¹⁴ A photomicrograph of the bulk material of the milk crate [Fig. 1(b)] reveals an imperfect spherulitic structure consisting of very small spherulites which were formed during quenching of the melt. This figure also shows a pigment particle having dimensions much larger than those of spherulites.

Fig. 1. Photomicrographs (magnification: $200\times$) of cross sections of the wall of the milk crate, taken with crossed polars.

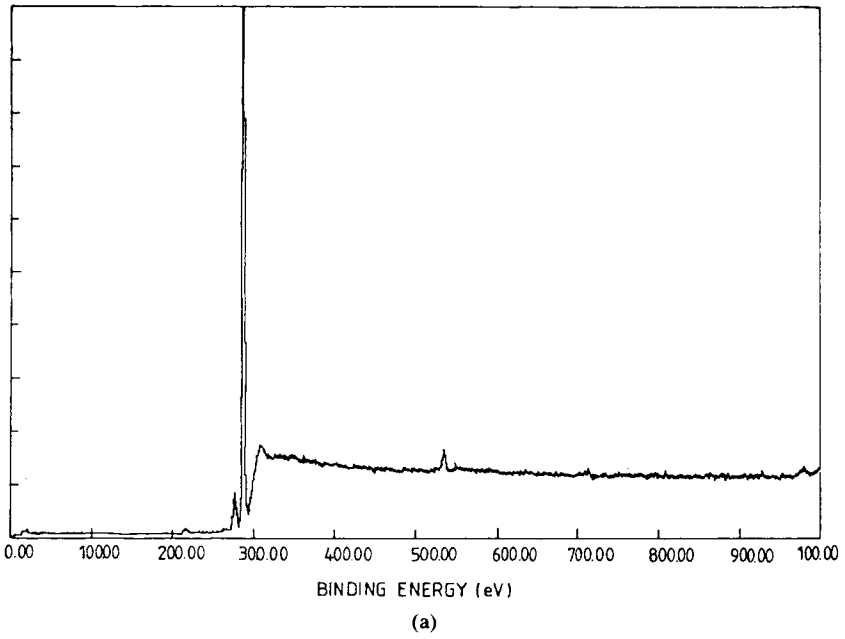
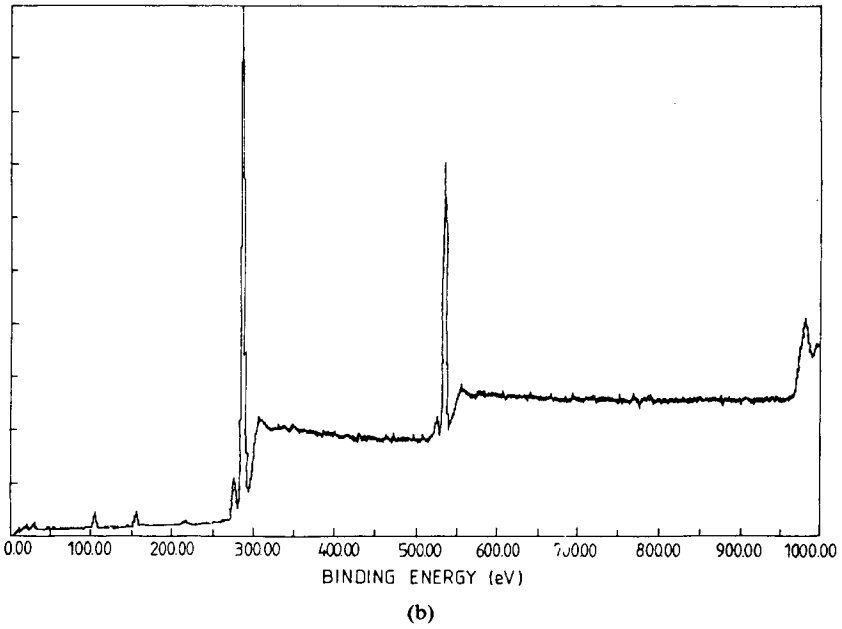
In order to better understand the nature of surface chemical changes occurring due to aging and weathering of the milk crate during service, ESCA spectra were obtained from microtomed sections of the surface and of the interior of the crate wall (Fig. 2). A comparison of the spectrum of the interior or bulk material [Fig. 2(a)] with the spectrum of weathered, degraded surface [Fig. 2(b)] brings out the following facts:

(a) A sufficient amount of oxygen has been incorporated on the surface of HDPE crate after weathering. An atomic concentration calculation of data reveals that incorporation of oxygen has increased from 1.9 atomic percentage in the bulk to approximately 13% on the surface. This finding supports the diffusion-controlled mechanism^{15,16} of autooxidation of HDPE, in which oxidative degradation begins at the surface and penetrates below in proportion to the concentration gradient of oxygen present at successive depths. It is observed that when oxygen is incorporated by different treatments of polymer surface modification, a broadening of the carbon region of the spectrum occurs^{17,18} due to the formation of carbon-oxygen bonds. In the present work, a deconvolution of data was not attempted because the line positions¹⁹ of HDPE carbon-oxygen bonds are crowded together²⁰ at 286.6, 287.9, and 289.1 eV (attributed to bonds of one carbon atom with one, two, and three oxygen atoms, respectively). ESCA spectra of the carbon region of the bulk and surface layers of milk crate are illustrated in Figure 3, where the line positions have been indicated. The oxygen (1S) spectrum was less informative, giving a single broad band at 532.8 eV which could not be subjected to further analysis.

(b) Lines at 102.4 and 152.3 eV signal the presence of silicon on the weathered milk crate surface. The origin of this silicon may be in air-borne silica particles¹⁹ which contaminate the milk crate during its service life.

(c) Traces of calcium and chlorine have been detected on the weathered polymer surface by ESCA. These may originate from polymer additives which migrate to the surface: calcium stearate (lubricant) and Tinuvin 327 (UV stabilizer).

Fig. 2. (a) XPS spectrum of the interior of the milk-crate wall; (b) XPS spectrum of the surface of the milk crate.

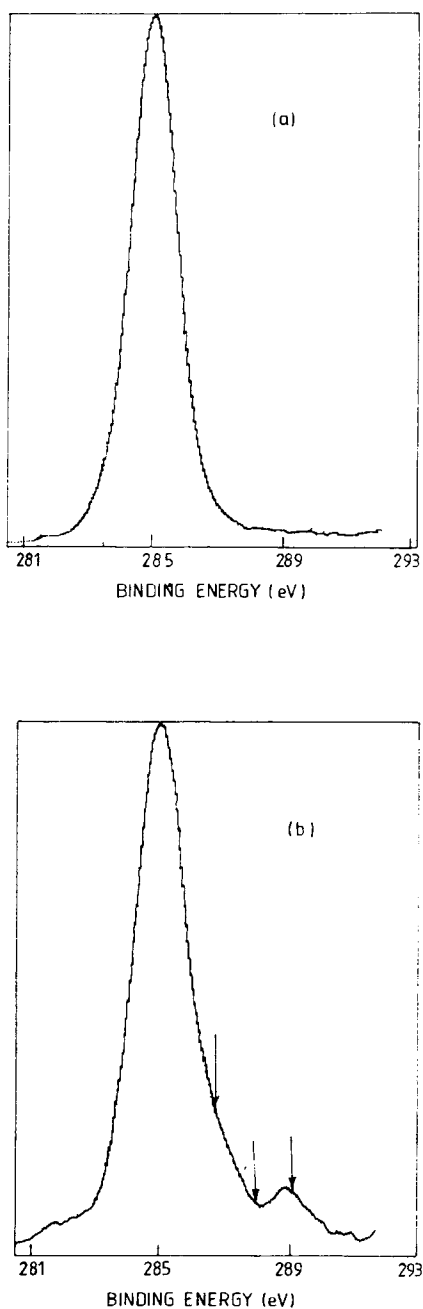
Fig. 3. Carbon region of (a) bulk and (b) surface layer of the weathered HDPE milk crate.

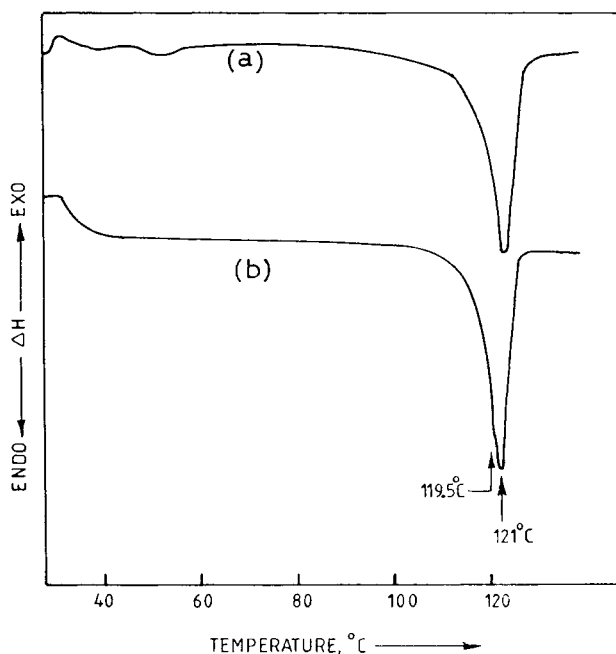
DSC scans of the microtomed surface layer and the bulk material have been compared in Figure 4. Whereas the bulk material gives rise to a single peak,

the surface layer contributes a bimodal endotherm. The bimodal character of the thermogram of the surface layer arises from its biphasic structure, which itself is a consequence of the rejection of crosslinks from the crystalline phase.¹⁴ According to this explanation, the 121°C peak corresponds to bulk HDPE whereas the 119.5°C peak corresponds to crosslinked HDPE phase

Fig. 4. DSC scans of microtomed sections of the milk crate: (a) bulk; (b) surface layer.

(Fig. 4). An alternative explanation for bimodal thermograms of the surface layer can be provided in terms of a segregation of low molecular weight and high molecular weight phases,¹ each phase giving rise to a different peak. It is difficult to choose any one of the two explanations offered from DSC data because both incorporate a phase that can be *brittle*, namely, the crosslinked phase and the low molecular weight material, respectively.

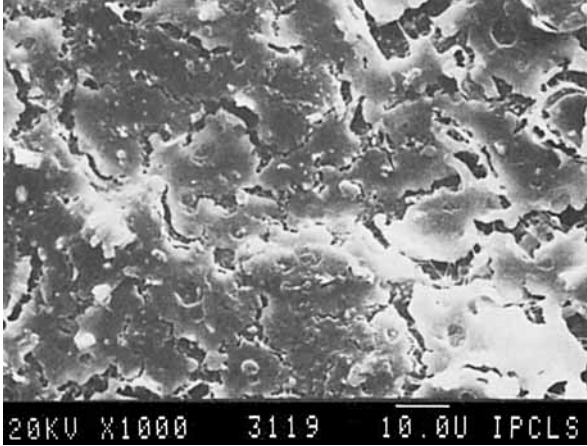
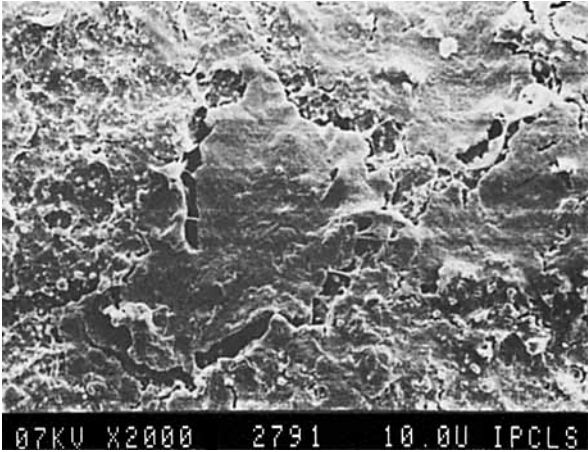
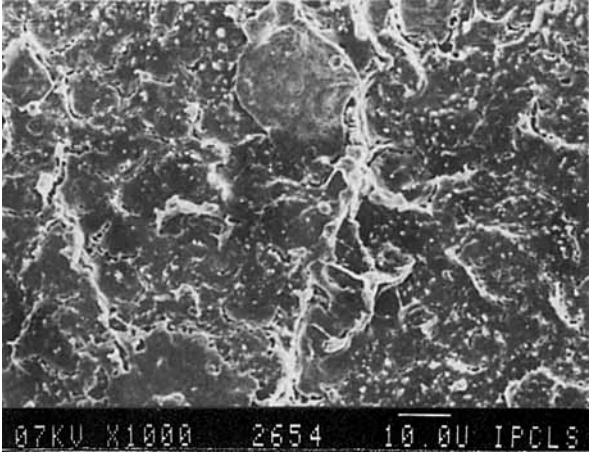
SEM photomicrographs illustrated in Figure 5 support the formation of a brittle surface layer^{12,14} on the fracture surface of the milk crate. Micrographs reveal a large number of cracks spread all over the fracture surface. These cracks are rather wide and have few "tie fibrils" connected across their width. Because the surface layer resembles a skin and has a finite thickness, it is very brittle. As a consequence, it gets easily detached from the fracture surface [e.g., the portion at the left in Fig. 5(b)], revealing the inner subsurface lying beneath the surface layer. This region underlying the fracture surface also exhibits a large number of cracks, shows very little fibrillation, and reveals a very large concentration of polymer additives (micro- and submicroparticles) which are migrating to the surface, resulting in their loss and depletion. Figure 5(c) shows two large pigment particles, one located near the top left and the other located near the top middle, the sizes of both particles exceeding 10 μm . On the other hand, the sizes of polymer additives are usually less than 1 μm . Summarizing the present SEM data, it can be concluded that the fracture of the milk crate is brittle. The surface layer has a structure which is nonspherulitic.

Fig. 5. SEM micrographs of the fracture surface of the milk crate.

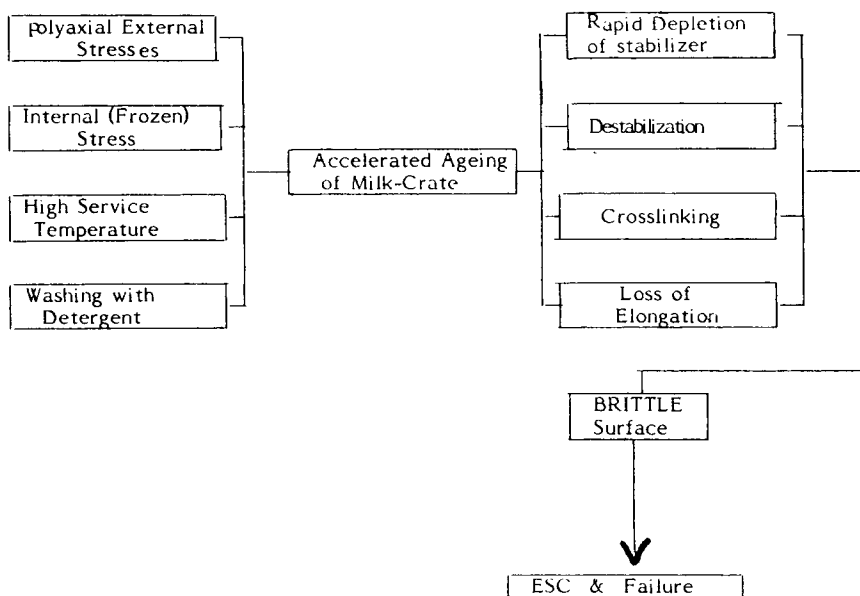
Aggressive environmental factors to which a milk crate is usually subjected to during its service life include its exposure to internal (frozen) and external (dynamic) stresses, impacts, temperature, sunlight, detergent, etc. After the milk crate has been in service over a substantial period, it becomes unprotected and vulnerable to degradation. The effects of accelerated aging and destabilization are maximum in the surface layer where the degradation is very pronounced. As a consequence of degradation, structural and morphological changes (crosslinking, embrittlement, loss of elongation) occur in the surface layer which reduce its resistance towards fracture initiation and eventually cause a failure of the milk crate (Fig. 6). Oxidative crosslinking of HDPE and a low number of tie fibrils^{13, 21} contribute to the brittleness of the oxidation skin. At low stress levels, a series of sharp cracks form on the surface which tend to propagate through the crate wall in a brittle way. A brittle failure of HDPE can also occur due to detergent-induced ESC.^{7,13} A catastrophic failure of the milk crate ensues, terminating its useful service life rather prematurely.

Fig. 6. A model of the probable mechanisms operating during the service life of the milk crate, resulting in its premature failure.

In order to prevent a premature failure of plastic articles, which are subject to aggressive handling when in service, the following precautions seem to be necessary:

(a) Since the protective agents (e.g., antioxidants, stabilizers, etc.) are consumed much more rapidly in plastics subjected to dynamic stress than in plastics aged in absence of stress,²² it is necessary to boost stabilizer levels in plastics or use more effective stabilizers in conjunction with mobilizing additives.²³

(b) Rapid cooling of a molded plastic leads to development of fine spherulitic structure and the lowest practical crystallinity in the material. Formation of impurity-rich, brittle spherulitic boundaries is prevented by rapid cooling.¹ Low matrix crystallinity and small spherulitic sizes ensure a better acceptance of stabilizers,²³ on the one hand, and improved crack resistance, on the other.^{24,25}

(c) Crack resistance of plastics can be enhanced by increasing their molecular weight²⁵ and by removal^{1,4} of brittle low molecular weight material (i.e., by narrowing the molecular weight distribution²⁶). The resistance to failure of plastic will depend on the number of tie molecules,²⁷ and this has been shown to depend on molecular weight.²⁵ Low content of tie molecules contributes to brittleness.
