# Phenomenology of Surface Failure of Poly(methylmethacrylate) Resulting from Rolling Contact Fatigue

S. M. HOSSEINI and T. A. STOLARSKI\*

Department of Mechanical Engineering, Brunel University, Uxbridge, Middlesex, UB8 3PH, United Kingdom

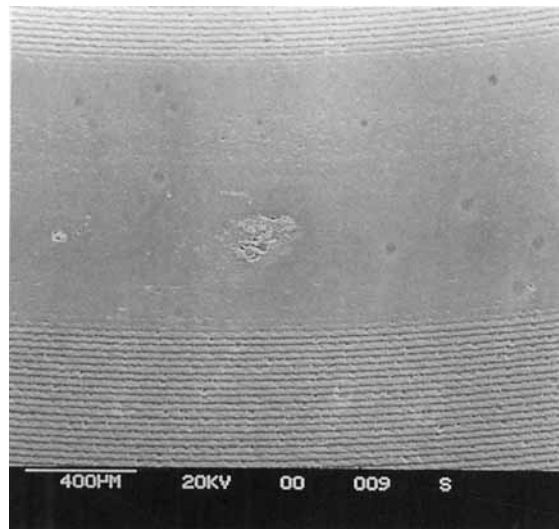
**Figure 3** Overview of contact path and adjacent regions with visible machining marks. Damage located within contact zone is also visible. Test conditions: contact stress, 2.9 GPa; upper ball rotational velocity, 2000 rpm; duration of test to failure, 37 h ( $13.32 \times 10^6$  load cycles); lubricating medium, base mineral oil.

Figure 3 is an overview of a typical appearance of the surface of a PMMA disc tested for 37 h in the presence of Talpa 20 at the speed of 2000 rpm (this is the rotational speed of the upper ball) and the

contact stress of 2.9 GPa. Three elements can be distinguished. Clear machining marks are visible on both sides of the contact path, which appears as a smooth band whose width represents the size of the contact region. Approximately in the middle of the contact path surface damage is visible. It is seen that the damage is in the form of an isolated pit and there are considerable stretches of surface where no damage has been produced. This is a characteristic feature of surface fatigue. It can be safely said that the damage was initiated at a point on the surface where some imperfection or weakness existed prior to testing.

It is important to stress that the failure of PMMA, in the form depicted by Figures 3–8, was confined to the surface only and was produced after 37 h of testing under quite heavy load of 2.9 GPa. In terms of load cycles on any point of surface within the contact region, the time to failure corresponds to  $13.32 \times 10^6$  load cycles.

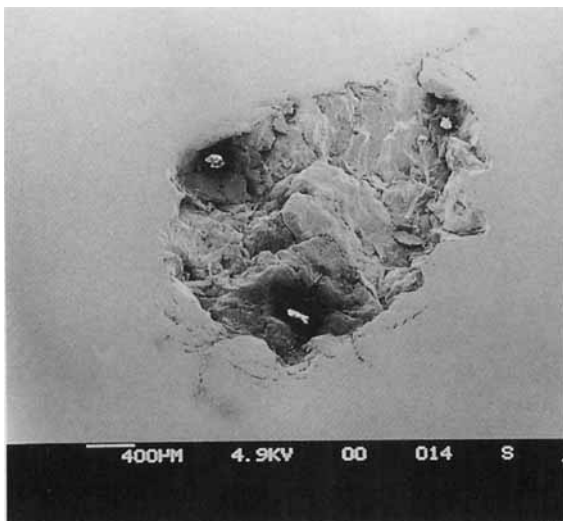
**Figure 4** View of pit produced on surface under test conditions specified in Figure 3 legend.

Figure 4 shows the surface damage of the previous figure at higher magnification. More details characteristic of surface fatigue emerged. The pit itself is filled with debris of material, and at its edges, a network of cracks has formed. Figure 5 gives even more details about the damage produced. The pit edge region is shown at various magnifications in Figures 6–8. From these micrographs a clear picture of the mechanism responsible for the surface damage of PMMA emerges. Apparently, initial damage is in the form of a pit (see Figs. 3 and 4) and spreads by creation of a network of cracks outside the pit. These cracks eventually merge and create another pit. It is possible that the pits themselves might eventually merge to create large-scale surface failure.

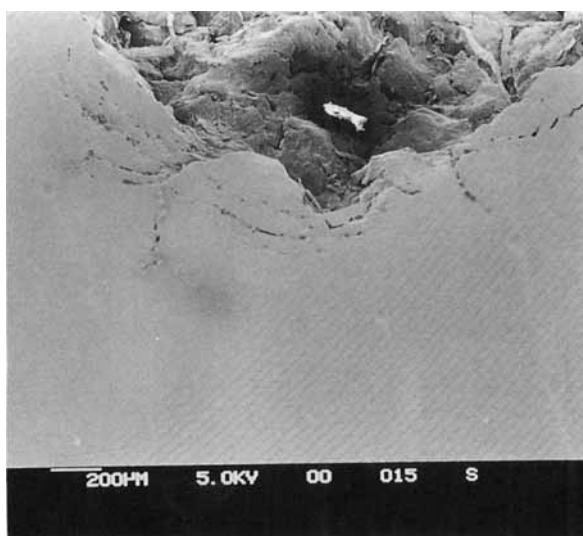
**Figure 5** Details of pit of Figure 4 at higher magnification.

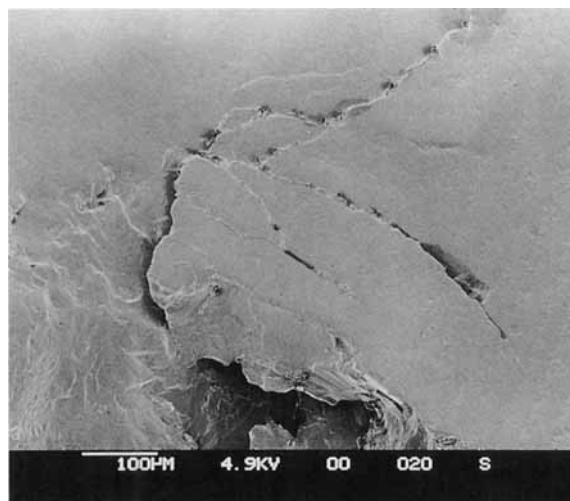
**Figure 6** Shelflike feature produced by crack extending into material. Pit visible at bottom of micrograph gives some indication about depth of crack.

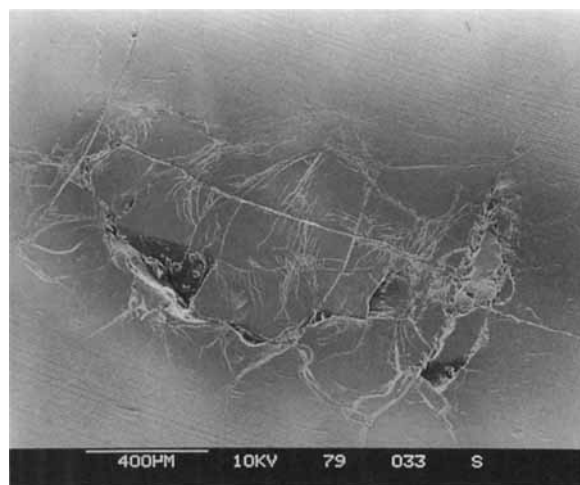
**Figure 7** Details of cracks shown in Figure 6 but at higher magnification.

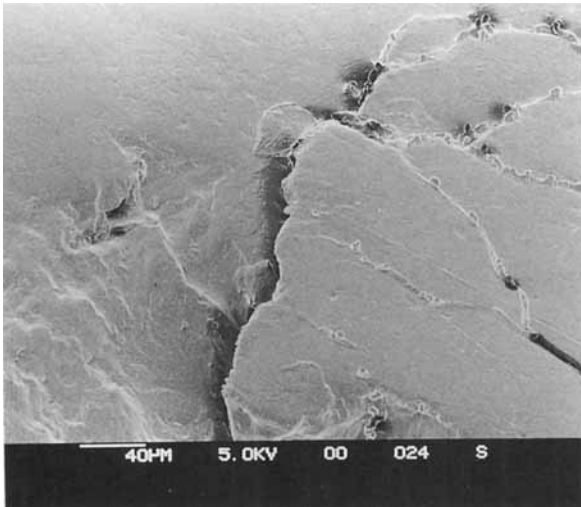
**Figure 8** Higher magnification of area shown in Figure 7.

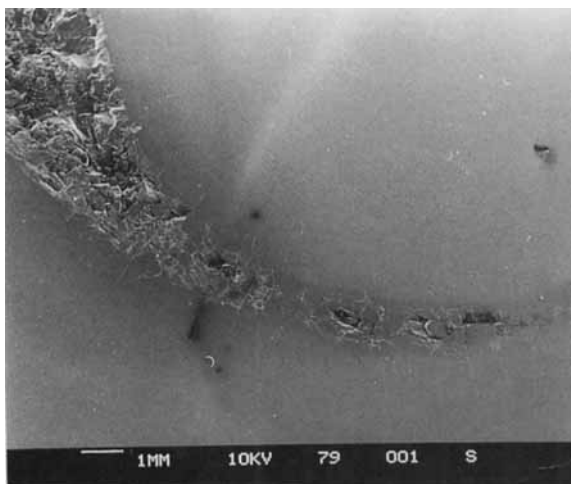
**Figure 9** Overview of surface damage produced on surface of PMMA during rolling contact fatigue test under following conditions: contact stress, 2.3 GPa; upper ball rotational speed, 2000 rpm; test duration, 5 h and 55 min ( $2.13 \times 10^6$  load cycles); lubricating medium, brake fluid.

Figure 9 shows a fairly large portion of the contact path which illustrates the type of failure produced in the presence of brake fluid. Unlike the failure obtained in the previous case, this time the damage inflicted on the polymer is much more severe. Figure 10 is an example of an early stage of the failure process. A network of cracks is clearly visible as well as some pits. Figures 11 and 12 show, at different magnifications, characteristic features of the damage. The pits are still isolated from each other. With the progress of the failure process, cracks and pits tend to coalesce and surface damage on a macroscale is produced. This is well illustrated in Figure 13. It took only 5 h and 55 min ( $2.13 \times 10^6$  load cycles) to produce damage to the extent shown in Figure 12. The rotational speed of the upper ball was 2000 rpm and the contact stress 2.3 GPa.

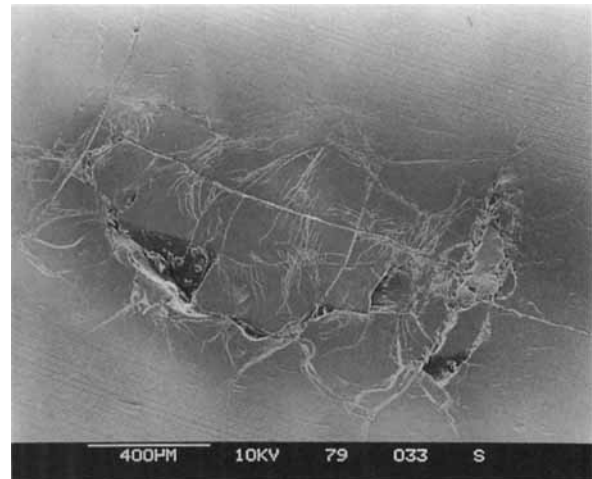
**Figure 10** Typical early stage form of surface failure produced under test conditions specified in Figure 9 legend.

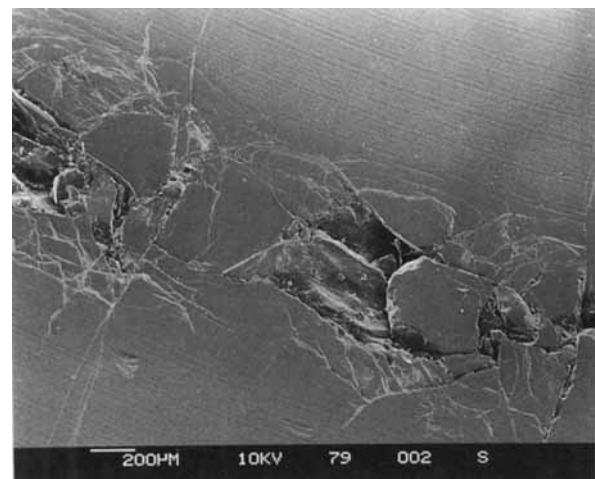
**Figure 11** Example of progress in surface failure process (test conditions as specified in Fig. 9 legend).

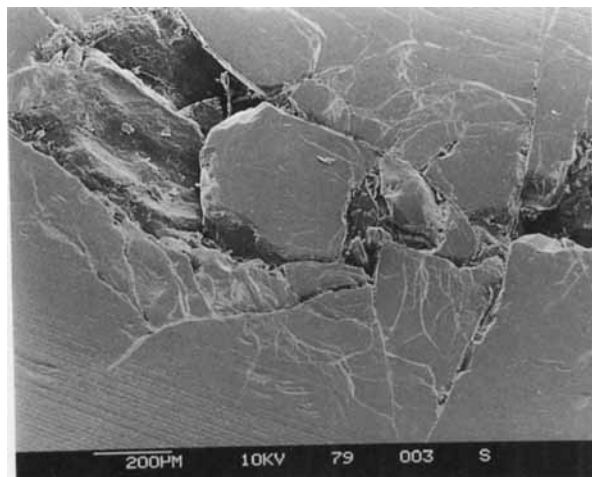
**Figure 12** Details of damage shown in Figure 11 but at higher magnification.

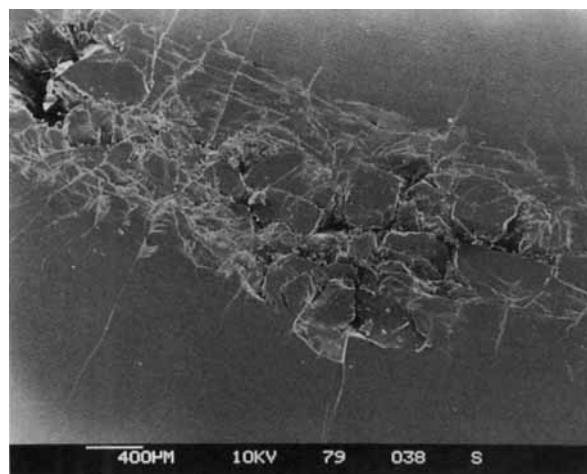
**Figure 13** Typical macroscale form of damage characteristic for final stage of surface failure process.
