Striped-Pattern Deterioration and Morphological Analysis of Injection Moldings Comprising Polypropylene/Ethylene α -Olefin Rubber Blends. I. Influence of Ultraviolet Irradiation

ABSTRACT: Unique deterioration with a periodical striped pattern on the injection moldings of polypropylene/rubber blends is reported. After exposure to ultraviolet irradiation with a sunshine fade meter, striped patterns appeared on the injection moldings along the flow direction of the molten resin during the filling process of injection molding, even though the initial specimen showed no sign of any stripe pattern on its surface. The stripe was carefully observed with ultrasonic echo imaging, scanning electron microscopy, transmission electron microscopy, and Fourier transform infrared spectroscopy. As a result, a number of microvoids were observed

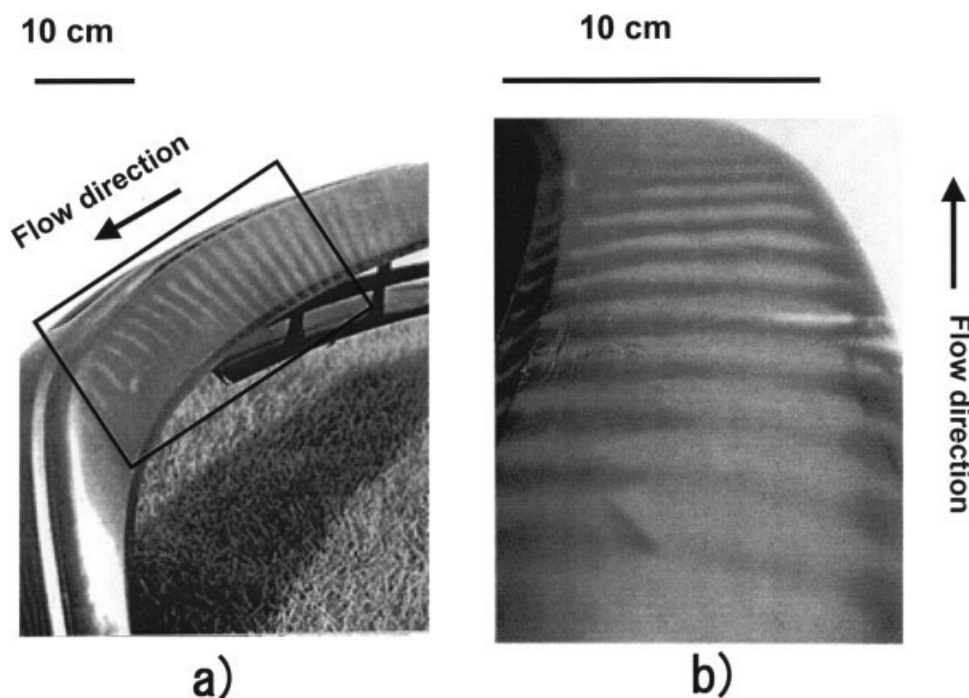
Figure 1 shows typical striped-pattern deterioration of an injected bumper composed of PP/rubber blends (sample E in Table I) after exposure for a year in Okinawa Island, a southern part of Japan. A striped pattern formed by the alternation of strongly and weakly whitened parts can be easily seen by the naked

Figure 1 Typical patterns of the striped deterioration of real parts composed of the PP/rubber/talc blend (sample E) caused by outdoor exposure: (a) left half of the bumper and (b) macrograph of the bumper.

eye. The tiger stripe was not severe as in this photograph just after molding (in its initial state). However, both sunshine and weather induced such severe deterioration on the tiger-stripe pattern. In this sample, glossy (darkish) and cloudy (whitish) parts of the original tiger stripe became weakly and strongly whitened parts, respectively. Here this deterioration with a striped pattern was paid special attention.

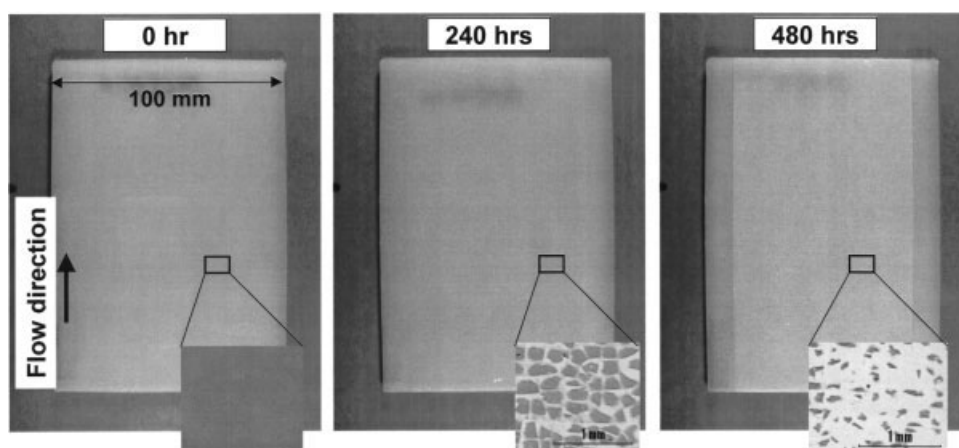
Figure 3 Photographs of the bPP (sample A) dependent on the UV-irradiation time.

The appearances of samples A and C, dependent on the irradiation time, are compared in Figures 3 and 4, respectively. No striped pattern was observed in the original specimen before UV exposure for both samples A and C by the naked eye or a confocal scanning laser microscope, as mentioned later in Figure 7. In sample A, the surface roughness increased with increasing elapsed time. This result was explained in terms of microcrack growth, which is shown in the macrophotograph of Figure 3. This was general deterioration for PP.¹⁷ In contrast to sample A, a striped pattern developed on sample C with increasing irradiation time. This stripe was formed by the alternation of strongly and weakly whitened parts (indicated as S

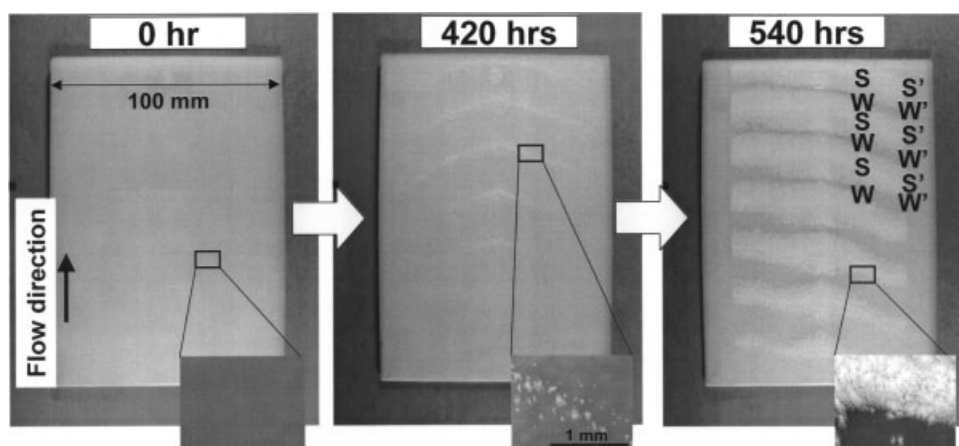
Figure 4 Photographs of the PP/rubber binary blend (sample C) dependent on the UV-irradiation time.

and W, respectively, in Fig. 4). The macrophotograph shows that small, whitened domains occurred with irradiation. Moreover, a number of these whitened domains became dense with increasing irradiation time, especially in the strongly whitened part. A similar stripe was observed on sample D.

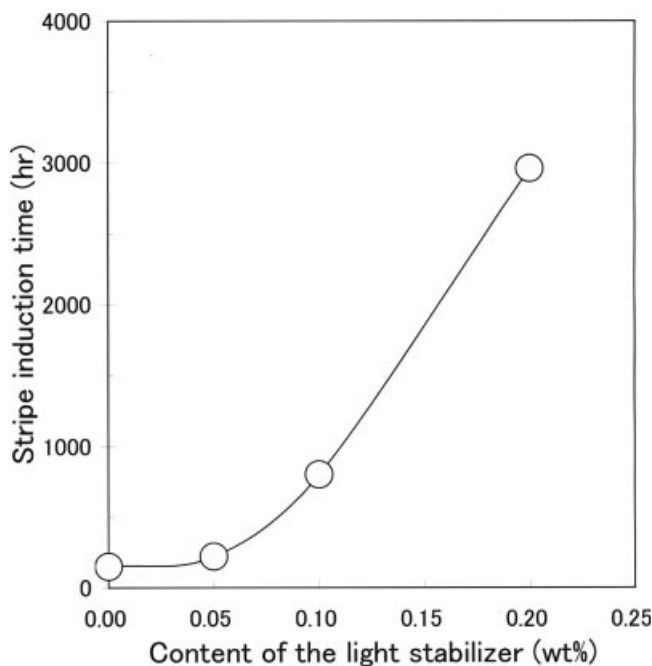
Figure 5 Induction time of the deteriorated stripe versus the light stabilizer content (sample C).

For sample C (PP/rubber binary blend), the effect of the light stabilizer was confirmed on the basis of the content dependence of the stabilizer (Fig. 5). With increasing stabilizer content, the induction time of the deteriorated stripe clearly increased. Here, it was defined as the time at which narrow whitened lines approximately perpendicular to the flow direction (just like a pinstripe) were first detected by regular daily checking during the exposure experiments. This result was very important because of the distinct evidence that indicates the deteriorated stripe was controlled by UV but not the thermal history during the UV-exposure experiment. The effect of CB mentioned previously was also evidence.

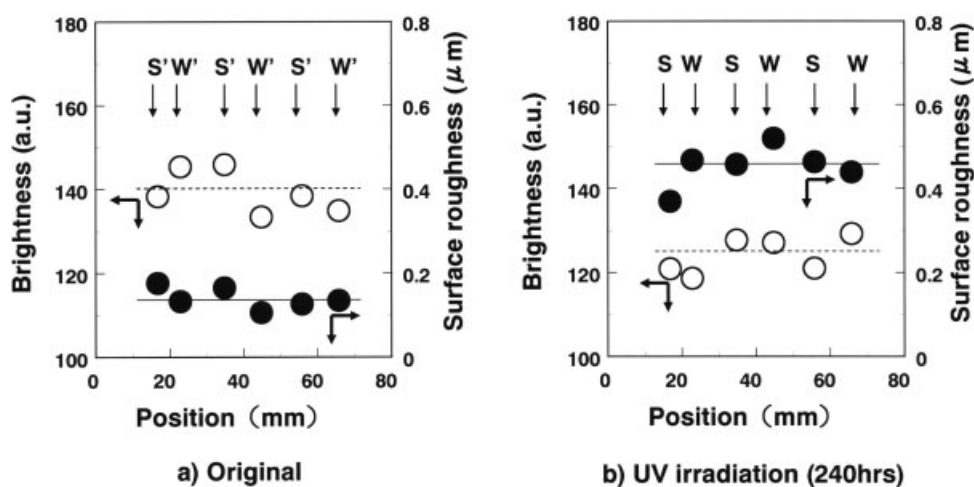
Here, the deteriorated stripe of sample C was characterized for its surface by means of confocal LSM, which could provide the brightness and roughness of a specimen's surface. Figure 7 shows the surface properties obtained with LSM. Both the brightness and surface roughness are plotted to the position along the flow direction. The original part (nonirradiation area) indicated higher brightness and lower roughness. It was clarified that the surface of the original plate had a smooth surface on the basis of these data.

On the other hand, the irradiated part indicated lower brightness and higher roughness in comparison with the original part. This meant that the irradiation made the surface entirely rough by UV deterioration.

Figure 7 Results of surface analyses with a confocal scanning laser microscope.

Incidentally, the data varied with the position, but no periodical change corresponding to S' and W' or S and W was observed. These variations of the data were allowable errors in the LSM apparatus. This result is important. Even though the conspicuous stripe was developed on the irradiated area, no striped traces were observed on the surface. The striped deterioration of the PP/rubber binary blend caused by UV irradiation did not exist on the surface. Where did the striped deterioration form?

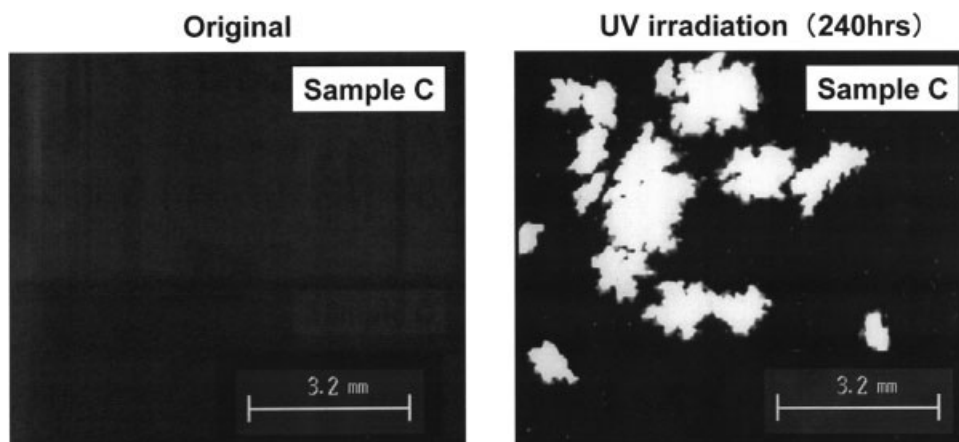
For more discussion, ultrasonic echo imaging was performed. This method is able to provide the internal structure according to the reflection and interference of ultrasonic echos.¹⁸ Figure 8 shows the imaging of sample C before and after irradiation. For the original (before irradiation), the entire view was black. This result indicated that no hollow structures existed inside the original plate. In contrast to this result, for the UV-irradiated plate, white-spotted regions were observed partially against a black background. These white-spotted regions corresponded to some hollow

structures inside the irradiated plate. The spotted region increased and grew with the time of UV irradiation, and it was large in the S part versus the W part. As mentioned later, these spotted regions were formed by the aggregation of microvoids inside the specimen.

Figure 8 Ultrasonic echo imaging of the whitened part in the striped deterioration.

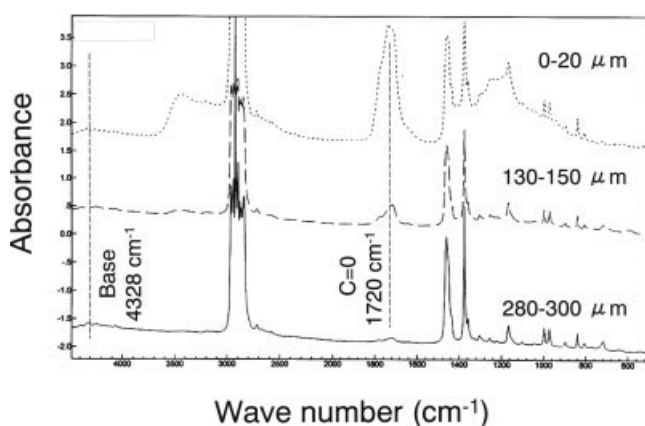
Figure 9 Depth-profile FTIR spectra of the deteriorated part (weakly whitened part of sample C after UV irradiation for 420 h).

Figure 9 shows a set of FTIR spectra dependent on the depth from the surface to the inside. The peak of 1720 cm^{-1} is assigned to C=O. The absorbance ratio of the C=O index is defined as the ratio of the peak intensity for 1720 cm^{-1} to that for 4328 cm^{-1} . The C=O index was strongest at the surface, and it decreased with increasing depth. It is clear that the peak intensity of C=O is strong at the surface.

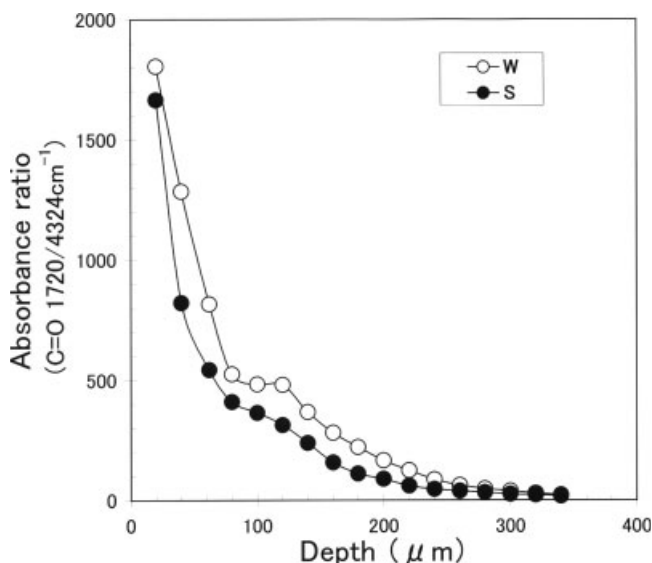
The depth profile of the C=O index of the striped deterioration is shown in Figure 10. Two profiles for the S part and W part are compared in this figure. Here, the generations of C=O were almost the same between the S and W parts. The surface was mostly

Figure 10 Depth profile of the carbonyl group (S is the strongly whitened part, and W is the weakly whitened part). Sample C after UV irradiation for 420 h.

Therefore, the chemical deterioration (C=O produced by oxidation) could not directly provide this striped deterioration because a significant difference in the C=O contents was not observed in both S and W through the depth.

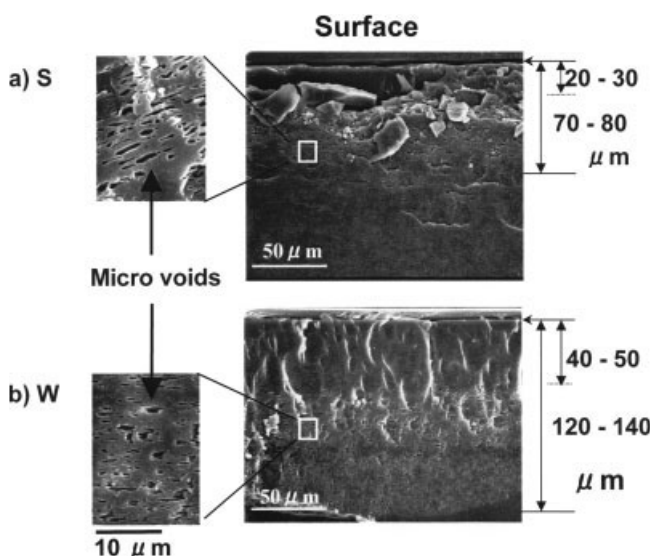
The result of the ultrasonic echo imaging shows that some hollow structures occurred inside the specimen of the PP/rubber binary blend after UV irradiation. To confirm where the hollow structure occurred, SEM observations were performed. The SEM photographs of the cross sections of the striped deterioration parts are shown in Figure 11. Here, the number of microvoids can be easily seen. Hollow structures (microvoids) certainly existed inside the injection molding in which the striped deterioration was caused, as the ultrasonic echo experiment indicated.

The microvoids occurred at about a 20–140- μm depth from the surface. In the S part, the voids existed in a shallow region. On the other hand, in the W part, the voids existed in a deeper region. The depths in which the microvoids were generated differed in these two parts of the deteriorated stripe.

In addition, no voids were observed at the surface, including extremely near the surface region. This result supported the idea that the surface

Figure 11 SEM photographs of the deteriorated stripe near the surface of sample C after UV irradiation for 420 h.

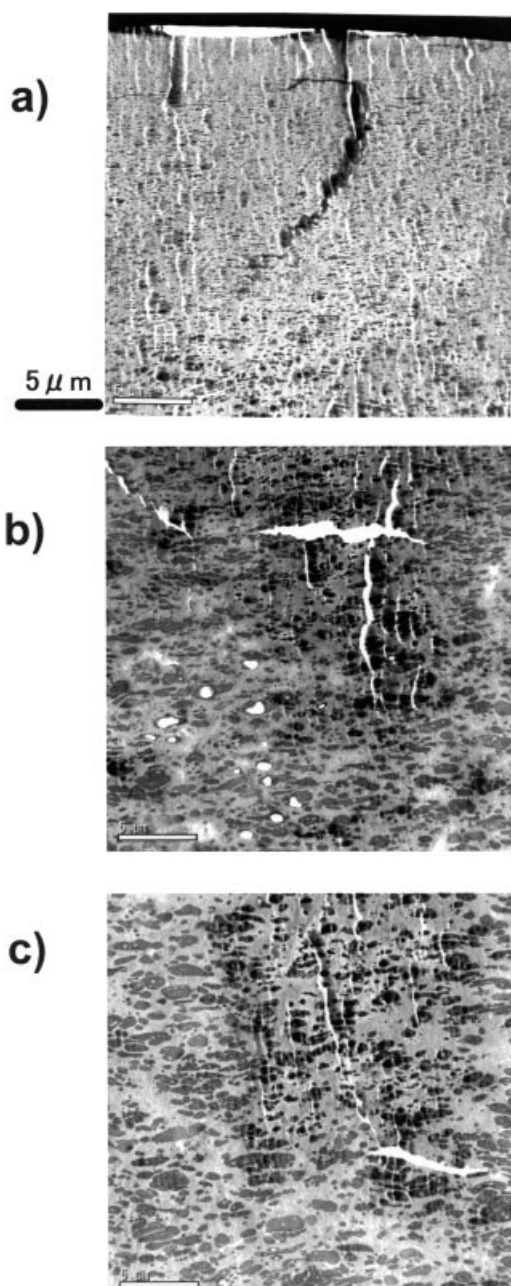
Figure 12 TEM photographs of the cross sections of a deteriorated stripe on sample C after UV irradiation for 240 h: (a) 0–20- μm depth, (b) 30–50- μm depth, and (c) 90–110- μm depth.

To discuss this on the basis of the multiphase morphology, TEM observations were performed. Figure 12 shows TEM photographs of sample C (0.05 wt % light stabilizer) after UV irradiation for 240 h. The specimen was irradiated for a longer time; it had many microvoids inside it and was too brittle to prepare an ultrathin film for TEM observation. Then, the 240-h specimen was used. In this figure, three points in the depth are shown. Some cracks appear in the photographs. They were caused by the operation with a glass knife because the specimen was brittle according to the irradiation.

In these photographs, the dark domains are assigned to the dispersed rubber phase. At the region near the surface (0–20 μm), the domain size is relatively small and highly orientated along the flow direction. In the shallower region (30–50 μm) and the deeper region (90–110 μm), the domain size is relatively large and moderately orientated.

Incidentally, where do the microvoids exist? The void can be seen in only the shallower region [Fig. 12(b), 30–50 μm], especially on the left and underside of the photograph. The other two regions do not have any microvoids, except for the cracks caused by the glass-knife operation.

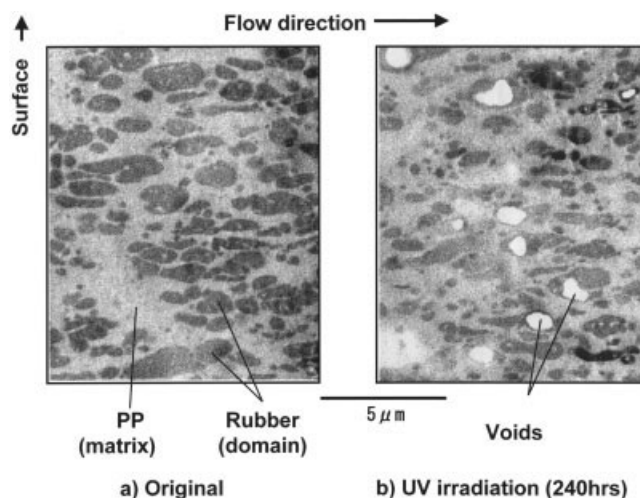
A macrophotograph of the microvoids is shown in Figure 13, in which the original part (not irradiated) is

Figure 13 Expanded view of the TEM images of sample C at a 40–60- μm depth after UV irradiation for 240 h.

also shown. The typical matrix-domain structure can be seen for the original specimen. The photograph of the irradiated one clearly indicates that microvoids were generated. In addition, all the voids observed here are surrounded by a dark portion. As mentioned previously, the dark portion is the rubber phase. Therefore, the voids are generated not at the PP matrix or the interface but just inside the dispersed rubber domain. It is a very interesting result as we know. It was confirmed that the rubber used in this study (the ethylene butene copolymer) is not apt to deteriorate by UV in comparison with PP on the basis of the UV-irradiation experiment in which either the rubber or PP was examined independently. The measurements of the C=O index of the surface using FTIR provided the following results: 1090 ppm for bPP, 454 ppm for the PP/rubber, and 27 ppm for the rubber after UV irradiation for 220 h at a black panel temperature of 63°C. Moreover, the domains having higher orientation near the surface of the specimen did not have any microvoids inside, even though the surface was directly exposed by UV.

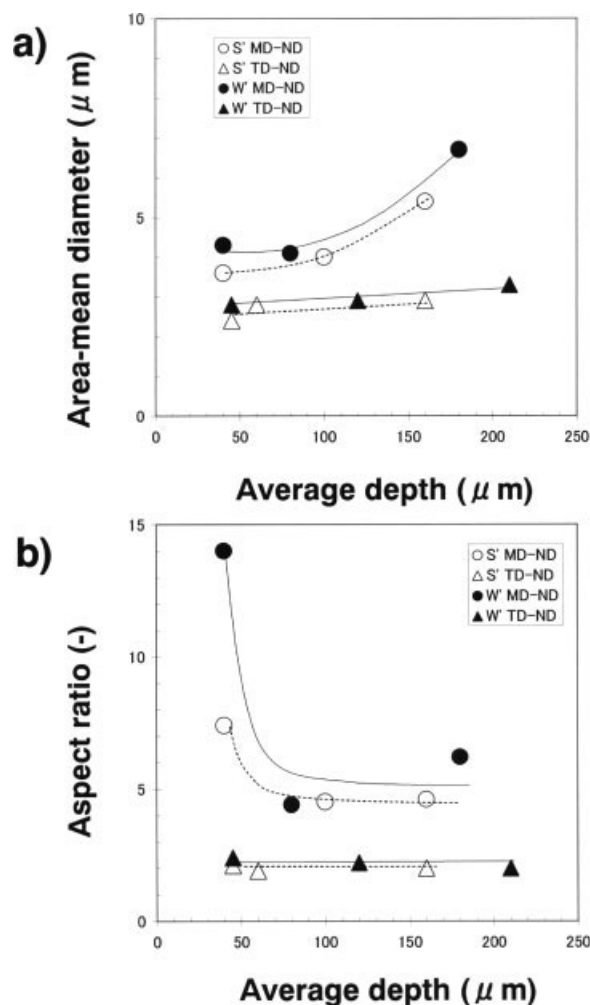
Figure 14 shows the average diameter and aspect ratio of the dispersed rubber domain along the depth. This morphological analysis was performed for the two cross sections MD-ND and TD-ND, where MD is the machine direction (flow direction), TD is the trans-

Figure 14 Morphological analyses of the dispersed rubber phase with binarized images of TEM photographs of sample C: (a) depth dependence of the average length and (b) depth dependence of the aspect ratio.

The average size increased with increasing depth, but it did not indicate a significant difference between S' and W' for both MD-ND and TD-ND. On the other hand, the aspect ratio dependent on the depth differed in S' and W' for their MD-ND cross sections. Figure 14(b) shows the data. A deeper region from the average depth of 100 μm did not indicate distinct difference in the aspect ratio of the dispersed rubber phase for both MD-ND and TD-ND cross sections. However, a shallower region near the surface of the injection molding indicated that the aspect ratio of W' was higher than that of S' . It was a significant difference because hundreds of the particles (dispersed rubber phase) were used for the statistical analysis of imaging. These data show that the dispersed rubber is highly oriented along the flow direction (MD) with a rodlike shape near the surface. Moreover, the orientation of rubber develops more deeply for the W' part than for the S' part. Therefore, the boundary depth between the oriented rubber region having the higher aspect and the elliptical rubber region having the lower aspect is shallower in the W' part than the S' part. Generally, this boundary is for the shear zone and core zone in injection moldings composed of a PP/rubber blend.²²

A more highly oriented rubber domain develops to a deeper position for the W part, and it does not cause microvoids after UV irradiation.

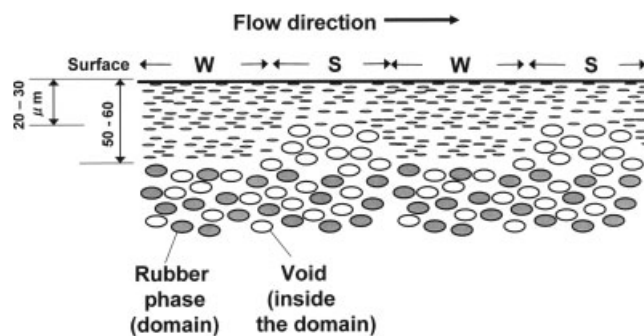
Finally, we obtained a morphological schematic view (Fig. 15).

Highly oriented rubber domains exist in a shallow region from the surface. Under this zone having a highly oriented rubber domain, weakly oriented rubber domains exist. UV irradiation causes microvoids inside these weakly oriented rubber domains. In the S part, the thickness at which the highly oriented rubber domains exist is thin. Therefore, the microvoids are generated in the shallower position in comparison

Figure 15 Schematic drawing of the striped deterioration of the PP/rubber binary blend.

with the W part. As shown in Figure 7, the surfaces did not have any striped pattern but instead had a smooth surface. Of course, these two parts are adjacent to each other along the flow direction. These results show that a trace of a snakelike, unstable flow was recorded under the smooth surface.
