Application of ion chromatography to failure analysis of electronics packaging

IBM Corporation, Product Quality Assurance, East Fishkill, Road 52, Hopewell Junction, NY 12533 (U.S.A.)

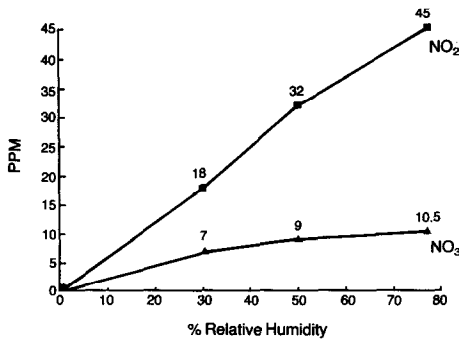
Fig. 1. Concentration of nitrates and nitrites formed during arcing vs. relative humidity in the room.

placed a few feet away from the arcing operation. The water from both dishes was collected and analyzed via ion-exchange chromatography. High amounts of ionic nitrate and nitrite were detected in all samples placed under the arc, whereas none were detected in either blank. These experiments were then repeated with arcing only no wire was stripped. The results were interesting: the wire insulation itself did not contribute to the formation of nitrogen species. Rather, these species were being formed from NO_2 and moisture in the air (acid rain). The formation of nitrate and nitrite ions was found to be proportional to the number of arcs (Fig. 1) and relative humidity. Ionic nitrite could be detected in the water samples using the above techniques after only ten arcs and ionic nitrate after a minimum of 50 arcs. The arcing-over-water experiments were performed on the automated tools, varying the relative humidity in the room from 70 to 35%. The results showed that higher relative humidity produced higher concentrations of nitrite and nitrate (Fig. 2). It has been shown [5] that Cu will corrode [form blue $\text{CuNO}_3\text{-Cu(OH)}_2$ by-product] when exposed to an atmosphere polluted with oxides of nitrogen. With an NO_2 concentration of 8 ppm and a relative humidity of 15%, corrosion can be appreciable and increases with relative humidity. It is also known [6] that positive-polarity d.c. arc at atmospheric pressure yields predominantly a hydrated proton $\text{H}^+(\text{H}_2\text{O})_n$ and some other species, like O^- , NO_2^- , O_3^- , O_3 , NO_2^+ and NO^+ . Combining with water, nitrogen dioxide forms highly corrosive acids that precipitate on the part, causing exposed Cu to corrode.

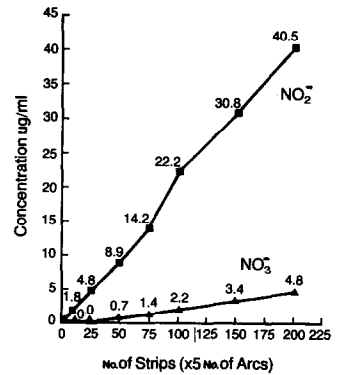
Fig. 2. Concentration of nitrates and nitrites formed during arcing vs. number of arcs.

An attempt to remove the contaminant introduced during wire bonding on the auto-tool using DI water and IPA rinse was unsuccessful. All engineering efforts were then directed toward eliminating or minimizing the source of the contamination. A successful solution to the problem was the installation of a small vacuum tube next to the arc to evacuate by-products away from the part surface. The effectiveness of the vacuum was tested by placing the petri dish with DI water on the automated tool under the arc, performing 200 wire strips with vacuum on, and analyzing the water sample using IC chromatography. No ionic nitrite or nitrate was detected in the samples collected on the auto-tool with vacuum of 15 p.s.i. or higher. The parts wired
