Hannelore Schmidt-Orndorff,¹ J. A. Reitz,² and W. U. Spitz,³ M.D.

Peculiarities of Certain .22 Caliber Revolvers (Saturday Night Specials)

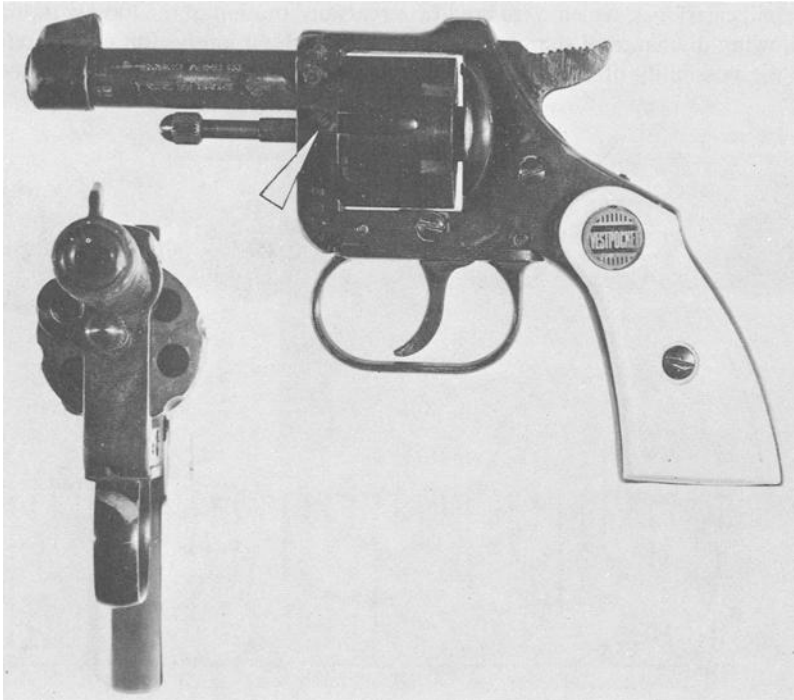
FIG. 1—Rosco Vestpocket .22 caliber six-shot revolver, barrel length $2\frac{1}{4}$ in. Note the marks on the frame of the gun produced by the bullet discharged from the cylinder chamber (arrow). The insert shows the front view of the gun and the position of the cylinder at the time of discharge. The frame causes a half-moon-like obstruction of the cylinder chamber, and is the object which is responsible for "shaving" the bullet.

Examination of the test weapons disclosed that unimpeded rearward motion of the cylinder following discharge of the fully loaded gun caused a second cartridge to be fired from the cylinder chamber immediately to the left of the barrel (Fig. 1). This missile was deflected from its course by scraping along the frame of the gun before striking the target in ricochet fashion. In one instance we noted that the second bullet exited by way of the ejector rod hole.

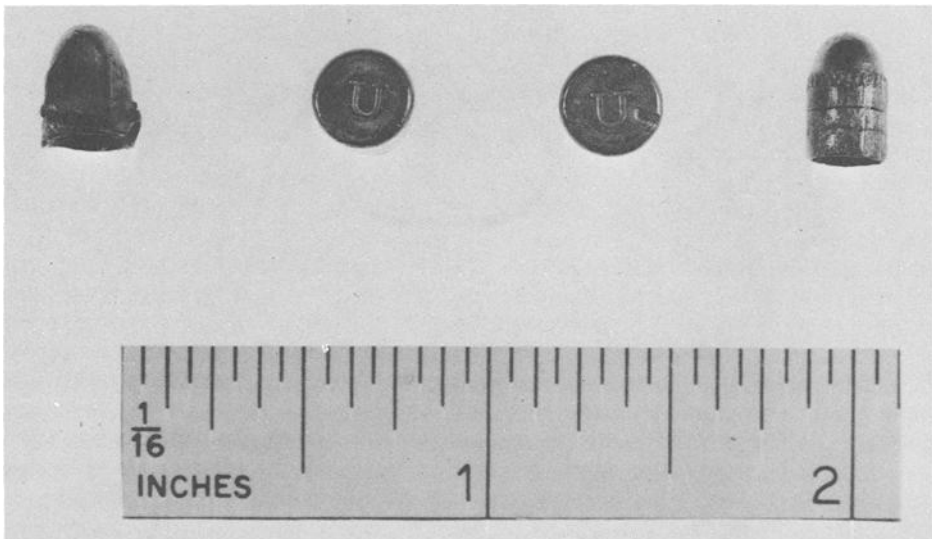
FIG. 2—From left to right: mutilated bullet expelled from the cylinder chamber (fine marks on the shaven surface can be matched with marks on the frame of the weapon); its cartridge case, which is devoid of a firing pin impression; cartridge case with firing pin indentation; and bullet with rifling marks on its cylindrical surface, indicative of having been fired by proper ignition.

bullets proved more rewarding. Rifling marks on the cylindrical surface of the missile identified this bullet as having been fired through the barrel of the gun. Since cylinder chambers are smooth-bored, those rifling marks were not present on the missiles discharged from the cylinder. However, that part of the bullet which on its course had struck the frame of the gun, had taken on the marks of the surface of that weapon. Under the comparison microscope matching of the fine striae could be obtained, thus unquestionably identifying the weapon from which the mutilated bullet was fired (Fig. 2).

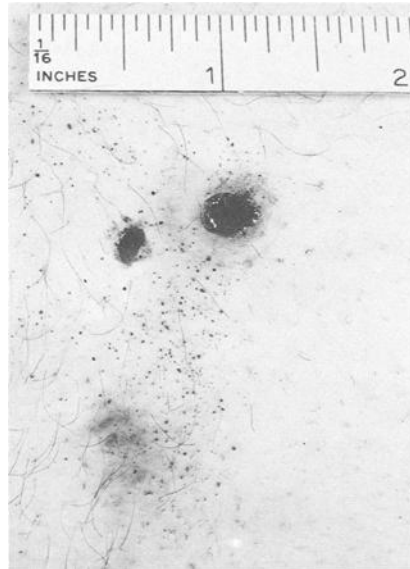
FIG. 3—Contact shot into anatomical specimen (human thigh) by a .22 caliber Rosco Vestpocket revolver using Western Long Super-X ammunition. On the right a typical contact wound is noted. The wound on the left was obviously caused by the bullet fired from the cylinder due to the wide distribution of burnt and unburnt gunpowder particles and the small amount of soot deposited on the target at some distance from this wound. This configuration is due to the fact that the bullet was fired from a distance of $2\frac{1}{4}$ in., which is the distance of the cylinder from the target.

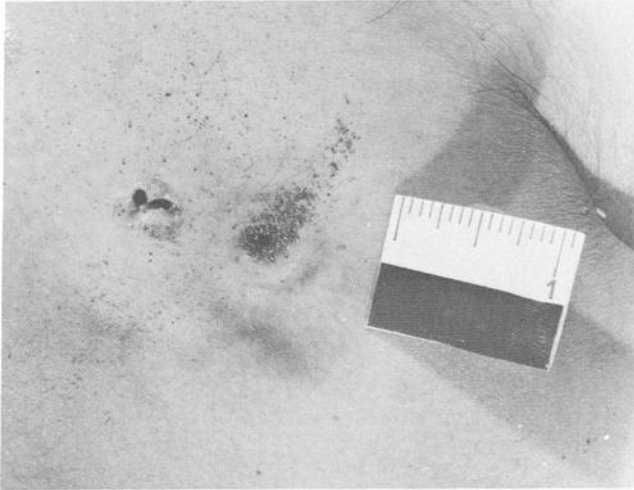
FIG. 4—Contact shot into anatomical specimen (human chest) by a .22 caliber Rohm RG 10 revolver using Western Long Super-X ammunition. Left: the injury produced by the cylinder bullet resembles an exit wound. The atypical wounding results from lack of gyrostatic stability of the bullet in flight, causing it to tumble and to strike the target in ricochet fashion. A small amount of soot and gunpowder can also be identified.

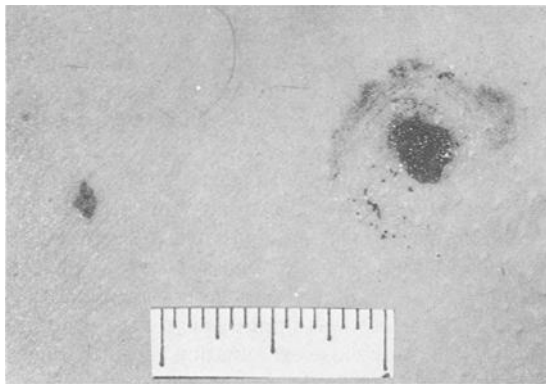
FIG. 5—Contact shot into anatomical specimen (human upper thigh) by a .22 caliber Rohm RG 10 revolver using Western Long Super-X ammunition. Soot and powder densely surround the injury produced by the missile fired through the barrel of the gun. The injury to the left was produced by the bullet fired from the cylinder chamber. No products of ignition are identifiable here. The explanation for the minimal abrasion is that the bullet, being shaven off on one side while scraping the frame of the gun, is sharp and “cuts” into the skin like a dull knife.
