*M. A. Haas,¹ B.S.; M. J. Camp,¹ Ph.D.; and
R. F. Dragen,² B.S.*

A Comparative Study of the Applicability of the Scanning Electron Microscope and the Light Microscope in the Examination of Vehicle Light Filaments

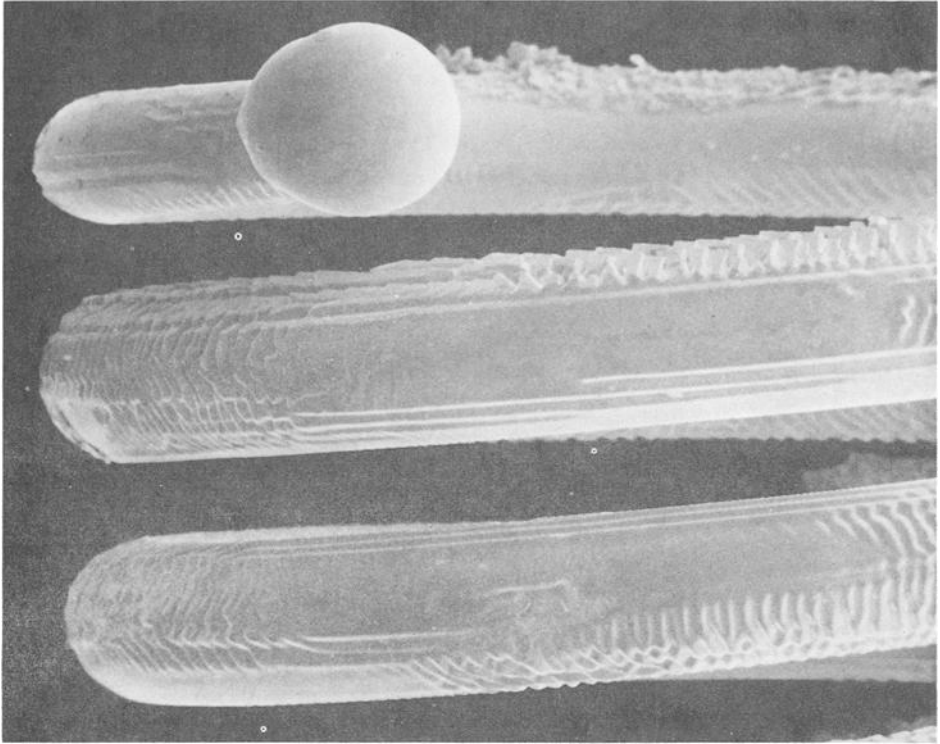
Filaments which burn out in normal use with no oxygen present exhibit a break which has a blunt but rounded or ball-shaped bead of metal (Fig. 1), or a necked-down tip which is smooth at the end (Fig. 2), depending upon the time interval during which the burnout occurs. There should be no glass particles adhering to it.

FIG. 1—Old filament which has undergone normal burnout, SEM, original magnification $\times 100$.

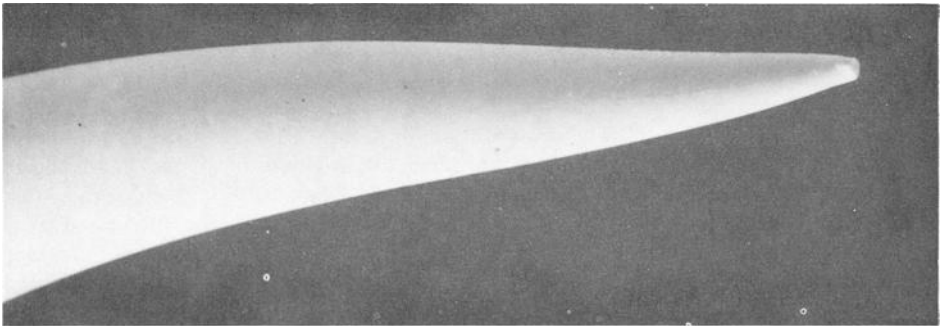
FIG. 2—Old filament which has undergone normal burnout, SEM, original magnification $\times 500$.

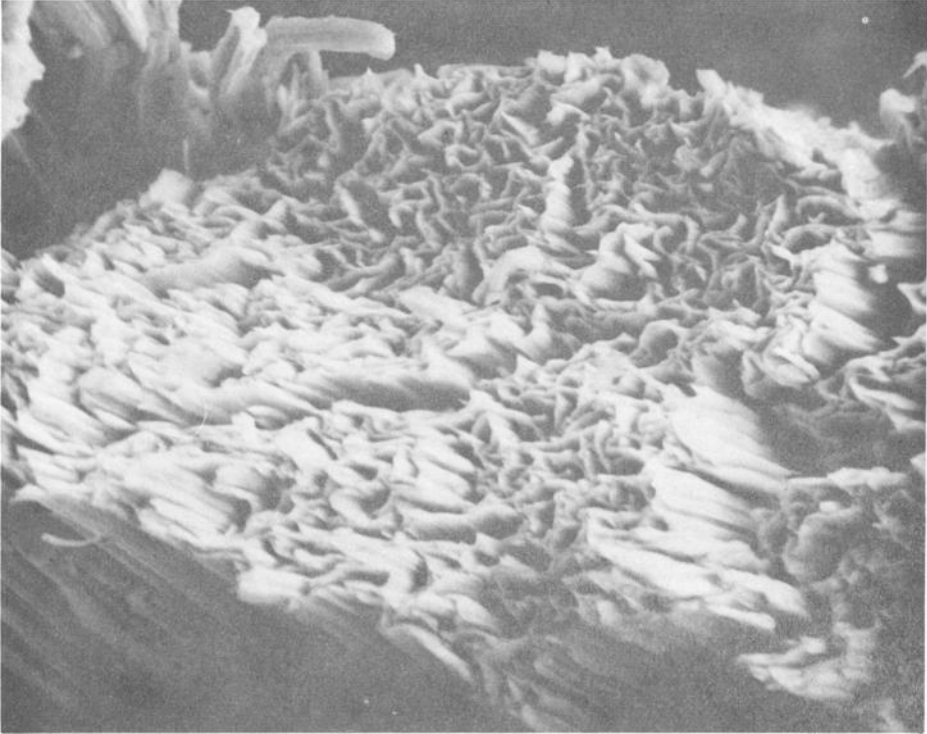
1. A ductile fracture at the broken end (Fig. 3). This fracture is caused by mechanical stress. There will be some necking of the filament and the broken end will be separated into many small pieces which are oval or flattened in cross section. The tips of these pieces will often display small cups or "dimples" which are characteristics of an overload ductile fracture. It should be noted that a cold ductile fracture can also occur in a new filament which has not been embrittled by heating. This condition is unlikely to be encountered except in a new original or replacement lamp. If there is any doubt, a portion of the filament can be broken to determine if the fracture is ductile or brittle.

FIG. 3—Ductile fracture of a hot filament caused by impact failure which did not break the vacuum, SEM, original magnification $\times 3000$.

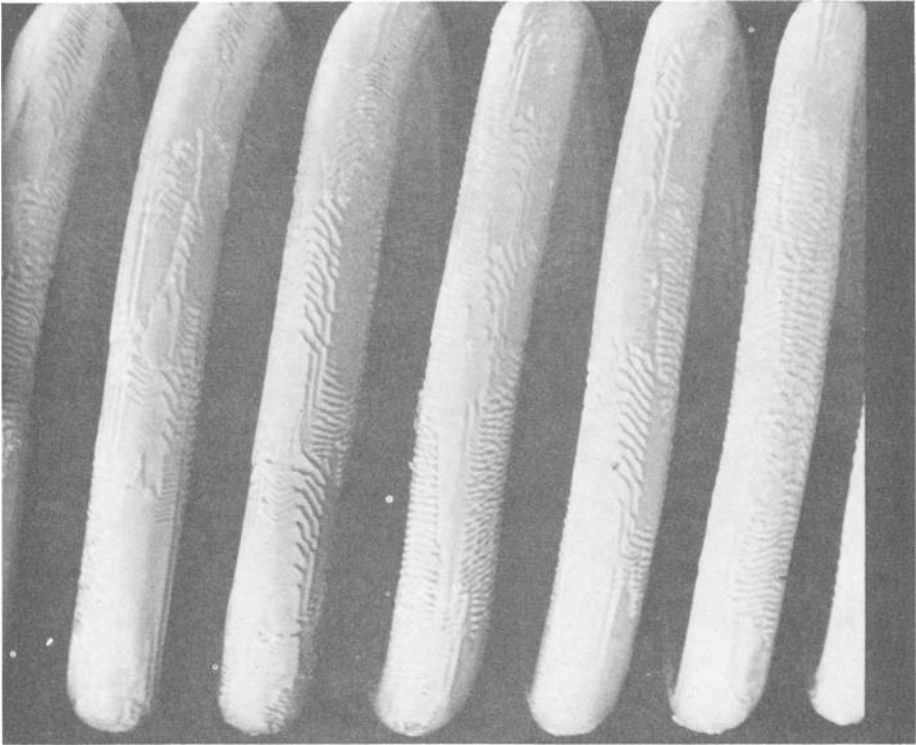
2. A blunt but rounded or ball-shaped bead. As the hot filament distorts, leading to the necking down or stretching out of the filament, the decrease in diameter increases the resistance to current flow and the temperature rises. A sufficiently high rise in temperature will melt the metal filament. This process, which combines mechanical stress with melting, would be difficult if not impossible to distinguish from normal burnout. The filaments may or may not show distortion, but will not exhibit discoloration or oxidation (Fig. 4).

FIG. 4—Filament resulting from an impact failure which did not break the vacuum, SEM, original magnification $\times 120$.

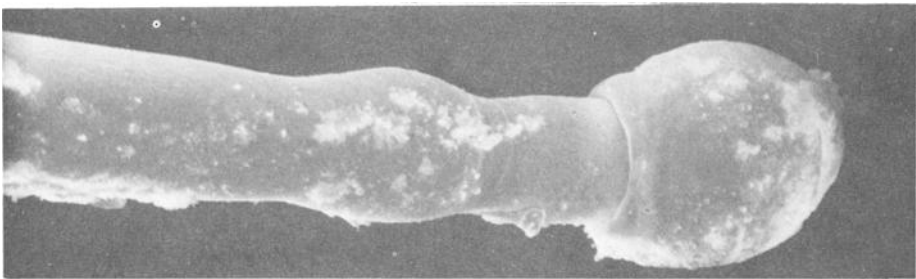
When the glass envelope is broken and the hot filament exposed to air (Figs. 5 and 6), the following physical characteristics will be noted.

3. In the broken area the filament will have a teardrop (Fig. 8) or ball-shaped (Figs. 5 and 6) appearance. The ball-shaped type is slightly elongated and is readily distinguishable from the bead formed by a normal burnout. Also, of course, the normal burnout will lack any debris or oxidation.

FIG. 5—Old filament which underwent an impact failure and exposure to air, SEM, original magnification $\times 100$.

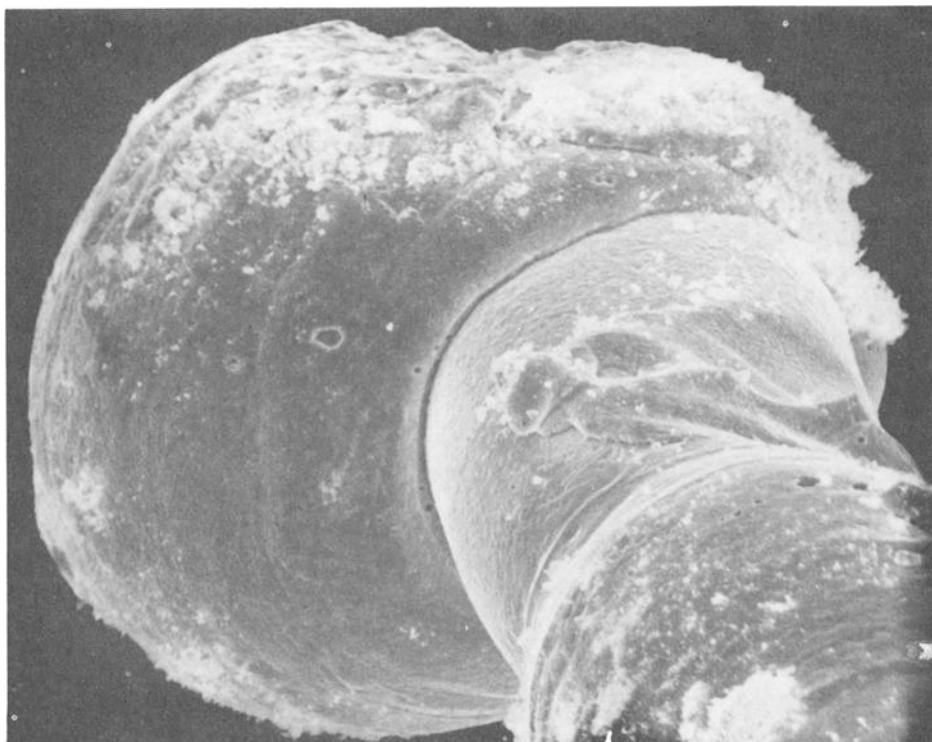
FIG. 6—Closeup of ball-shaped bead from Fig. 5, SEM, original magnification $\times 1000$.

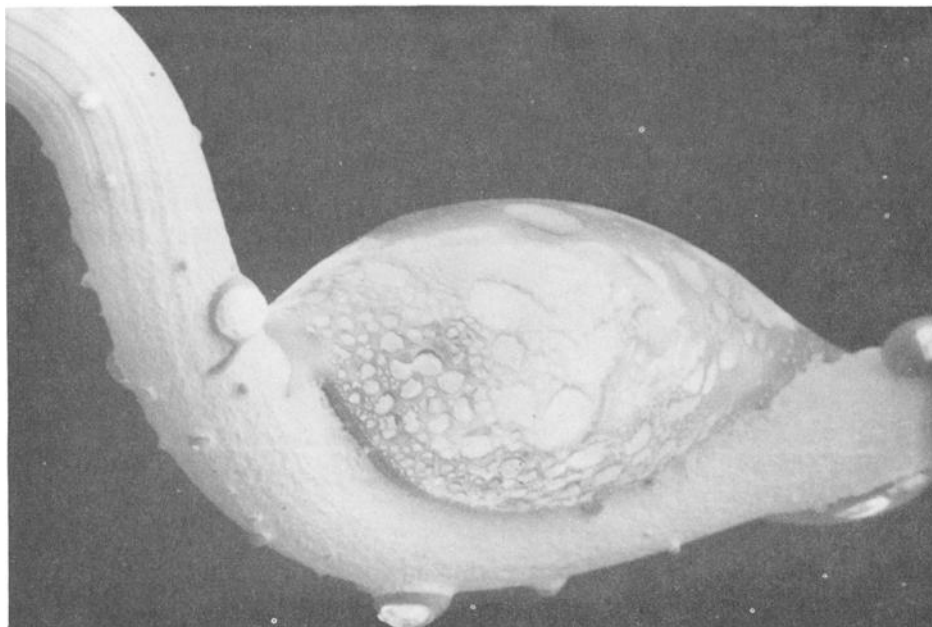
2. Pieces of glass may be welded onto the filament, and often a bead of fused glass will be found on the coil (Fig. 7). The headlight which sustains a direct hit, breaking both the glass and filament, will be severely distorted and discolored and will have fused glass on it.

FIG. 7—A chip of glass which has been fused onto a new filament, SEM, original magnification $\times 100$.

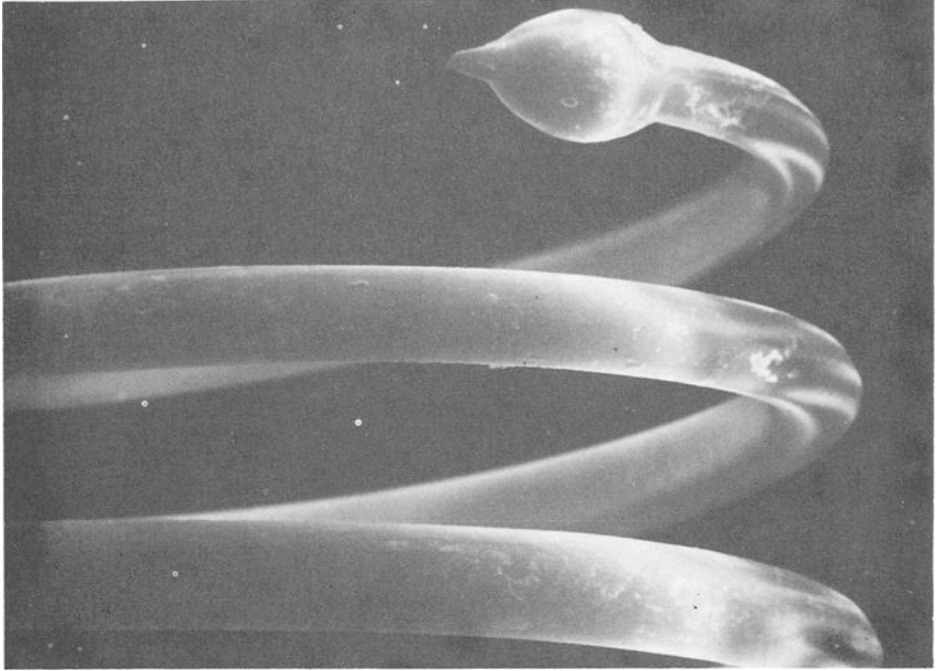
FIG. 8—Characteristic teardrop end formed when filament suffered impact failure while burning, SEM, original magnification $\times 100$.

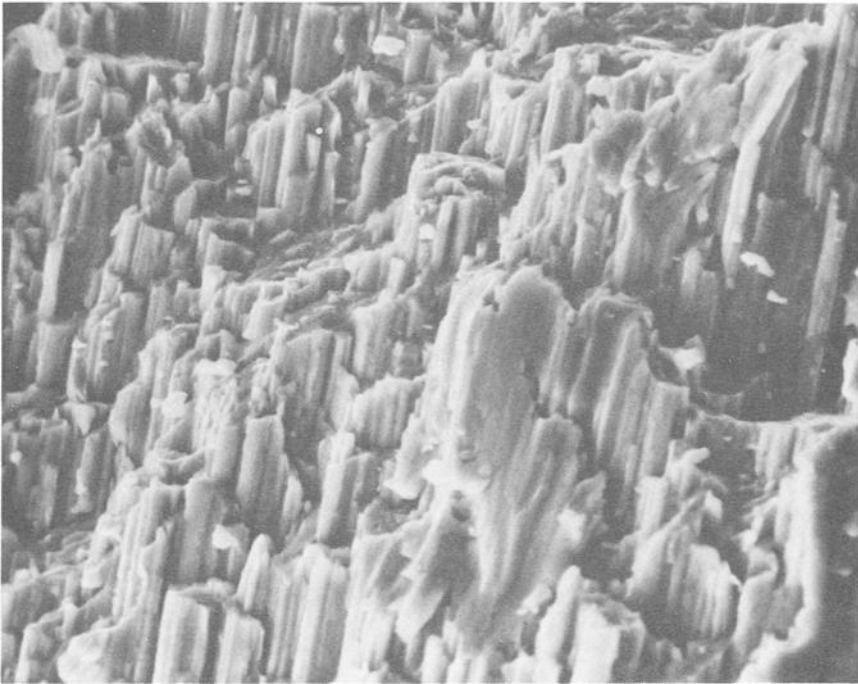
An embrittled filament broken while cold displays none of the characteristic features of hot failures. Oxidation will be lacking and the fracture will be brittle (Fig. 9), with no necking or distortion.

FIG. 9—Brittle fracture of a cold filament, SEM, original magnification $\times 3000$.

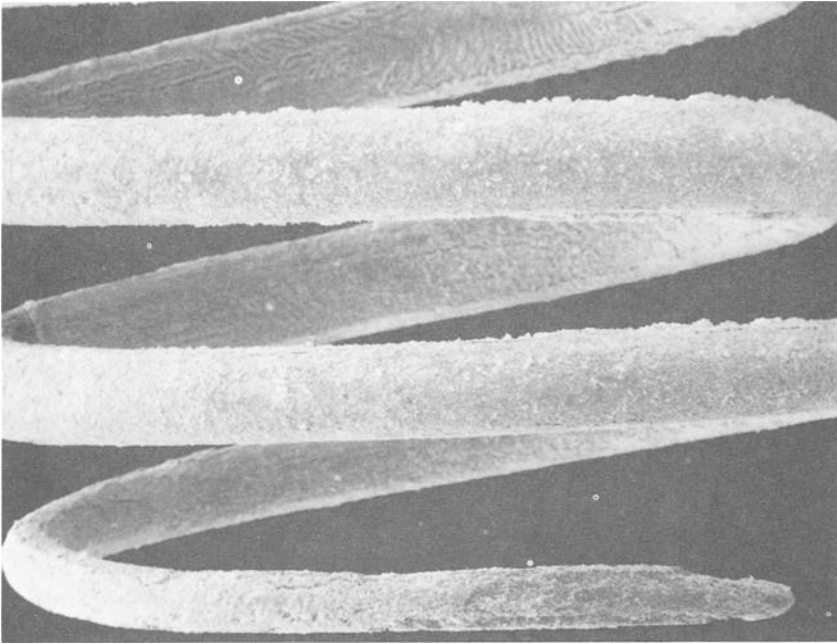
The filament also necks down to a tip which is blunt and rough at the end (Fig. 10), and may show a small amount of distortion. The entire filament should be attached to the terminal posts of the headlight.

FIG. 10—A filament which was turned on after being exposed to air, SEM, original magnification $\times 100$.

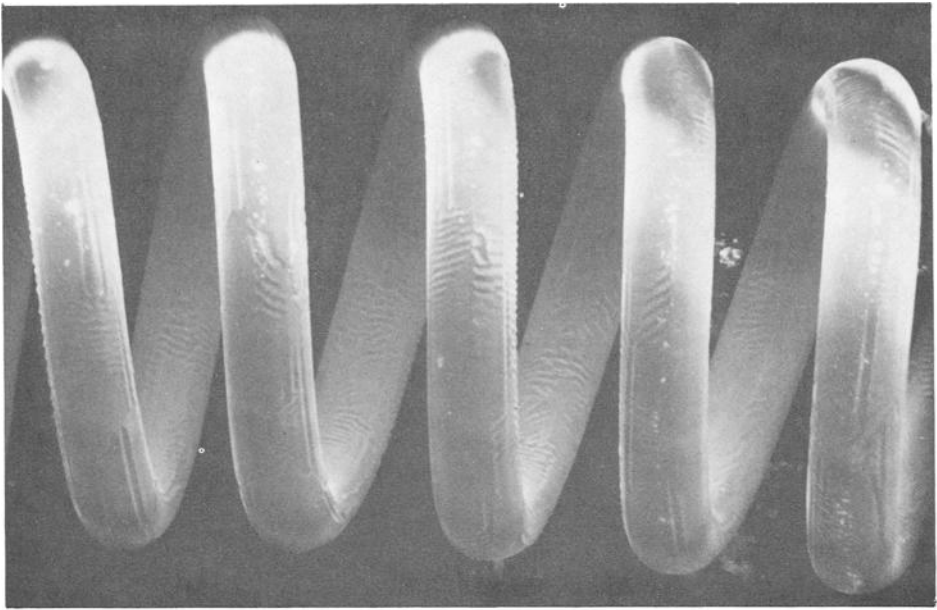
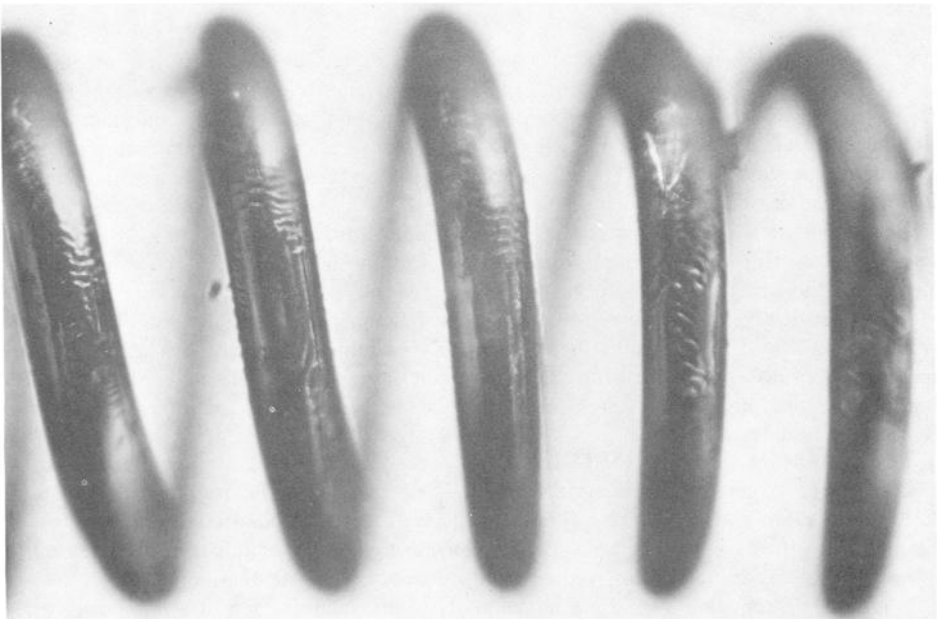
The real advantages of the SEM lie in its larger viewing area, its increased depth of field, and the larger possible magnifications. These points are illustrated in Fig. 11 and 12, which show equal magnification optical and electron photomicrographs of two filaments. In the example cited above, where the critical examination of the broken ends is necessary, only the SEM can show the entire bead and its surface topology.

FIG. 11—Two views of a filament which was not operating when broken (original magnification $\times 100$): (top) SEM and (bottom) optical microscope.

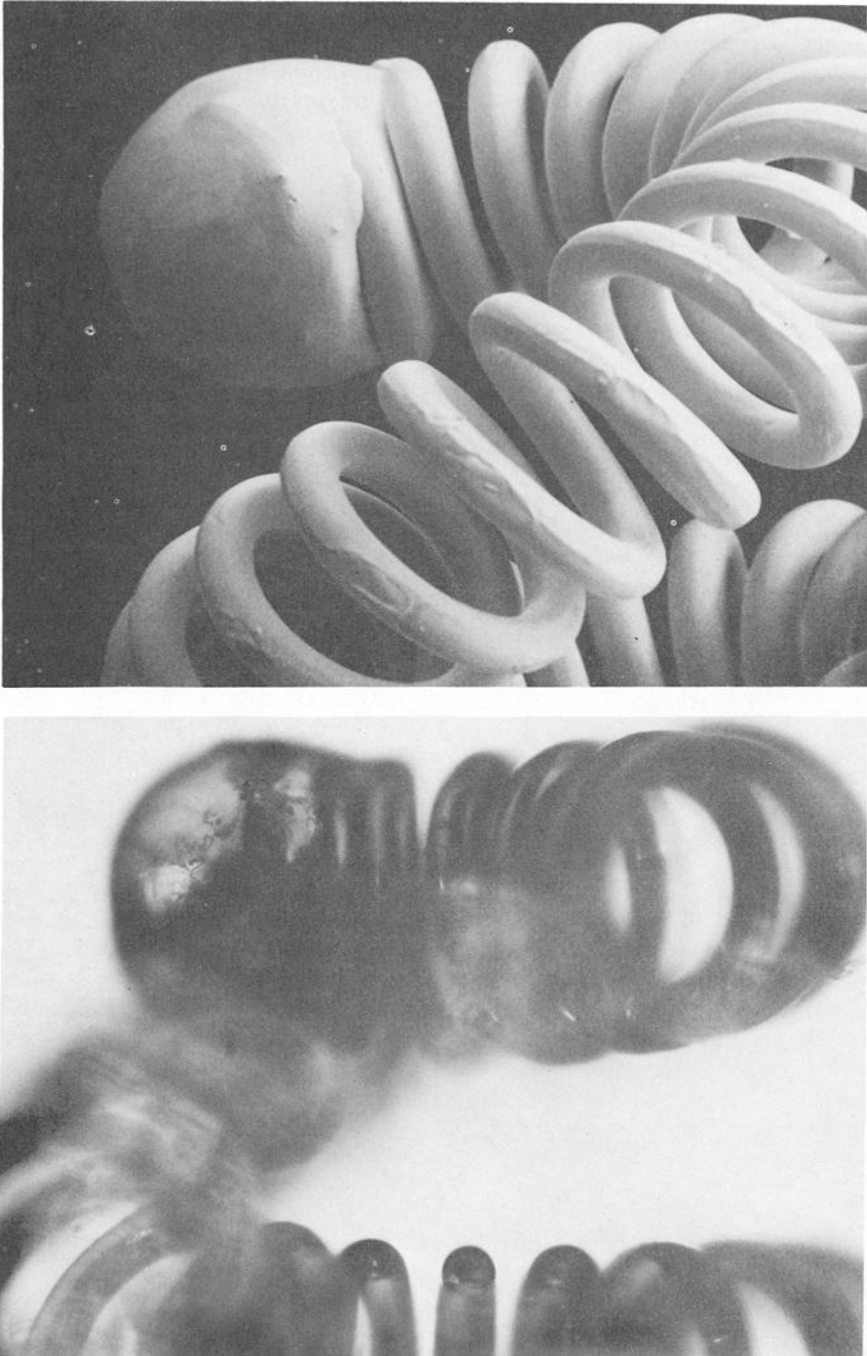
FIG. 12—Two views of a filament, including its broken end, which was exposed to air while operating (original magnification $\times 100$): (top) SEM and (bottom) optical microscope.
