J. D. Temple, Jr., ¹ B.S.; R. T. Bosshardt, ¹ B.S.; and J. H. Davis, ² M.D.

SCUBA Tank Corrosion As a Cause of Death

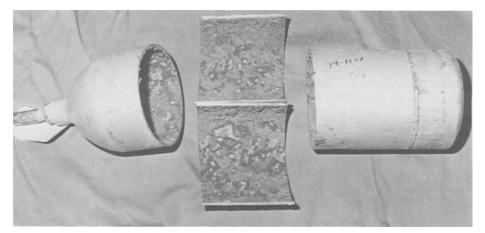
The tank was a 71-ft³ steel cylinder which was estimated to be approximately three decades old, according to what appeared to be a month and year mark "6 41." The last hydrostatic test was apparently four years previously. The tank contained a little less than 200 psi of air pressure. The regulator filter was noted to be soiled with a black, scale-like material. The initial purge was sluggish but was adequate when the regulator was placed upon a tank containing 2000 psi of air pressure. It must be presumed that the diver would have noticed a severely clogged filter, for he was under no compulsion to continue this dive in relatively shallow water. Analysis of the residual air with a Beckman D-2 oxygen analyzer revealed an oxygen concentration between 2 and 3%, instead of the normal 20%.

The tank was sawed open and the interior was noted to be markedly corroded with black scale and some orange-red spots of lighter colored rust, as shown in Figs. 1 and 2. Subsequent investigation revealed that the tank had been filled at a commercial dive shop some three months prior to the fatal dive. It had been partially used at that time and then stored at home.

FIG. 1-Lack of external corrosion as compared with the interior of the tank.

FIG. 2-Massive internal accumulation of corrosion products.

The investigation of a SCUBA mishap should include an intensive determination of all circumstances and background information pertaining to the diver and the event. A complete autopsy should be performed with tests for drugs, alcohol, and carbon monoxide. The equipment should be carefully examined for any evidence of mechanical failure and residual air should be analyzed for carbon monoxide and oxygen content. An oxygen analyzer may be borrowed from the anesthesiology department of a hospital. The tank should be carefully inspected, inside and out, to determine if it has been properly maintained, has been regularly given hydrostatic tests, and is free of any evidence of corrosion. Even if the gas analysis reveals no hazard, the interior of the tank should be visually inspected. In the event that the tank is corroded it should not be returned to the owner for continued use.

The prevention of such mishaps must depend upon a program of acquisition of proper equipment and regular inspections, not just the infrequent hydrostatic pressure tests. Corrosion resistant tanks may be preferred.

Tanks should be subject to visual inspection at least every twelve months. Even a corrosion resistant tank may acquire oil, water, or dirt contamination which could constitute a hazard or cause a malfunction. If the tank is found to be dirty it should be cleaned before refilling. If it is seen to be badly corroded it should be removed from service. The hydrostatic test regulations should be amended to prevent approval of a pressure-safe, yet corroded, tank. A tank that has been allowed to become completely empty must be visually inspected regardless of its last visual inspection date. This is because water may have been allowed to inadvertently enter the tank due to the lack of pressure within. Tanks held in reserve for use by firemen or other professional or commercial individuals must be subject to a regular routine of exhaustion of the air, visual inspection, and immediate refilling. In steel tanks it is preferable to keep the tanks upright in the event that some moisture has collected. Corrosion under these circumstances would tend to be confined to the bottom, a smaller and thicker area.
