G. L. F. Powell,¹ Ph.D.

Interpretation of Vehicle Globe Failures: The Unlit Condition

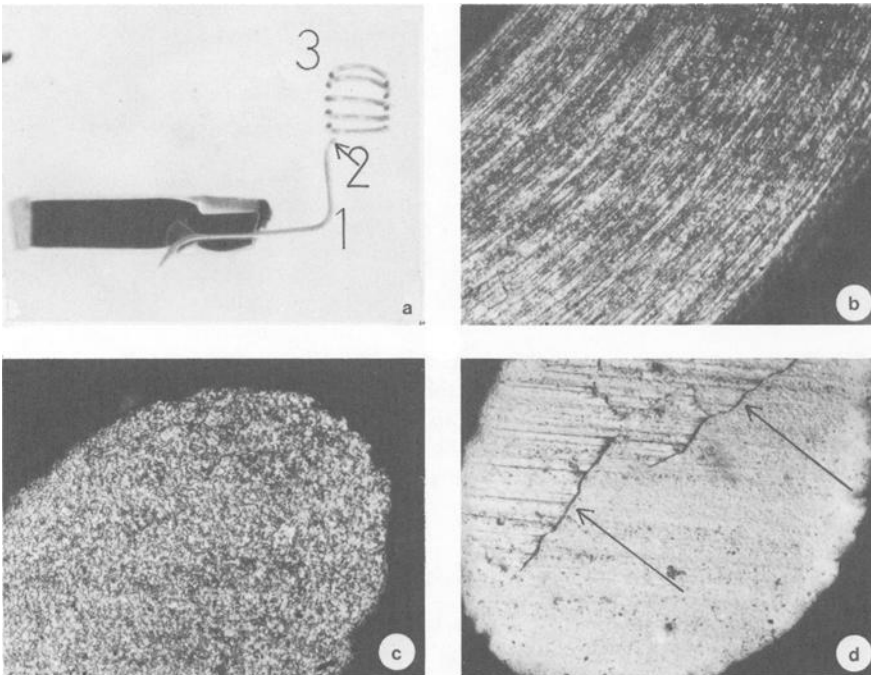
Figure 1a shows part of a vehicle globe that had been in service mounted in clear plastic. The microstructure of the tungsten at Position 1 is exhibited in Fig. 1b. It should be noted that the microstructure is one of deformed elongated grains of tungsten typical of the original cold-drawn condition. The microstructure at Position 2, where the wire is leading into the first coil of the coiled section of the filament, is as shown in Fig. 1c. Again the microstructure is consistent with one of deformed elongated tungsten grains.

FIG. 1—Part of a vehicle globe that had been in service. (a) Mounted in clear plastic. (b) Microstructure of part of the filament shown as Position 1 in (a); note the deformed elongated grains of tungsten. (c) Microstructure of part of the filament shown as Position 2 in (a); note the small cross-sectioned area of elongated grains. (d) Microstructure of cross section of the filament within the coil shown as Position 3 in (a); note that recrystallization and grain growth have occurred, producing large grains of tungsten. (For b, c, and d: etchant, modified Murakami's reagent; magnification, approximately $\times 300$).

In Fig. 1c the section of examination is at right angles to the axis of the wire, the so-called cross section, while the section of Fig. 1b at Position 1 is parallel to the axis of the wire, the longitudinal section. In Fig. 1c each of the black lines is a grain boundary, that is, a boundary between a grain or crystal and its immediate neighbors. By contrast the cross section of the grains is large at Position 3 in Fig. 1a. This is depicted in Fig. 1d, where a grain boundary is marked with arrows. All the wire to the bottom and right of that boundary is one grain.

The reason for this variation of grain shape and size is understood when the temperature variations within a filament are studied (Fig. 2). When a filament in a conventional globe is lit, only the coil glows, the straight part of the filament between coil and lead wire being cooled by conduction to the lead wire and possibly by convection. Since only the coiled part glows, only this part can exceed the recrystallization temperature for tungsten. This is shown schematically in Fig. 3. Since only the coil exceeds the recrystallization temperature, the straight part between coil and lead wire does not recrystallize and this is the explanation for the variations in microstructure shown in Figs. 1b, c, and d.

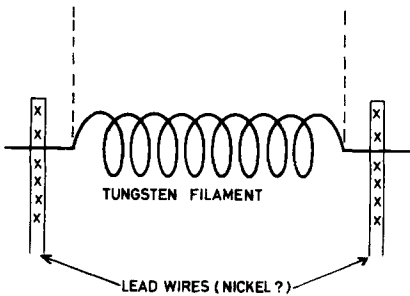
FIG. 2—Schematic diagram of temperature variation within a lit filament. Only the coil glows when the globe is lit.

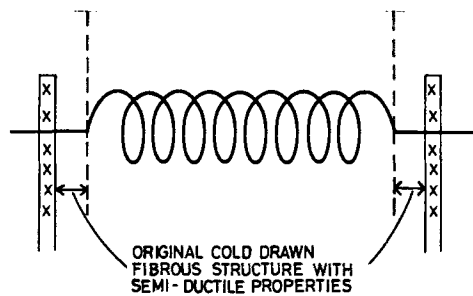
FIG. 3—Schematic diagram showing how recrystallization occurs only within the coil of the filament, increasing brittleness.

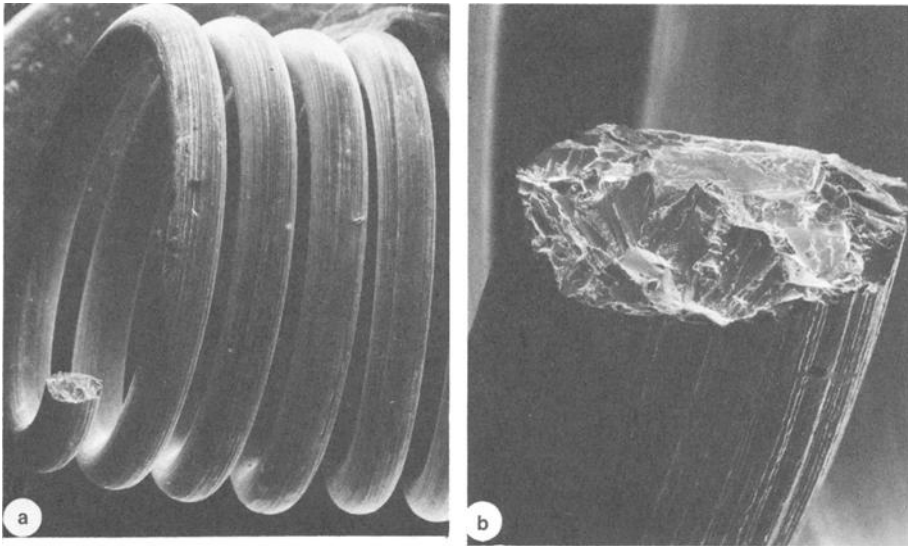
A portion of the other part of the filament of Fig. 1 is shown in Fig. 4 as it appeared in the SEM. The brittle nature of the fracture in the bottom left-hand corner of Fig. 4a is shown at a higher magnification in Fig. 4b. The nature of the fracture at the other end of the coil of Fig. 4 where the filament joins the lead wire is shown in Figs. 5a, b, and c. The semiductile nature of the fracture with attendant delamination is shown most clearly in Fig. 5c.

FIG. 4—Scanning electron micrographs of coil from filament that had been in service and subsequently broken in the laboratory; (a) magnification, approximately $\times 35$; (b) fracture surface in bottom left-hand corner of (a) at higher magnification (approximately $\times 235$) showing brittle nature of fracture and detail of drawing lines on the surface of the wire.

When a vehicle is suddenly decelerated during a collision inertia will tend to keep the coil moving, thus producing a bending moment. As a result, brittle fracture (as shown in Fig. 4b) may occur near the junction of the coil and the straight section when recrystallization has occurred. The magnitude of the stress varies as the magnitude of deceleration. Although the bending moment and hence the stress will be a maximum in the straight section adjacent to the lead wire, fracture will not occur since an original cold-drawn fibrous microstructure with semiductile mechanical properties persists at that position. The response of an unlit filament to deceleration during a collision is summarized schematically in Figs. 7a and b.

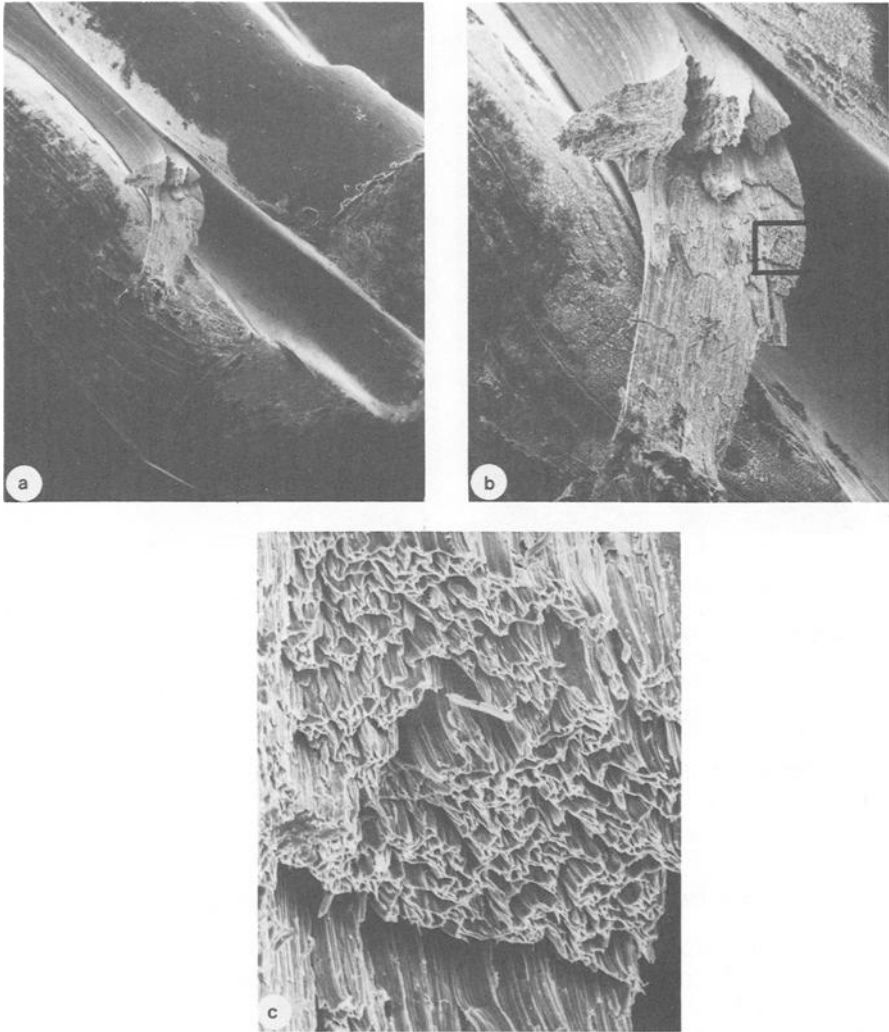
FIG. 5—Scanning electron micrographs of fracture of coil at junction of straight part of filament and lead wire under slow bending; (a) magnification, approximately $\times 35$; (b) magnification, approximately $\times 110$; (c) boxed section of (b) at magnification of approximately $\times 1100$ showing semiductile nature of fracture with attendant delamination.

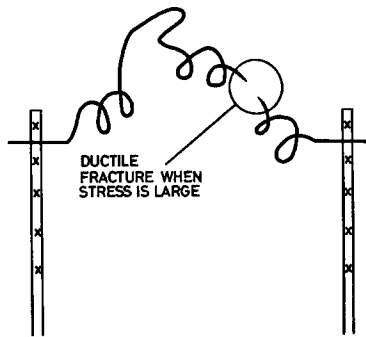
indicate whether the filament was lit; a large change in momentum produces a fracture with tapered ends, as depicted schematically in Fig. 6 for a case of the change in momentum being at right angles to the axis of the coil.

FIG. 6—Schematic diagram of a coil lit when vehicle decelerated during collision at right angles to the axis of the coil.

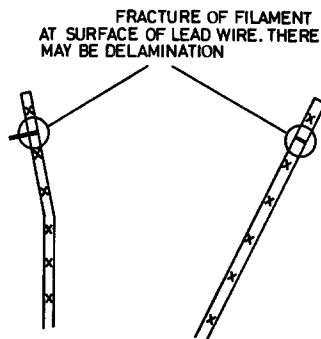
Bending moments producing stress may occur as the result of a combination of deceleration and contact with objects. Under these conditions the lead wires are usually deformed, and fracture may occur at the junction of the straight section of the filament and the lead wire. Figure 8 is a schematic diagram of an idealized situation where both leads have made contact with an object and fracture has occurred at the junction of the filament and lead wire.

FIG. 8—Coil unlit at time of collision and globe made contact with another object. This is an idealized situation where both leads have made contact with an object and fracture has occurred at the junction of the filament and lead wire.

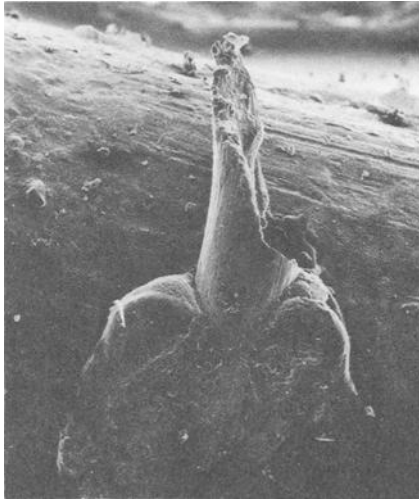
Fracture occurs under the rapid application of a bending stress. Under these conditions fracture is initially by cleavage, but this is arrested by delamination (Fig. 9) and

is in conformity with the results of Stokes and Li [3] and Gilbert [4]. Figure 9 shows how fracture was initiated on the right-hand side of the straight section of the filament at the junction with the lead wire and how delamination has arrested the brittle fracture after approximately 60% of the diameter had been separated in this manner.

FIG. 9—Scanning electron micrograph of unit filament that has come into contact with another object during collision. Fracture has initiated at the right side by cleavage but this has been arrested by delamination (magnification, approximately $\times 75$).
