CASE REPORT

Trace Element Analysis of Steel Sections on Either Side of an Oxygen Cut in a Vehicle Suspected of Being Stolen

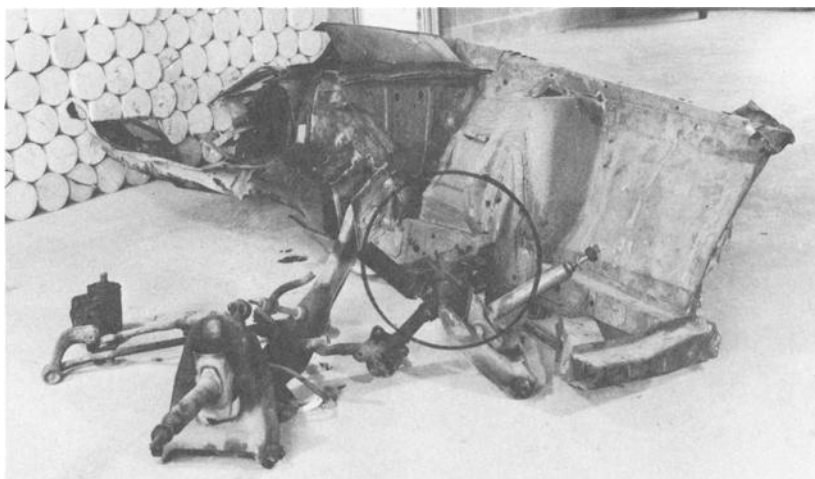
In a case of this type which arose in South Australia, a burnt portion of the front end of a vehicle, recognized as being from a late model, was recovered from a large public rubbish dump. Guided by information received, police found the front subframe of a similar late model vehicle in a suburban backyard. It then became necessary to check for common origin (Fig. 1).

FIG. 1 —*Photograph of part of a vehicle with unburnt subframe in left-hand bottom region and burnt body section in right top region. The circle shows the position of the oxygen cut.*

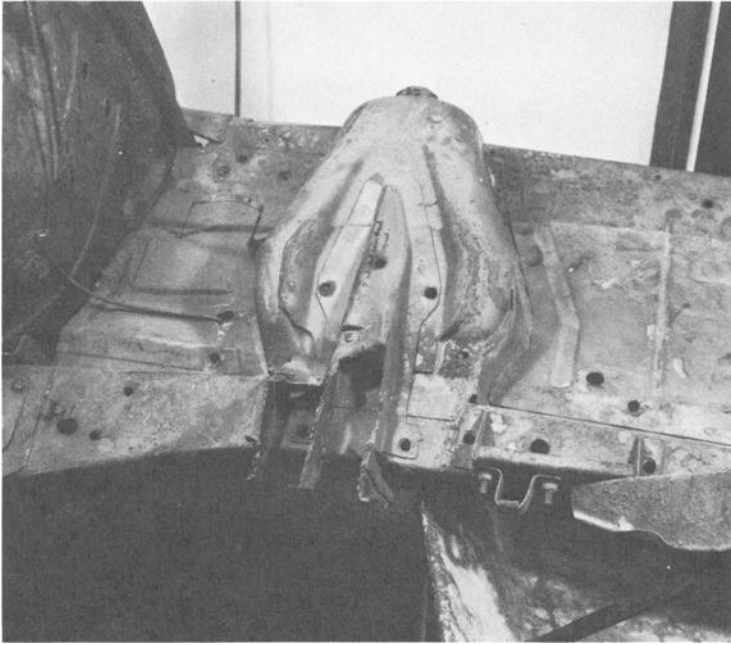
The subframe had been cut with oxygen from the suspension-tower mounting (Fig. 2). The matching of the oxygen-cut surfaces is shown in Fig. 3. In oxygen cutting, the heat for melting is derived from the oxidation of the steel. With thick steel parts, the pattern of drag lines enables an unequivocal conclusion regarding common origin to be drawn. However, with thin sections control of oxygen cutting is more difficult and a less well-developed drag line pattern is made.

FIG. 2—Close-up photograph of burnt body section in the region of the suspension-tower mounting. The oxygen-cut surfaces are in the center of the photograph.

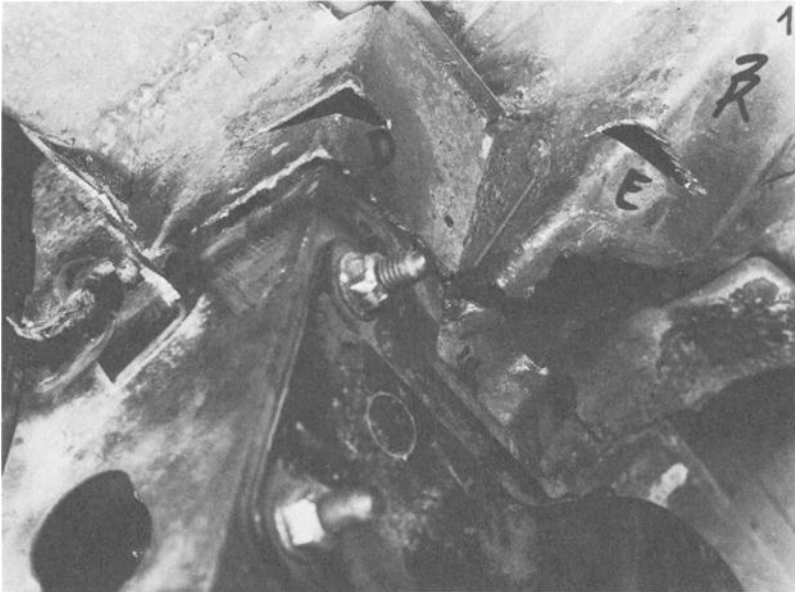
FIG. 3—Close-up photograph of the oxygen-cut section within the circled area of Fig. 1. The sub-frame is in the foreground.
