CASE REPORT

G. L. F. Powell,¹ Ph.D. and K. R. Spanswick¹

A Case of Arson?

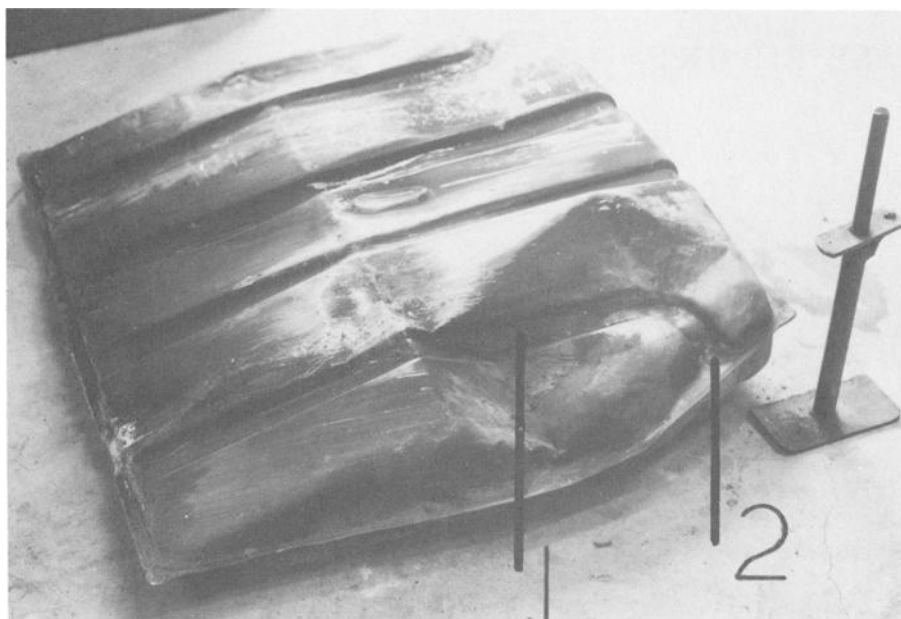
A visual examination of the remains of the vehicle showed that the gas tank had been punctured at one position and that there were indentations at a second position. The jack was in the "down" position, that is, the position for lowering the vehicle. The stand was unusual in that the top flat section was missing. Figure 1 shows the indentations at Position 1 and a hole at Position 2. The stand is shown to the right of the gas tank.

The fire damage to the vehicle suggested that the fire had spread from the gas tank. Figure 3 confirms that there is a hole through which gas leaked at Position 2.

FIG. 1—Photograph of the gas tank and stand. The positions of indentations (1) and a hole (2) are shown at a higher magnification in Figs. 2 and 3, respectively.

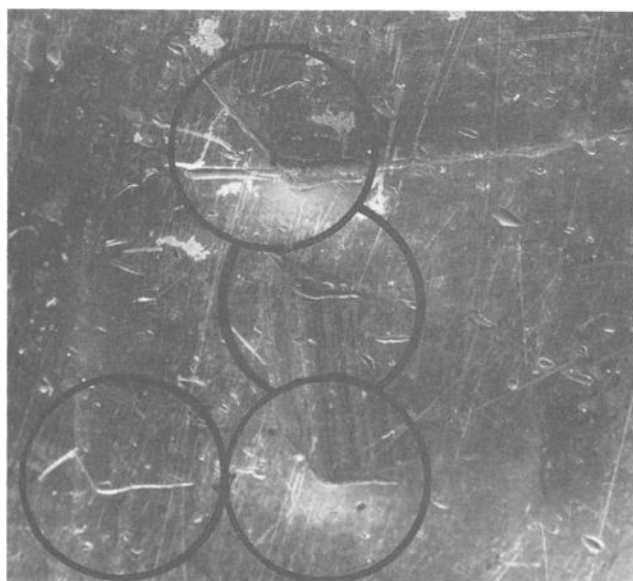
Figure 2 is a close-up photograph of Position 1 in Fig. 1. Note that there is a superficial mark in the bottom left and there are three similarly shaped indentations in the center of the photograph. The top indentation is the deepest. No object that would produce indentations of this shape could be found on the vehicle. The top edge of the stand did not match the indentations. The top indentation appeared to have penetrated the terneplate (lead-tin alloy) coating, exposing the steel base. No rusting had occurred, suggesting that the indentation was recent.

FIG. 2—Close-up photograph of Position 1 of Fig. 1. Note that, in addition to the superficial mark in the bottom left, there are three similarly shaped indentations in the center of the photograph.

position, indicating that it was being used to lower the vehicle. Also, there were other indentations of recent origin close to the hole that could not be explained in terms of contact with any other part of the vehicle or the top edge of the stand. It is probable that these indentations were made by the flat section before its removal.

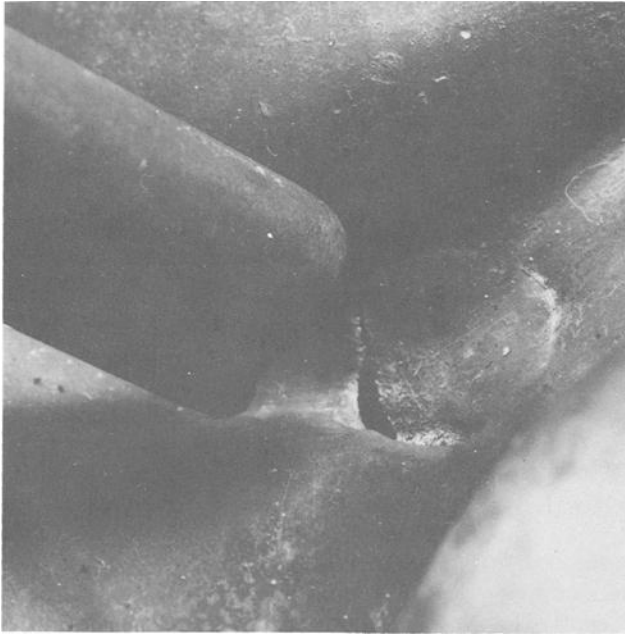
A close-up photograph of Position 2 of Fig. 1 is shown in Fig. 3. Also shown in this figure is the match between the top edge of the stand and the hole in the gas tank at Position 2, demonstrated by bringing the edge of the stand close to but not touching the hole in the gas tank.

The events leading to the hole at Position 2 did not appear to be accidental. The stand that had made the hole was lacking the top flat section and the jack was in the down

FIG. 3—This close-up photograph of Position 2 on the gas tank shows that the hole can be matched with the top, sharp edge of the stand.

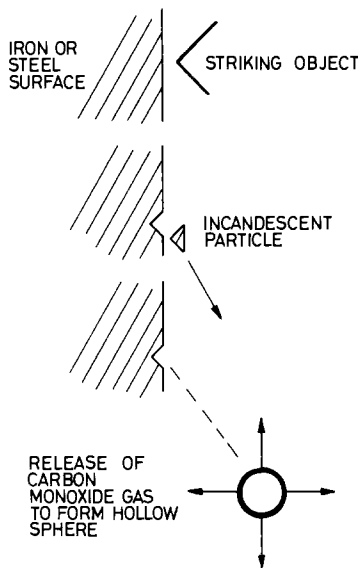
FIG. 4—Schematic representation of the mechanism of mechanical sparking.

The mechanism of mechanical sparking is shown schematically in Fig. 4. A particle of a ferrous alloy (iron or steel) must be torn from the surface with sufficient energy built up in the particle for it to exceed the ignition temperature for iron, which is approximately 800°C. If this temperature is exceeded, the iron will oxidize readily with release of heat, that is, burn. The oxidation of carbon within the iron or steel blows the particle into a hollow sphere, thus producing the spark. The outer surface of the gas tank was covered with a coating of terneplate, which cannot be made to spark. Thus the puncturing by the stand would not cause a mechanical spark. Sparking cannot occur if the gas tank falls onto a hard abrasive surface such as the road surface. The stand would be expected to remain in position while puncturing the gas tank. Thus there is no reasonable explanation for the production of a mechanical spark when the gas tank ruptured.
