CASE REPORT

Bullet Ricochet in Automobile Ceilings

ABSTRACT: Test shots were fired into real and simulated automobile ceilings in an attempt to determine what types of evidence should be available for determining the direction of flight of the bullet. The information obtained was used in a shooting investigation.

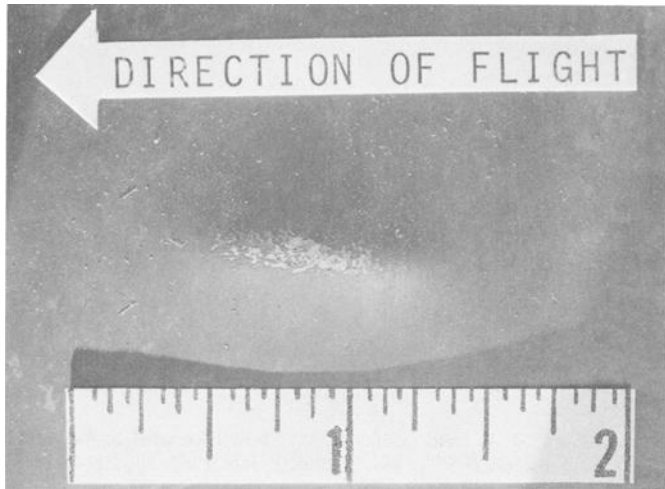
The dents in the metal, on the side opposite the bullet impact, showed small fractures in the paint that were roughly V-shaped with the point of the V pointing back towards the gun (Fig. 1). These fractures are essentially opposite to the ones described by Mitosinka [3], which occur when a bullet strikes the painted side of the metal. Even the lowest angle shots produced these fractures if they struck with enough force to cause a dent. On the inside of the dents there were either oval or comet-shaped scuff marks. The oval marks did not appear to indicate any direction of bullet flight, but in the comet-shaped marks (Fig. 2) the head pointed towards the gun.

FIG. 1—The exterior of a ricochet dent showing paint fractures that indicate the direction from which the shot came.

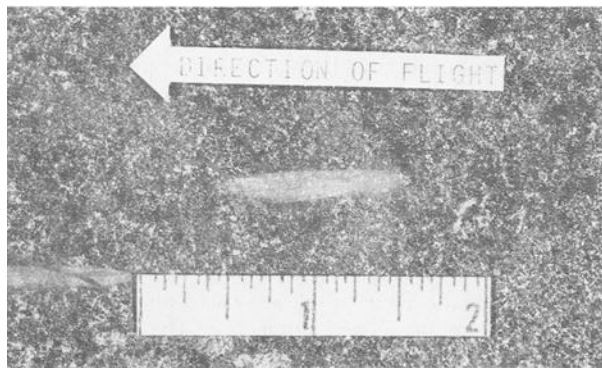
FIG. 2—Comet-shaped scuff mark on the inside of a ricochet mark.

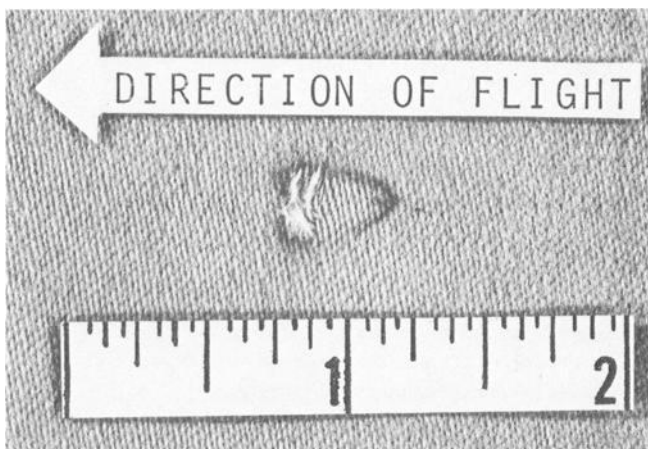
Microscopic examination of the entrance holes showed bullet wipe (material wiped from the passing bullet by the target) primarily along the edge of the hole closest to the gun. On the low-angle shots this wipe extended into a "tail" pointing towards the gun. This tail is caused by the bullet sliding along the cloth prior to penetration. On the hard fiberglass cloth

the wipe marks were in the form of copper fragments, whereas on the softer material they were the dark wipe deposits expected from a bullet (Fig. 3).

FIG. 3—Entrance hole showing bullet wipe "tail" pointing towards the gun.

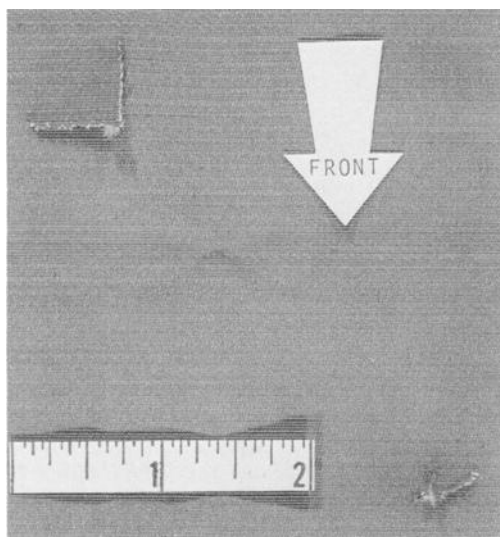
The liner had two holes (Fig. 4), one each on opposite sides of the dent. The hole in the front was smaller and microscopic examination revealed minute abrasions present only along the front edge of the hole on the rubber surface of the cloth. Although there was no bullet wipe (in this case probably as the result of an intermediate target), these abrasions were apparently made by the bullet and indicate that the shot came from the front of the car. The hole to the rear of the dent was larger and had a square corner pointed towards the front of the car. The relative size of the two holes and the orientation of the right-angle tear were consistent with evidence observed in the test shots and demonstrated a front-to-back direction for the shot.

FIG. 4—Ceiling liner from automobile involved in the shooting incident.
