*Erik K. Mitchell,<sup>1</sup> M.D. and Joseph H. Davis,<sup>2</sup> M.D.*

## Electrocution by Street Lighting

**REFERENCE:** Mitchell, E. K. and Davis, J. H., "Electrocution by Street Lighting," *Journal of Forensic Sciences*, JFSCA, Vol. 29, No. 3, July 1984, pp. 836-842.

**ABSTRACT:** Four lethal and one nonlethal electrocutions from street lighting equipment are described. These cases have in common old installations, metal light poles, wet environment, 480-V power sources, and intact fuses. Identification of causative factors may permit future accommodation in design to reduce risk.

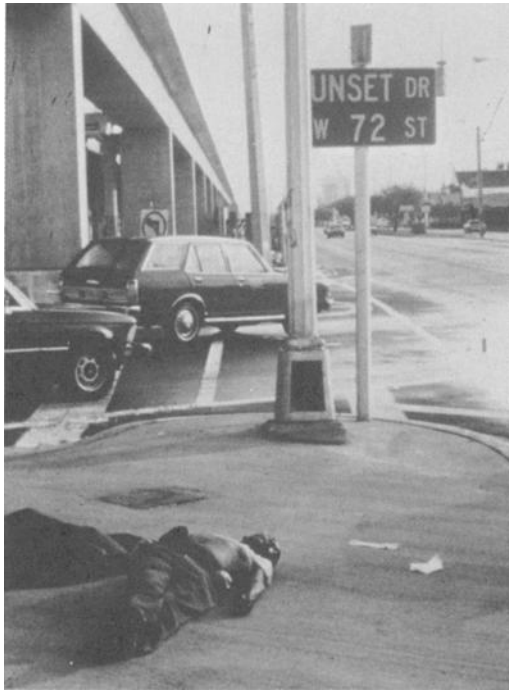
The traffic islands on which the poles stood had a single light pole (Fig. 1) within which was found a wire bared by loss of insulation which could have allowed grounding of the 480-V single-phase circuit through the pole. This was a top-wired pole with a ballast in the base to which wires had to run. The base of the pole was open (Fig. 2) allowing the entrance of water, the rainwater possibly contributing a circuit for a ground fault. The installation was approximately 40 years old. Records of installation and maintenance were not available. Test of the grounding circuit demonstrated this to have a very high resistance, essentially not providing a ground.

FIG. 1—Traffic island and light pole with victim of Case 5.

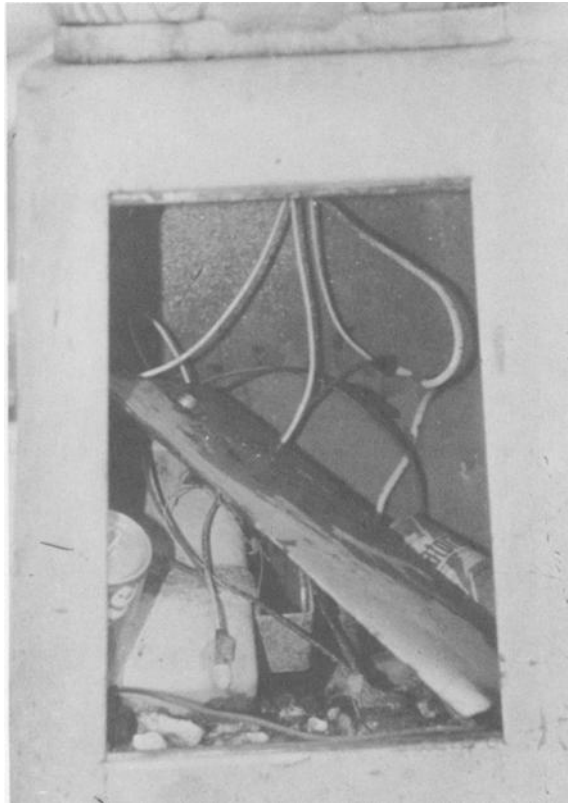
FIG. 2—*Open base of light pole in Case 5.*

That each electrocution occurred in a rainstorm could be the result of several factors. Rain may have penetrated the wiring as in Case 5 where the base plate was open to expose wire within. The light circuitry was not designed as a functional underwater circuit.

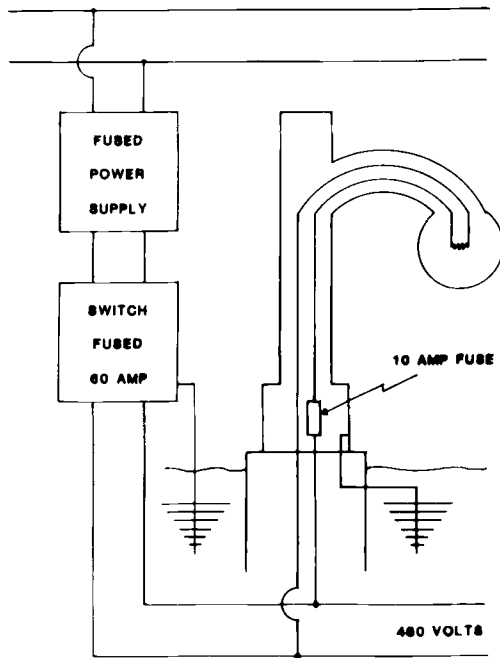
In each instance where electrocution was demonstrated, the source was a short circuit coupled with a ground fault which prevented fuses from interrupting the circuit. Fuses were provided primarily for the protection of equipment which would be damaged by excess current flow to ground if there was a short circuit into an adequately grounded pole.

In the particular circuits involved, fusing was beyond the actual amperage requirements for the service itself in order to reduce voltage drop and to prevent nuisance outages as a result of temporary overloads by lightning or other temporary defects in the poles. The circuits were supplied through time delay fuses at 30 to 60 A at a main source. Each pole was then individually fused at 10 A (Fig. 5).

FIG. 5—Circuit design for typical streetlight installation.

A new fusing requirement could conceivably show some potential for protection of the pedestrian. Ground fault interrupting circuits might be developed sufficiently to become useful as additions to existing systems. For instance, with time delay ground fault interruptors, existing requirements for relatively high amperage fuses, and a certain time delay, to account for temporary overvoltages such as lightning, might be met and still allow only a relatively short existence for any developed ground fault, even of minor portions.
