CASE REPORT

Determination of Cause of Damage to an Automobile

REFERENCE: Kuperstein, I. S., "Determination of Cause of Damage to an Automobile," *Journal of Forensic Sciences*, JFSCA, Vol. 29, No. 3, July 1984, pp. 923-929.

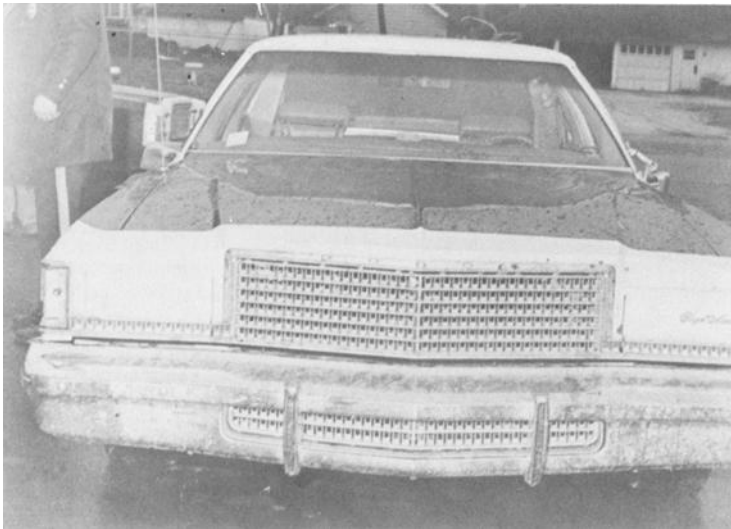
Figures 1, 2, and 3 show, respectively, the front, left front corner, and left rear side of the patrol car. Representative areas that were damaged on this vehicle can be seen in these figures. Details of the damage sustained at the left front turn signal lens (Fig. 2) and along the left side rear quarter panel (Fig. 3) are also visible. The damaged areas on the vehicle all are linear surface scratches, thin indentations of irregular shape, or points of spot or localized damage. It

FIG. 1—Front of the police patrol vehicle.

can also be seen in Figs. 1 and 2 that there was no damage sustained by the front bumper or grill of the vehicle, even in the area of, and extending in front of, the signal housing.

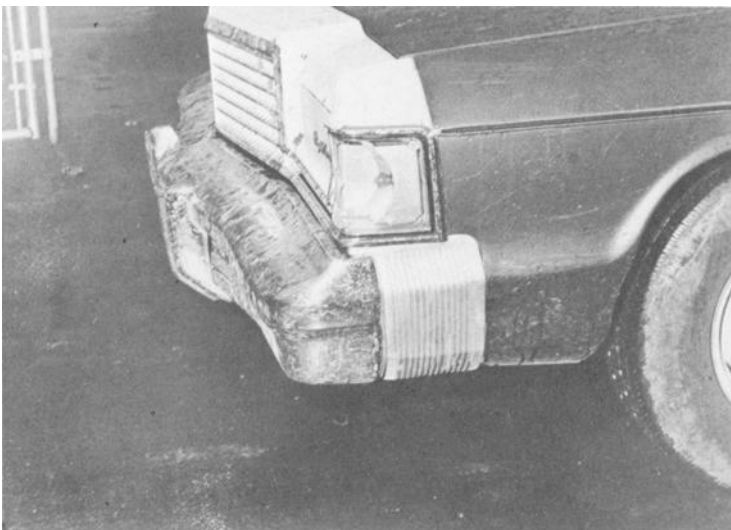
FIG. 2—Left (driver's side) front corner of patrol vehicle.

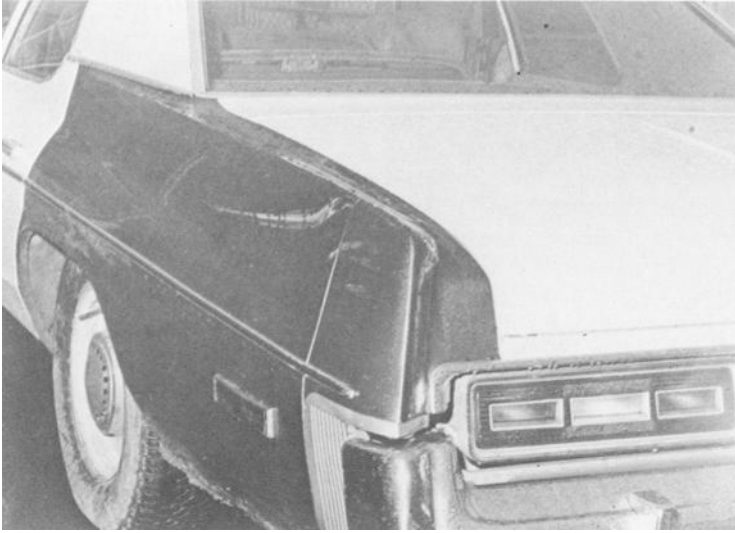
FIG. 3—*Left rear of patrol vehicle.*

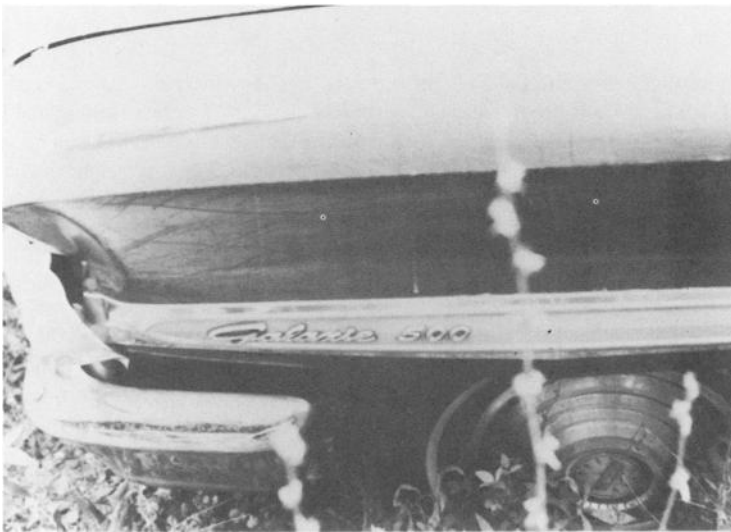
A similar type of damage was sustained by the Ford. Figures 4 and 5 show the front and right (that is, passenger) side of the vehicle. Again narrow, longitudinal indentations were present on the vehicle, and there was no front end damage to the vehicle, aside from that at the corners which showed the characteristics described.

Neither vehicle, therefore, displayed the type of damage that would be consistent with the reported vehicular contacts, nor were there any other indicators (for example, paint transfer between vehicles) of direct collision contact between them.

FIG. 4—*Front of Ford.*

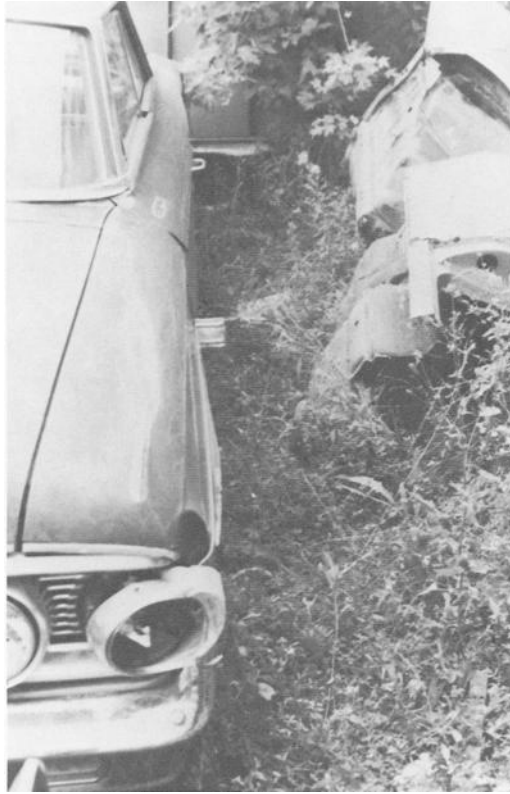
FIG. 5—Left (driver's) side of Ford.

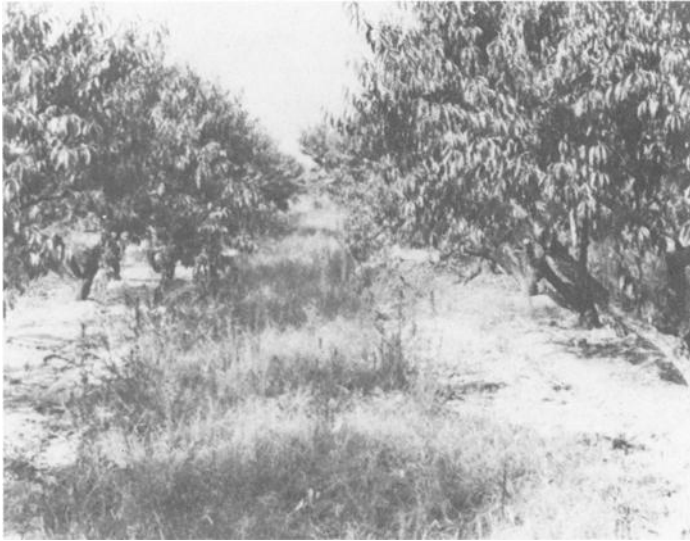
A portion of the area where the chase of the Ford by the patrol car occurred is presented in Figs. 6 and 7. The rows of peach trees and relatively clear aisles between them can be seen in Fig. 6, and the nature and configuration of the pruned limbs of a typical tree can be seen in Fig. 7. The solid and wedge shaped edges of some of the cut branches, the height of the branches above the ground, and their extension into the aisles can be seen.

A comparison of the height of the pruned tree limbs and of the scratches on the Ford and on the Dodge (through their photographic images) indicated that all were located in the same height range above the ground surface. Therefore by relating the nature, location, and details of the damage to both the Dodge patrol car and the Ford and the physical features of the environment in which the chase occurred, it became evident that the damage sustained by both vehicles was caused by coming into contact with branches of the peach trees while the vehicles were moving through the orchard; there were no collisions between the vehicles, as had been reported.

FIG. 6—*Typical section of peach orchard.*

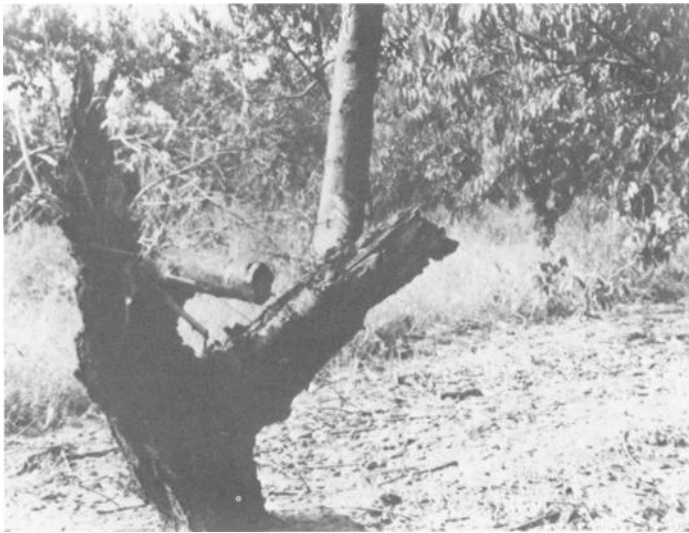
FIG. 7—*Representative tree in orchard.*

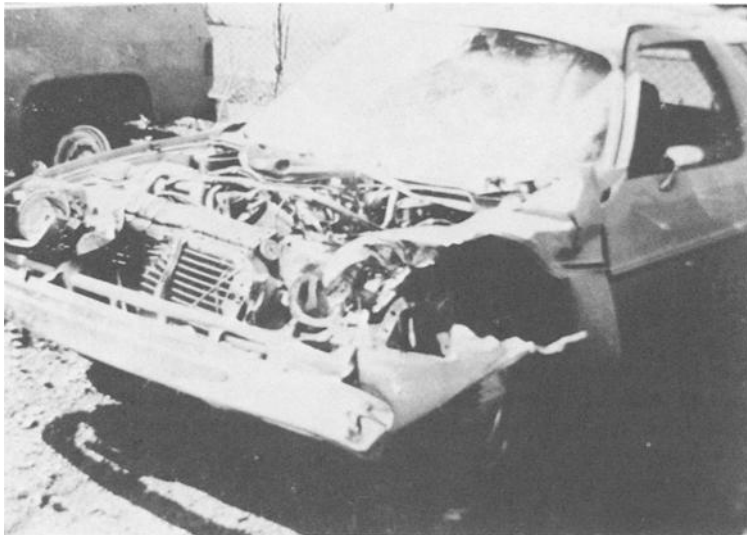
The passenger automobile sustained somewhat unusual damage. Figure 8 shows the front, or damaged portion, of the vehicle. The engine compartment hood had been detached from the vehicle as a result of the collision, there was distributed front end damage and deformation, and an unique tear along the left front fender. This damage was coded, according to the Society of Automotive Engineers Recommended Practice J224a as: 01FLMA3.² The last two coding digits specifically represent the fender damage (that is, A, damage caused by an overhanging object, and 3, the depth, or extent of the tear). The damage to the fender seems to have been caused by a thin object.

The damage sustained by the Pacer automobile is consistent with it having been caused by the liftgate of the truck in a lowered, or partially lowered, position. The direction of the force causing the damage came from the right of straight ahead (that is, the 01 direction in the defor-

FIG. 8—Damage sustained by Pacer automobile.

mation coding). The photographic analysis of the damage, therefore, has provided a basis from which to determine the relative position of the two vehicles with respect to each other, and thereby, with respect to the different lanes of travel. The analysis of the forces causing the damage to the Pacer, objects applying them, and the direction of their application has also shown that it is likely that the liftgate of the truck was in a lowered position before the collision, rather than having been lowered as a result of the collision. The chain securing the liftgate in the upright position, therefore, probably failed before, rather than a result of, the collision between the vehicles.

The probable sequence of events, therefore, was: the initial failure of the chain on the liftgate, which initiated the loss of control of the truck; then the collision between the Pacer automobile and the raised portion of the liftgate.
