CASE REPORT

Collision Marks on Plastic Materials on Motor Vehicles

REFERENCE: Ponnuswamy, P. K. and Kuppaswamy, R., "Collision Marks on Plastic Materials on Motor Vehicles," *Journal of Forensic Sciences*, JFSCA, Vol. 31, No. 2, April 1986, pp. 778-781.

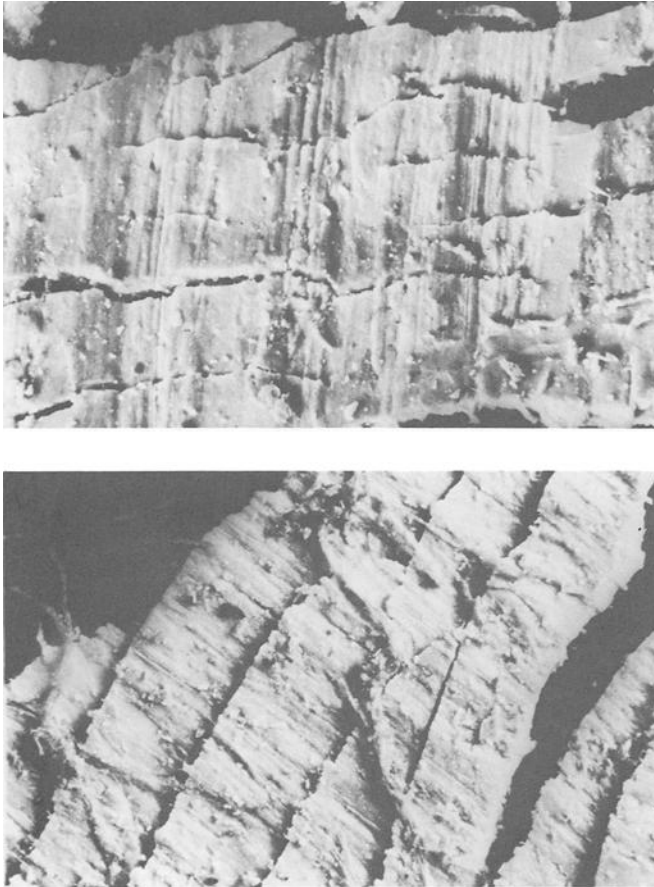
The rub-off marks on the surface of the van as revealed under a microscope in oblique illumination are shown in Fig. 1. These marks are characterized by ridges and depressions with embedding fibers at many places. The marks, on a detailed study, are found to be made by the structure of the molten plastic films. The appearance of this structure on the vehicle surface may be explained by the following reason: the heat generated during collision had softened the plastic material and further stretched it into films as shown in Fig. 2; as the force was sufficiently great to permit melting of the plastic, the emerging film structure in molten state was transferred on the van surface; during this process shedding of the plastic filaments from the film structure took place. Thus, while the temperature of the colliding plastic is moderate, softening of the plastic takes place and the emerging films are deposited on the vehicle surface; in such situations, the films can be peeled off from the surface. When the heat produced in violent collisions is sufficiently great resulting in plastic melt, the emerging plastic film structure leaves its characteristic marks on the vehicle surface. While it is possible to see the presence of plastic films in less violent and grazing collisions, the char-

FIG. 1—Photomicrographs ($\times 26$) of the marks noticed on the surface of a van which was involved in a collision. (top) ridges and depressions and (bottom) embedding fibers and filaments on the ridges and depressions. The cracks are caused by scraping of the paint from the vehicle surface.

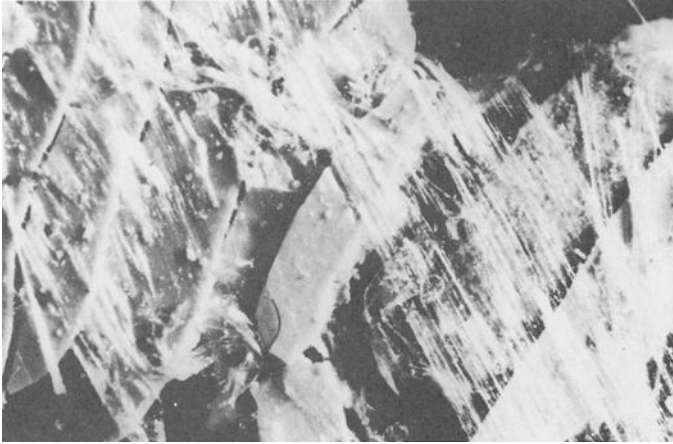
FIG. 2—Photomicrograph ($\times 26$) of the plastic film spread on the paint surface. In less violent and grazing collisions where softening of the plastic takes place, thin plastic films as seen in this figure are deposited on the vehicle surface. In more violent collisions resulting in plastic melt, the above structure in molten condition is embedded on the vehicle surface giving the characteristic appearance of the marks seen in Fig. 1.

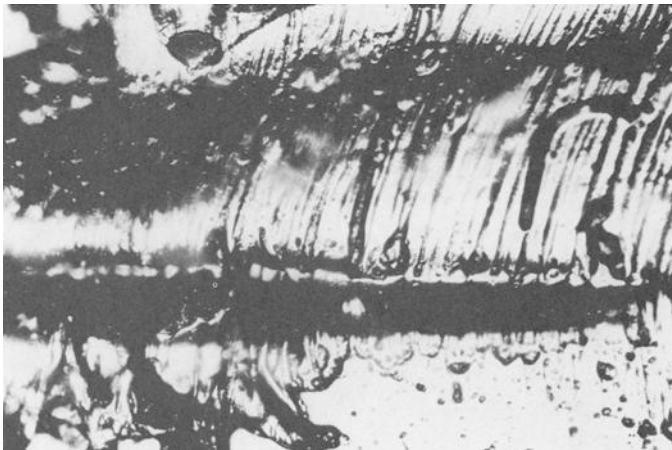
The damaged surface of the plastic sleeve of the bicycle brake lever handle on microscopic examination ($\times 21$, $\times 62$) in transmitted light showed the following two features: the melting of the plastic and the marks of stretching (Fig. 3). These features are to be expected in any plastic material involved in collisions of the type discussed in this article. The minute flakes of paint noticed on the plastic sleeve showed a two-layered structure which matched well with the layer structure of the control paint of the van.

FIG. 3—Photomicrograph ($\times 26$, in transmitted light) of the surface of the damaged plastic sleeve showing melting and marks of stretching.
