Fiber-Plastic Fusions in Traffic Accident Reconstruction

REFERENCE: Masakowski, S., Enz, B., Cothern, J. E., and Rowe, W. F., "Fiber-Plastic Fusions in Traffic Accident Reconstruction," *Journal of Forensic Sciences*, JFSCA, Vol. 31, No. 3, July 1986, pp. 903-912.

ABSTRACT: This paper discusses four traffic accident investigations in which fabric impressions in thermoplastic materials or hairs and fibers found embedded in upholstery or interior decorative components played important roles in the reconstruction of the accidents.

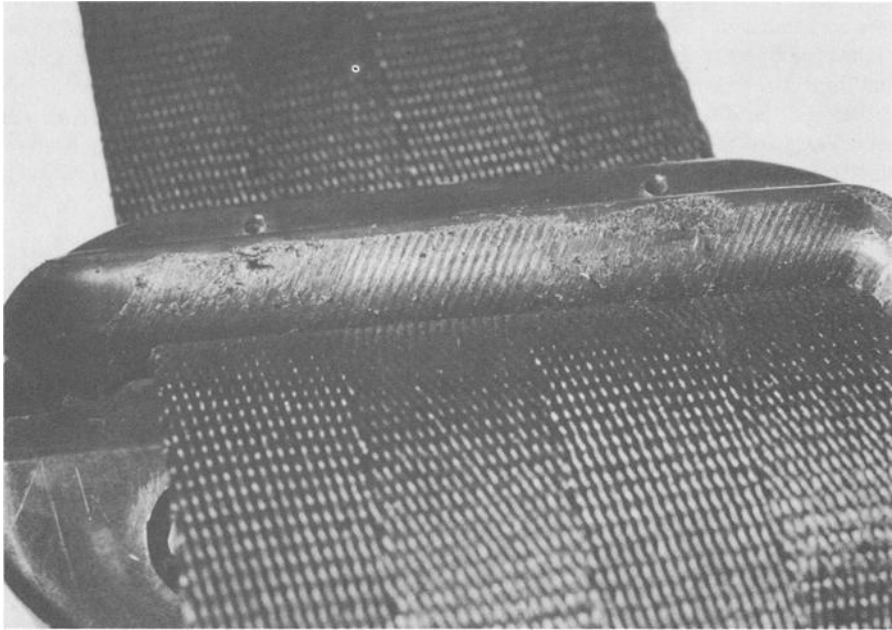
Often the patterns of textiles will be embossed on plastic surfaces by a high-speed impact. This case provides a good example of a textile pattern transferred to a plastic surface. In this case, a late model, mid-size, American passenger car collided with a pickup truck at an intersection. The vehicles were travelling in opposite directions. The left front of the car struck the left front of the pickup truck. The adult male driver of the car and the adult female passenger seated in the right front passenger seat were both wearing seatbelt shoulder harnesses of the standard three-point type. The driver was not hurt in the collision; however, the female passenger received severe maxillofacial injuries and multiple internal injuries from high-speed impact with the vehicle's dashboard. An examination of the passenger's seatbelt revealed that the seatbelt webbing had left an imprint of its weave pattern as it passed over the plastic retainer at high speed and that the resulting friction had melted the surface of the plastic retainer (Fig. 1). The pattern on the surface of the plastic retainer indicated that the seatbelt webbing had not been locked by the inertia system that is supposed to restrain the passenger; the seatbelt instead had rapidly "spooled out," permitting the passenger to hit the dashboard. Because of the tightness of the weave of the seatbelt webbing, no fibers were transferred from the seatbelt to the plastic retainer.

FIG. 1—*Plastic retainer from passenger restraint system showing fiber-plastic fusion resulting from "spooling" of the seat belt.*

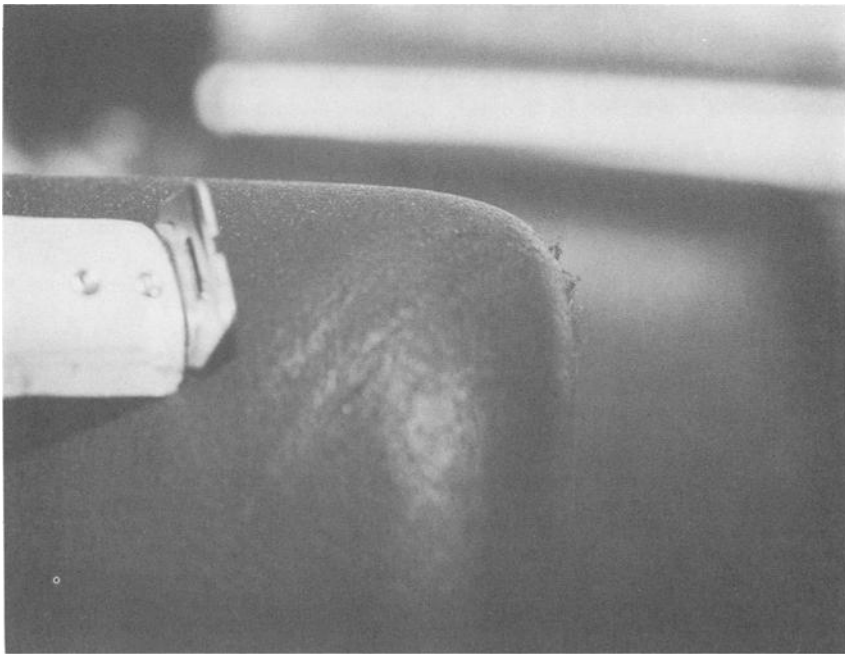
FIG. 2—*Fibers embedded in headrest of driver's seat.*

tured vertebrae, and damage to his aorta. The path of ejection was determined in part by fibers embedded in the plastic of the headrest of the driver's seat (Fig. 2). These fibers matched the fibers in the driver's coat. The threads of smeared plastic on the headrest indicated impact forces moving toward the rear of the vehicle. The presence of fibers in this location and the direction of the threads of smeared plastic indicated that the driver was ejected rearward through the open hatch. The damage to the driver's aorta may have resulted from his arching rearward over the seat.

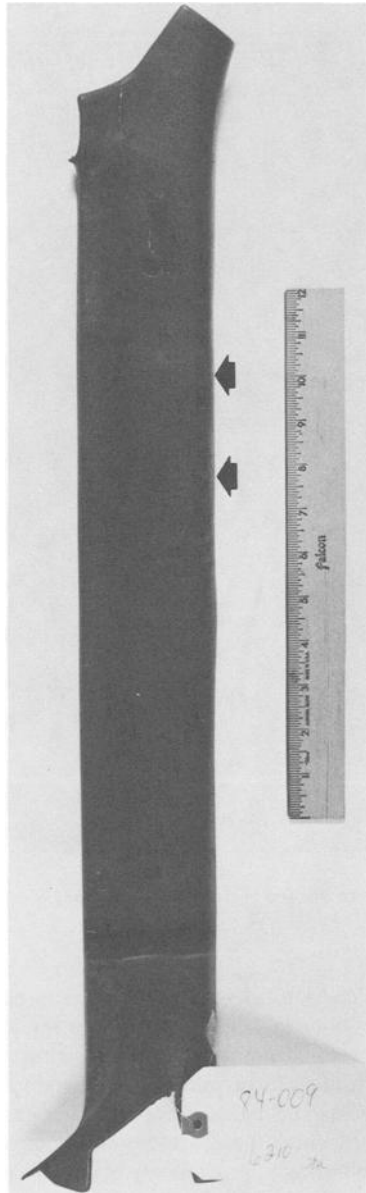
driver sustained head and chest injuries, as well as a fractured C-6 vertebrae and pelvis. The passenger sustained minor injuries. The driver brought suit against the manufacturer of the vehicle, alleging that his ejection from the car was due to its faulty design. An examination of the car showed FPFs on the glove box cover and on the right A pillar cover. The FPFs on the A pillar cover (Fig. 5) proved to be highly interesting: one was a large smeared area near the upper screw hole (Fig. 6) in which there were a number of red fibers embedded; the other was a patterned abrasion covering approximately 14 cm (5½ in.) (Fig. 7) in which there were a number of blue and white fibers. One of the red fibers from the upper FPF is shown in situ in Fig. 8. Microscopic examination of the red fibers showed them to be acrylic fibers having a dogbone cross section; the same type of fibers was found in the FPF on the glove box cover. The blue and white fibers from the patterned abrasion were unmercerized cotton. The presence of two different types of fibers in the FPFs indicates impacts involving two different garments, such as a shirt containing the red acrylic fibers and corduroy trousers containing blue and white cotton fibers.

FIG. 5—Passenger car A pillar cover showing locations of fiber-plastic fusions (arrows).

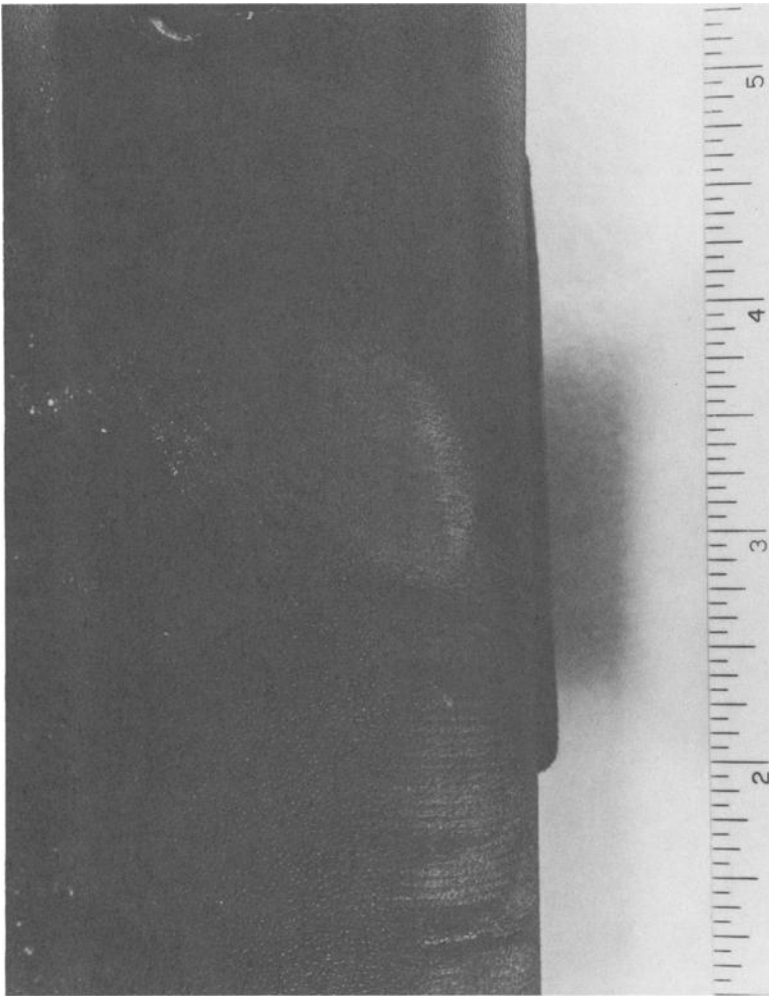
FIG. 6—Upper fiber-plastic fusion on A pillar shown in Fig. 5.

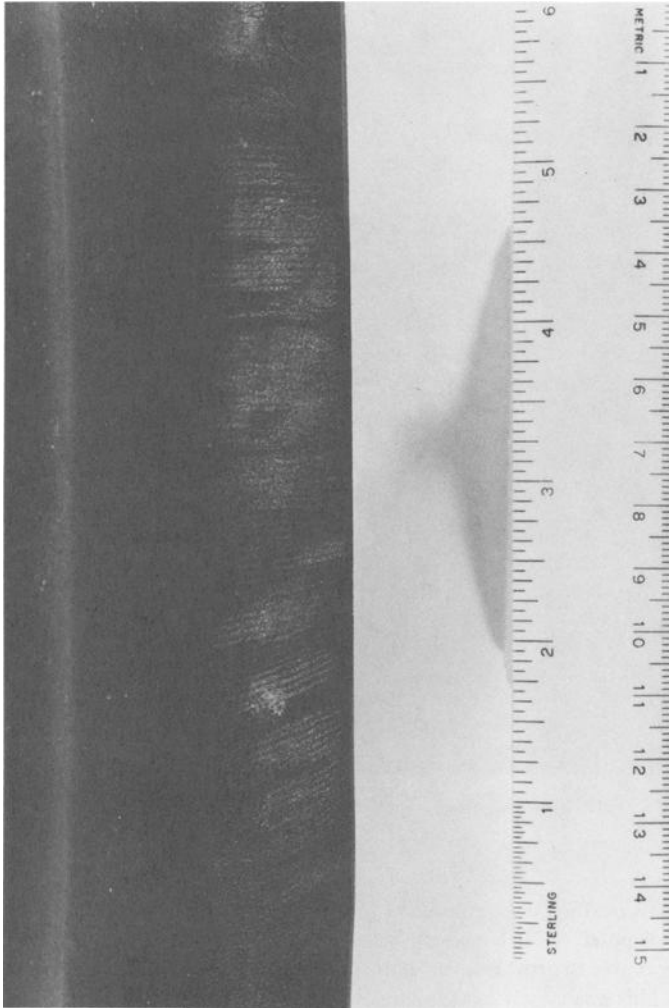
FIG. 7—Patterned fiber-plastic fusion on A pillar shown in Fig. 5.

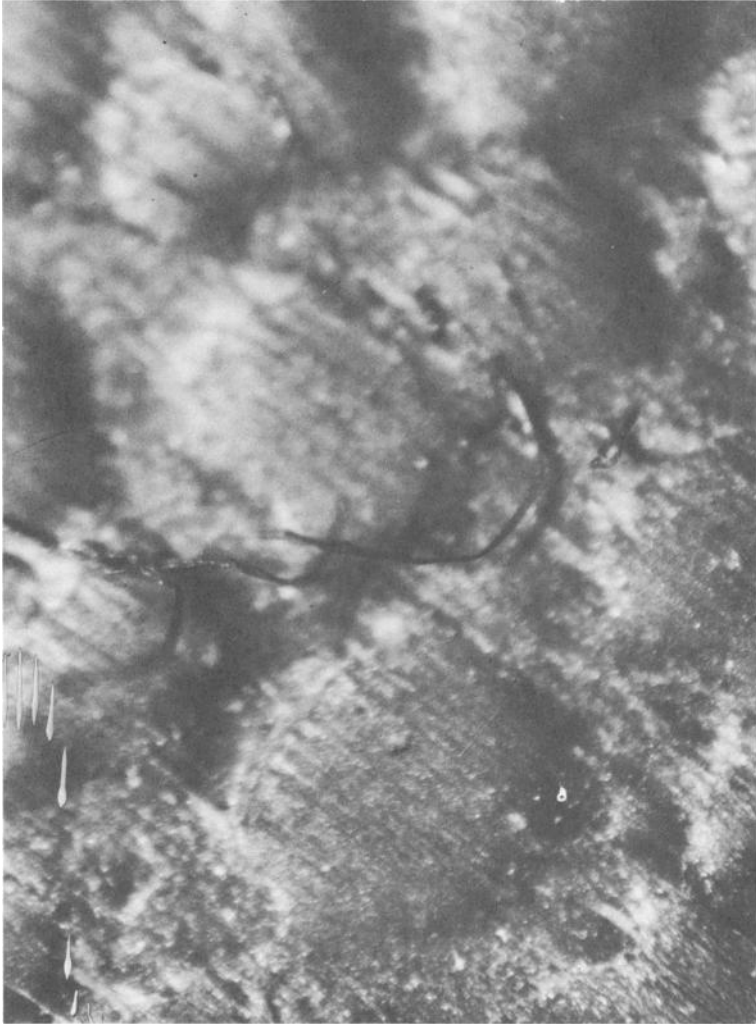
The plaintiff's clothing was removed at the hospital at which his injuries were treated and subsequently disposed of. The passenger was wearing a shirt and trousers at the time of the accident; he was able to provide investigators with the shirt that he was wearing at the time of the accident. This was a twill-weave, long-sleeved shirt composed of reddish-orange, black, and light-brown unmercerized cotton yarns. It could not have caused the patterned abrasion or the abrasion containing the red acrylic fibers. Consequently, the investigators concluded that the driver of the car had been ejected through the righthand passenger window.

FIG. 8—Red acrylic fiber in situ in fiber-plastic fusion shown in Fig. 6.
