TECHNICAL NOTE

Lightning Damage of Bearing Surfaces in Turboprop Aircraft Engines

REFERENCE: Hart, R. K. and Anderson, D. M., "Lightning Damage of Bearing Surfaces in Turboprop Aircraft Engines," *Journal of Forensic Sciences*, JFSCA, Vol. 31, No. 3, July 1986, pp. 1095-1101.

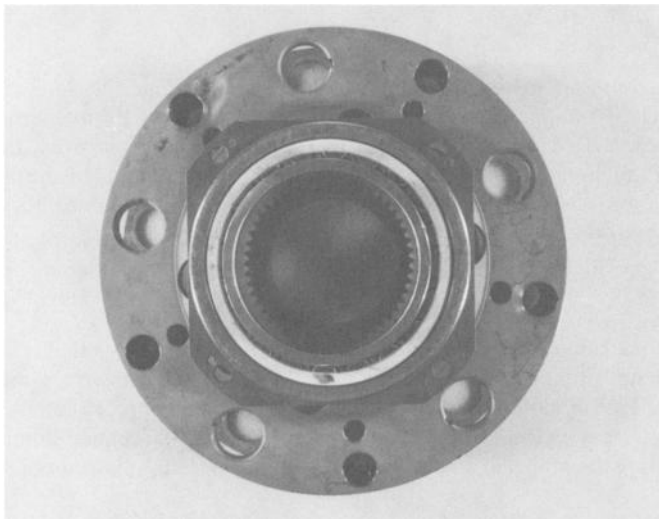
FIG. 1—Assembled No. 5 main bearing when viewed along propeller shaft from the propeller.

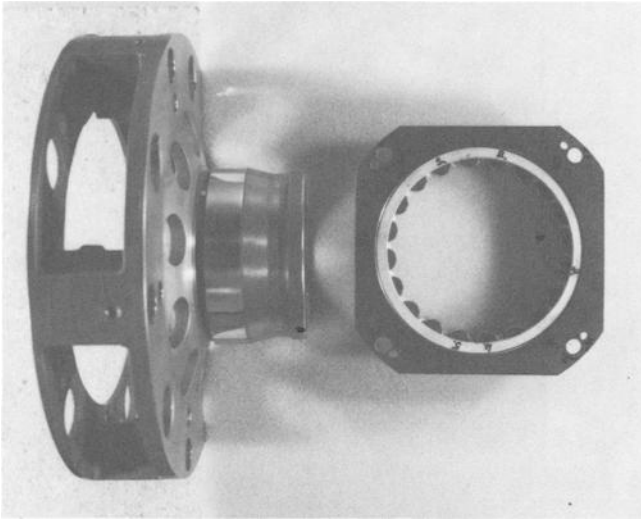
FIG. 2—View of the separated No. 5 bearing components showing its construction.

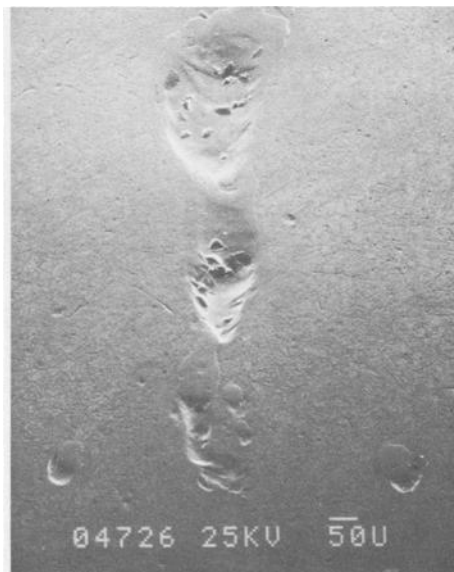
The surface pits of interest in this investigation were generally about $200\ \mu\text{m}$ in diameter, and strings of pits were spread out both in the rolling direction and lateral to the rolling direction. A blemished area containing a number of pits on a roller is shown in Fig. 3. More detailed examples of pits are shown in Figs. 4 and 5. In both these figures the rolling direction is indicated by the parallel wear marks, running from top to bottom of these figures.

FIG. 3—Surface pits in a roller showing both longitudinal and lateral placement of pits.

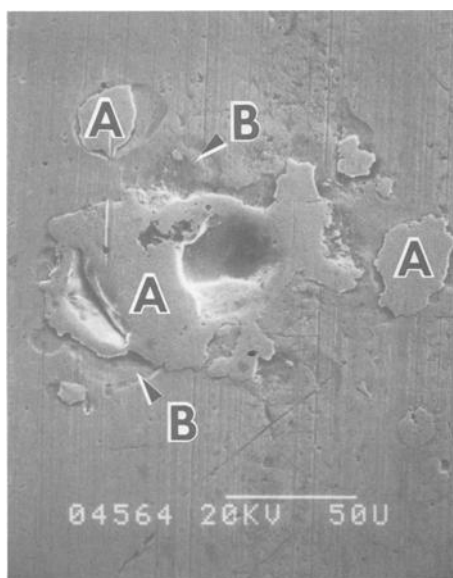
These pits were partly filled with metal which was rolled level with the roller surface (see A

FIG. 4—Surface pit in roller showing the pit partly filled with remelted metal and rolled in impressions in the surface.

in Figs. 4 and 5), and sometimes this extraneous metal was indented into the roller surface from the periphery of the pit, for example, b, in Fig. 4.

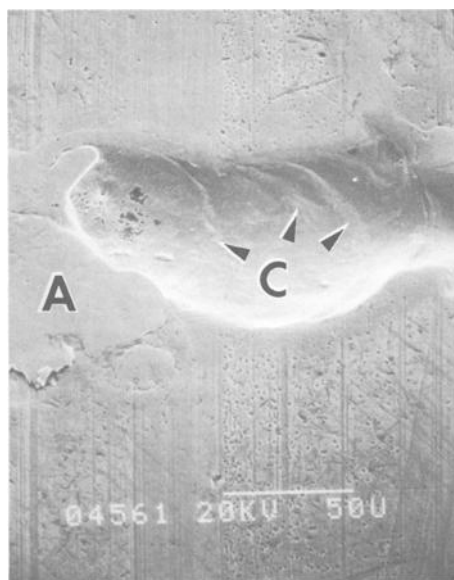
FIG. 5—The brightly reflecting base of a roller surface pit showing flow marks.

Sometimes the exposed pit bottom was relatively dull and had a matt appearance when viewed under the optical microscope. In other pits, the pit bottom appeared bright and highly reflecting. Such a pit is shown in Fig. 5. In addition to being highly reflecting, this type of pit had "flow" markings along their bases, as indicated by C in Fig. 5.

At low magnification, that is, less than $\times 1000$, there was no indication of the true structure of these highly reflecting pit bases. Actually, from the flow markings in these pits it appeared that metal in excess of the pit volume found its way into these pits and then had been flowed along the pit bases under exceedingly high pressure. This explanation of the observed flow markings would be conducive to a mechanical failure explanation.

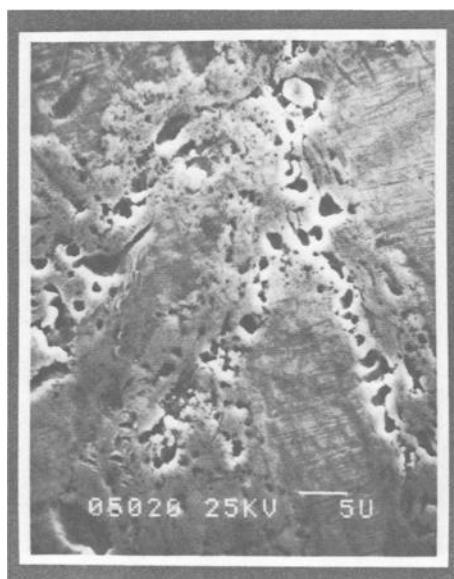
In some of the observed pits, especially the larger (about $500\ \mu\text{m}$), and more isolated ones, there was additional surface damage in the form of micropitting (see Fig. 6) fantailing out, like a wake from a boat, behind these pits. Although these micropits were only several microns in diameter, there were many of them congregated at various surface locations, and the resulting blemished surface was often visible to the naked eye.

FIG. 6—Micropit stringers fantailing away from a large pit which is out of view at top.

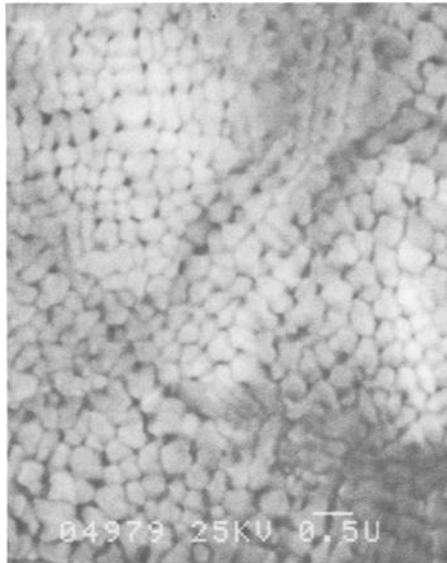
When viewed in the SEM at appreciably higher magnifications, that is, $\times 3000$ to $\times 10\ 000$, however, these "smooth" pit base surfaces were found to have a dendritic structure (see Fig. 7), which was characteristic of a solid metal surface which had been rapidly cooled from the melt (liquid phase).

FIG. 7—Dendritic crystal growth in the brightly reflecting base surface of a pit similar to that shown in Fig. 5.

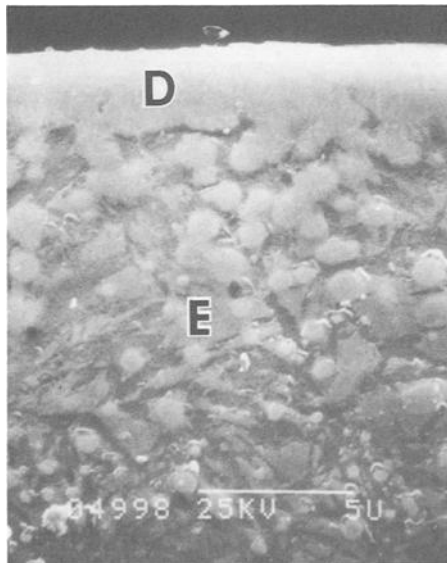
Additional data to support the conclusion that the base walls of these pits had been molten were obtained by cutting one of the pitted rollers through a pitted region and then grinding, polishing, and etching the exposed metal section. A typical SEM of the metal structure for about $15\ \mu\text{m}$ below a pit base surface is shown in Fig. 8. This figure shows the pit base surface had been melted and solidified for an average depth of $3\ \mu\text{m}$. The metal structure immediately below the solidified surface had also been thermally changed to an additional depth of $10\ \mu\text{m}$, before the typical martensitic structure of this bearing alloy became apparent.

FIG. 8—Polished and etched section through the base of a surface pit. D is the dendritic layer and E is thermally altered alloy.
