## The Comparison of Brake and Accelerator Pedals with Marks on Shoe Soles

**REFERENCE:** von Bremen, A., "The Comparison of Brake and Accelerator Pedals with Marks on Shoe Soles," *Journal of Forensic Sciences*, JFSCA, Vol. 35, No. 1, Jan. 1990, pp. 14-24.

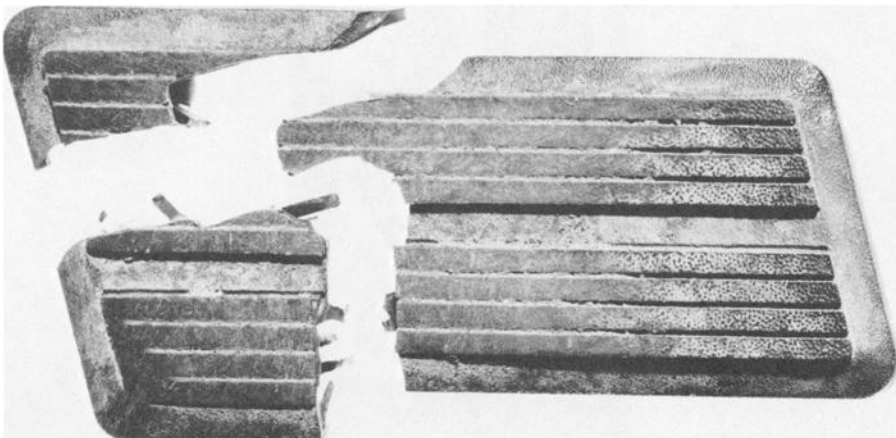
It should also be determined whether the metal pin holding the pedal to the metal arm is bent. The end of the arm may have been forced into the underside of the plastic pedal. Since the presence of damage to the accelerator unit can be significant to the examination, the pedal and arm should be removed from the vehicle and examined as a complete unit. Otherwise, unknown to the analyst, the investigator may have damaged it while removing it from the arm (Fig. 1).

FIG. 1—The accelerator pedal was broken during removal from the car after the accident.

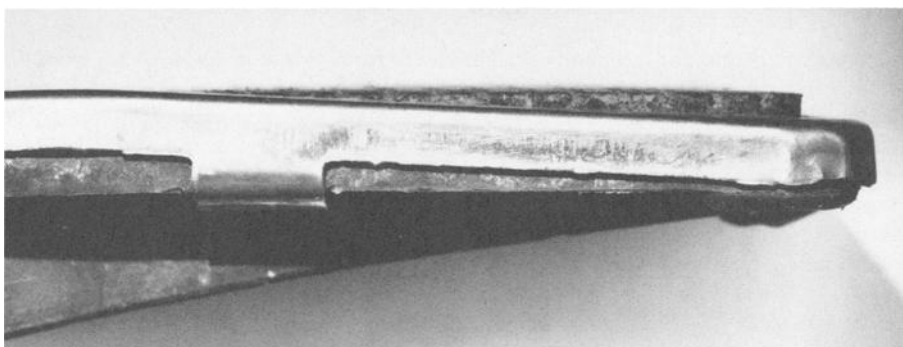
The side of the accelerator pedal may also reveal damage (Fig. 2). Here the lower half of this pedal was forced forward by a shoed foot or some other object during the collision. When the pressure on the pedal was released after the collision the plastic pedal sprang back to take on its original shape, but the metal trim surrounding the pedal remained bent.

FIG. 2—The side view of an accelerator pedal with metal trim that is not parallel with the pedal's top surface (magnification  $\times 1.8$ ).

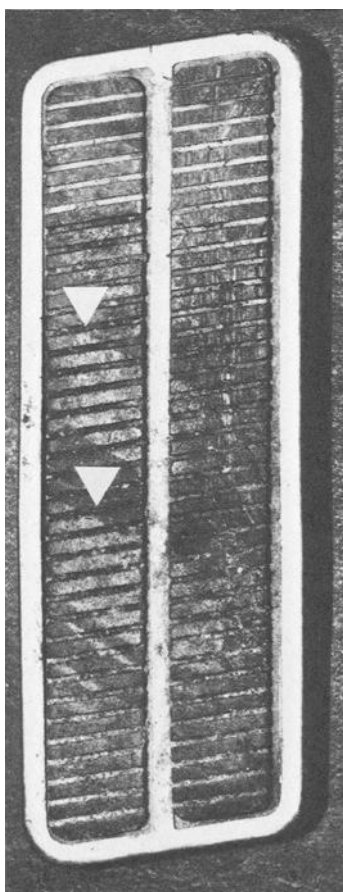
Frequently the accelerator pedal will have vertical ribs on its face and sometimes a herringbone pattern. Either of these may leave marks on shoe soles. The ribs are searched for marks such as glossy friction marks. Glossy marks are best revealed with a microscope spotlight placed next to the examiner's eyes. The marks in Fig. 3 were created when a patterned shoe sole under pressure slid off the pedal, and suggest unusual events such as a collision (compare to Fig. 4).

FIG. 3—Two parallel friction marks on an accelerator pedal revealed by a microscope light.

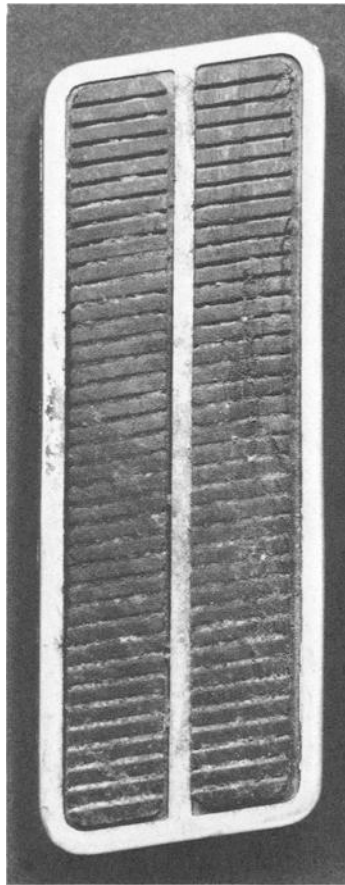
FIG. 4—The same pedal as in Fig. 3 seen with room light.

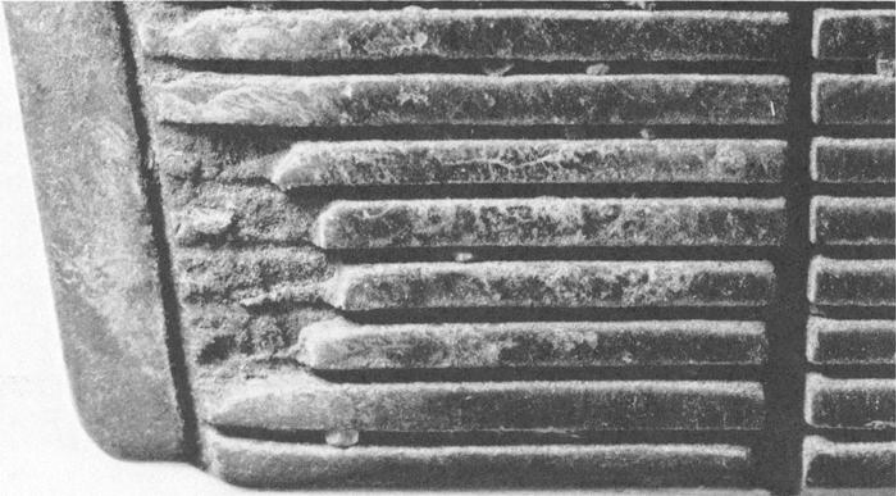
The brake pedal is usually manufactured from a metal plate that is welded to a strong metal arm and is designed to withstand extreme pressures. The author has not yet seen a broken brake pedal. The pedal has a rubber pad that must be removed carefully so that any surface marks will not be lost. The pad's face will usually have a textured pattern of either horizontal or vertical ribs. Some pads may have ribs that have been broken off from forceful or frequent contact with shoe soles, giving the pad an individual surface

FIG. 5—A sequence of broken ribs gives individuality to a pad surface.

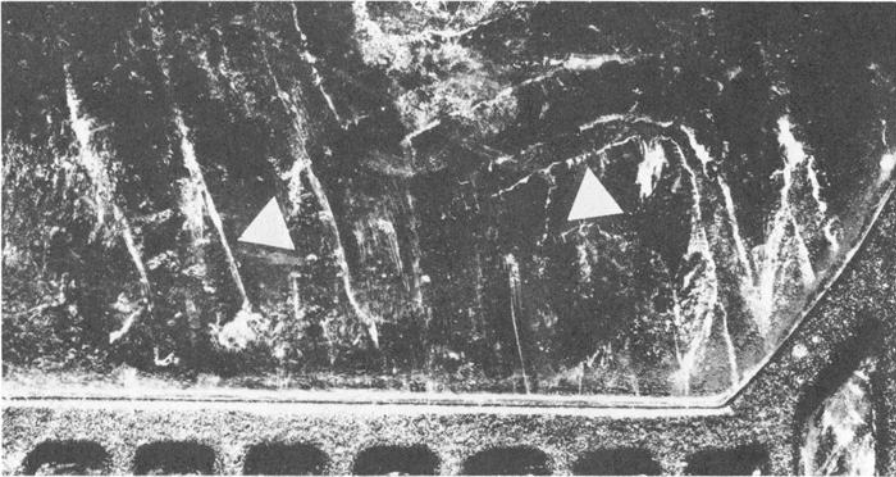
(Fig. 5). All brake pads are examined for friction marks and soil marks forming a pattern (Fig. 6). The microscope spotlight and reading glass are used again.

FIG. 6—Light-colored soil marks on the upper half of a brake pad (magnification  $\times 3$ ).

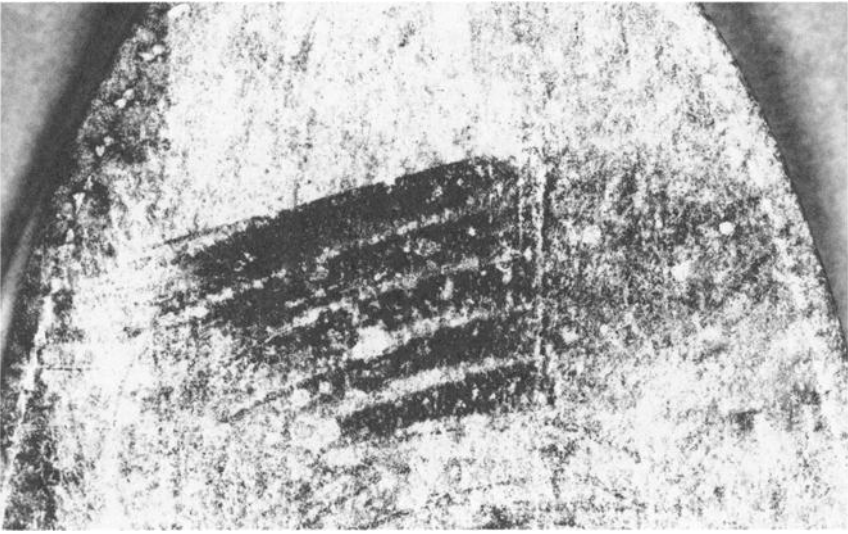
Light-colored synthetic soles show dark friction marks readily (Fig. 7). Faint marks are best seen when viewed at an oblique angle to reduce visually their size and optically "compress" them. Dark marks on dark soles are more difficult to see and compare. High-contrast photographs are made in some instances. Tests should be done to determine

FIG. 7—Black friction marks on a smooth sole.

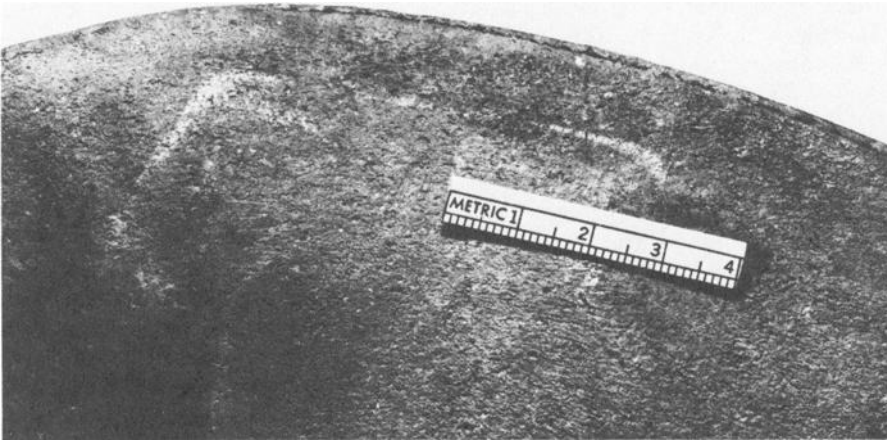
Leather soles are checked for indentations caused by ribs on pads. A microscope spotlight is used at an oblique angle. Leather soles may also pick up what appears to be a metallic sheen from metal trim surrounding a pedal (Fig. 8). This can be seen with diffused side lighting. Soles with a pattern of raised circles, rectangles, herringbone, and so forth are usually examined for any kind of recent damage. Soil marks are frequently found on shoe soles. If the marks are spaced at regular intervals or have abstract shapes, they may be related to a pedal.

FIG. 8—The metallic imprint on the right side of a leather sole originated from a brake pedal. The toe is at the right of the photograph.

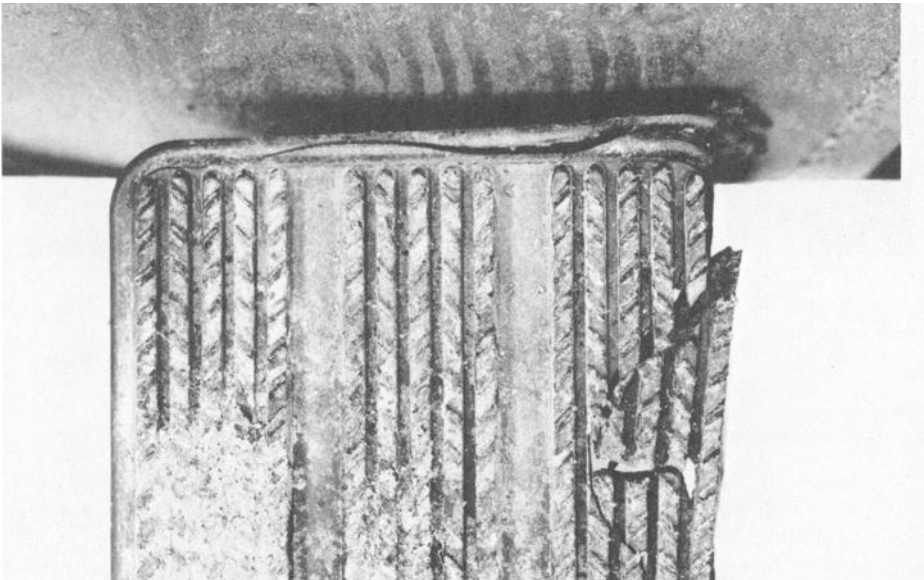
The accelerator pedal had three groups of vertical ribs with two spaces separating them (Fig. 9). The shoe sole had two groups of recently made black friction marks and a third somewhat fainter group. There was correspondence of size and spacing between the marks and the ribs. The toe-to-heel direction of the marks corresponded with the direction of the ribs on the accelerator pedal. The intensity of the marks suggested that they were made with force rather than during routine contact.

The accelerator pedal had a recent fracture indicating forceful contact. The fracture was located on the right side and corresponded in location with the darker friction marks on the sole. These two observations are an indication of where most of the pressure was applied. Further, some of the herringbone pattern on the surface of the pedal was forcefully abraded recently. The pedals' patina was removed revealing a new plastic surface. This was best seen with a stereo microscope.

FIG. 9—Marks on a shoe sole correspond with the ribs on the accelerator pedal (magnification 2×).

marks on the sole of the right boot were probably made by the accelerator pedal during the collision.” However, had it been possible to eliminate the brake pad and the floor mats the conclusion might have read: “The marks on the sole of the right boot were made by the accelerator pedal during the collision.”

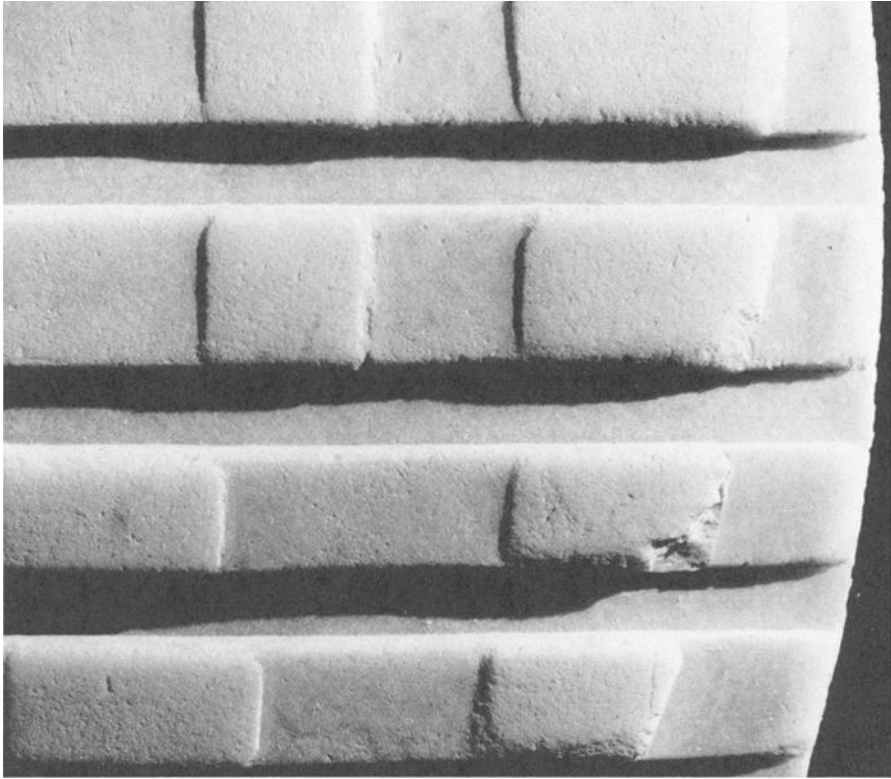
The soles of running shoes from Suspect A had a tread pattern of four-sided shapes of various sizes. Some of them were square, others were approximately parallelograms. One parallelogram on the left shoe measured approximately 14 mm wide. Its width corresponded with the width of the friction mark on the brake pad. A corner of this parallelogram was torn off. The sharp edges and clean surface of the broken area indicated that the damage was recently made (Fig. 11). This suggested that the edge of the parallelogram got caught by one of the ribs on the pedal and was then forced forward. Also, the parallelogram was located below the ball of the foot where one would expect most of the pressure on the pedal to be applied. The location of a friction mark on the brake pad was consistent with the operators driving habits. The mark was to the left of the center of the pedal suggesting a “two-footed driver.”

The conclusion was “The sole of the left shoe of Suspect A was probably in contact with the brake pedal during the accident.”

FIG. 11—Recent damage to tread pattern on left shoe of Suspect A. Toe is at bottom of photograph (magnification  $\times 2$ ).

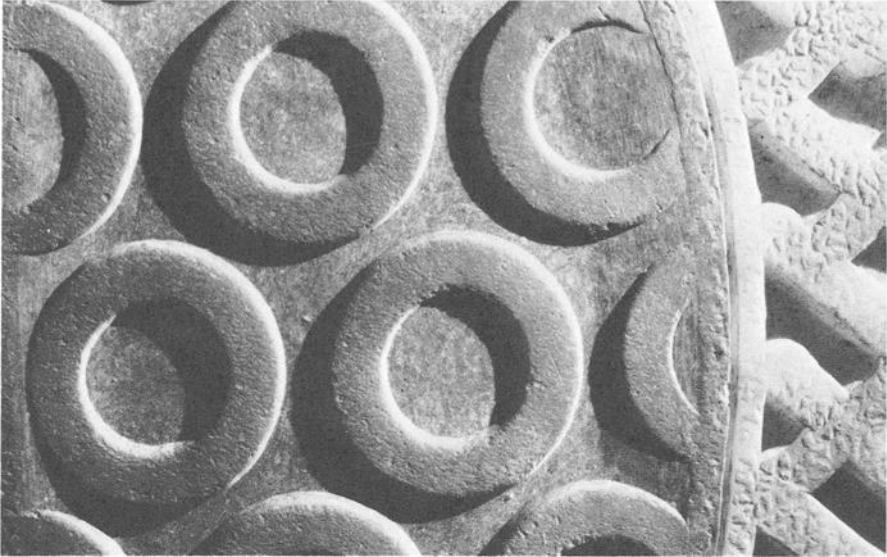
Eliminating Suspect B further strengthened the conclusion. His running shoes had a pattern of rings, each having a diameter of 17 mm, 3 mm larger than the damaged parallelogram on the first pair of shoes (Fig. 12). The soles had no recent marks or any indication of forceful contact with any of the pedals.

FIG. 12—Left shoe sole of Suspect B. Toe is at bottom of photograph (magnification  $\times 2$ ).

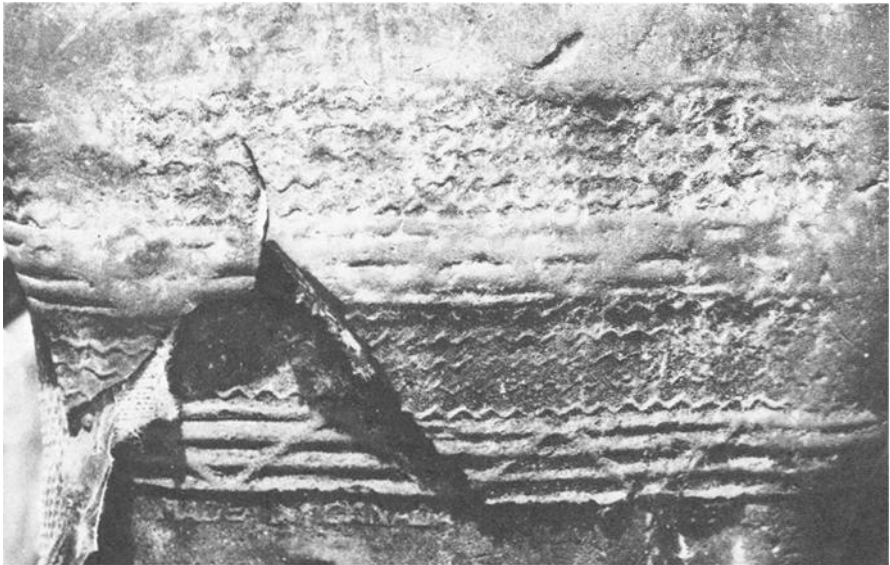
This case involved a collision between a tractor trailer and a construction crane at an intersection. The driver of the crane was wearing rubber overboots over workboots. His left boot had a recent tear starting at the sole and extending up past the ankle (Fig. 13).

The tear at the sole was in the shape of a right angle corresponding with the shape of two of three pedals. Both the clutch pedal and the brake pedal were of bare metal and without rubber pads. The clutch pedal plate had exceptional sharp edges all around.

It was not possible to relate the tear to a specific pedal, but since it was the left boot the conclusion was: "It is possible that the left overboot came in contact with the clutch pedal or the brake pedal during the accident." This suggested that the overboot slipped off one of the pedals while under pressure and the edge of a plate tore the boot.

FIG. 13—A right angle tear next to the instep on the sole of an overboot.

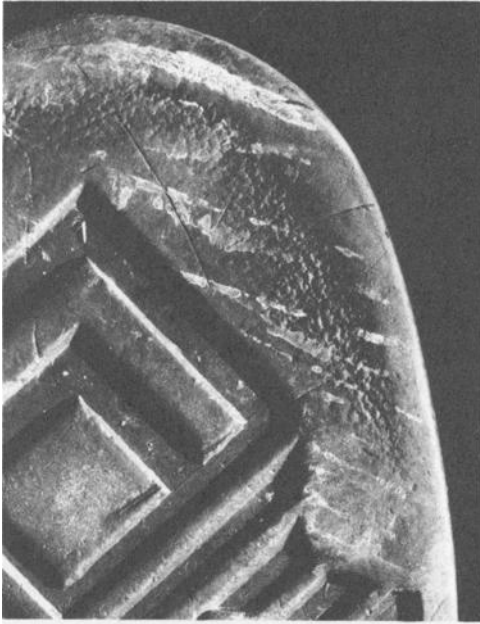
Light-colored marks (salt?) were found on the sole of the right boot (Fig. 14). They ran from side to side and little force if any was required to make them. Some of the marks were 10 mm apart.

The white marks on the soles were sharp and recent. The white deposits on the accelerator pedal were older, not as well defined, and did not run parallel with the ribs.

FIG. 14—White marks on sole of right boot.

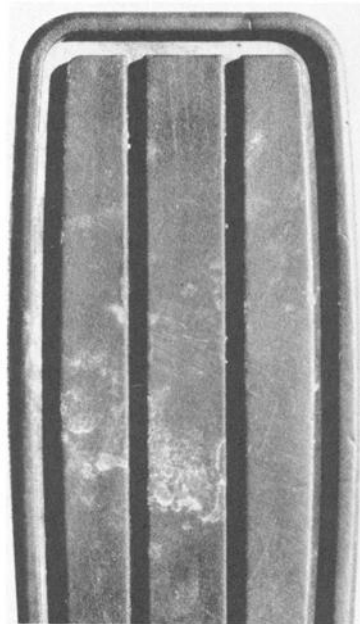
The undamaged accelerator pedal had three ribs, the center one measured 10 mm wide (Fig. 15). These ribs ran in an up-and-down direction and at right angles to the marks on the soles. To make these marks the driver, the only occupant, would have to rotate his right leg and foot by 90°. This maneuver would be difficult to achieve in a mini truck (Suzuki).

FIG. 15—Accelerator pad in Case 4.

The brake and clutch pedal pads had a pattern of solid circles, each with a diameter of 5 mm. The floor mats were not available. Therefore the conclusions stated: "The marks on the sole of the right boot were probably not made by any pedal pad in this vehicle." The marks were probably acquired after the accident.
