Identification of Photocopiers from Fusing Roller Defects

REFERENCE: Gerhart, F. J., "Identification of Photocopiers from Fusing Roller Defects," *Journal of Forensic Sciences*, JFSCA, Vol. 37, No. 1, Jan. 1992, pp. 130-139.

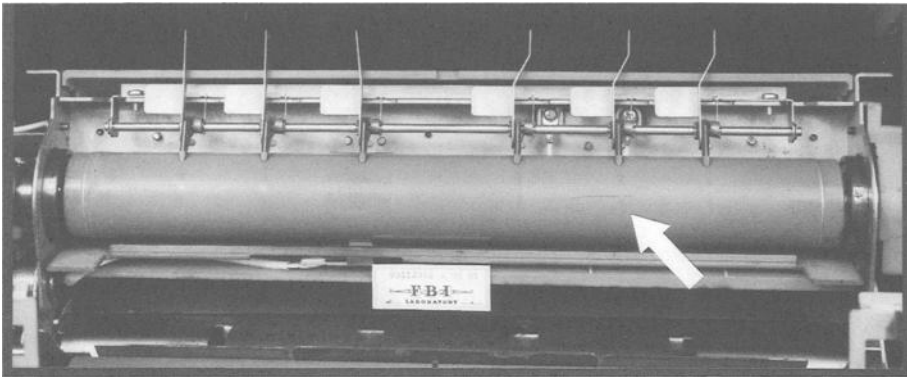
The Adler-Royal TA220RE (Copier 1), which was submitted to the laboratory for examination, was found to have fusing roller damage in the form of a distinctive scratch on the upper fusing roller. The scratch was deep enough to remove the Teflon coating from the surface of the cylinder. Subsequent accumulation of toner material in the scratch caused it to become raised above the Teflon surface, except where the separation prong rides over the top (Figs. 1a and 1b). This raised surface produced two corresponding

FIG. 1a—Adler-Royal TA220RE (Copier 1): The scratch on the upper fusing roller, indicated by the arrow, initially removed the Teflon coating, exposing the bare metal. Note the coil springs to the right of the six separation claws keeping them in contact with the fusing roller. The Teflon is beginning to show wear from the separation claws, but it is not sufficient to leave marks on copies.

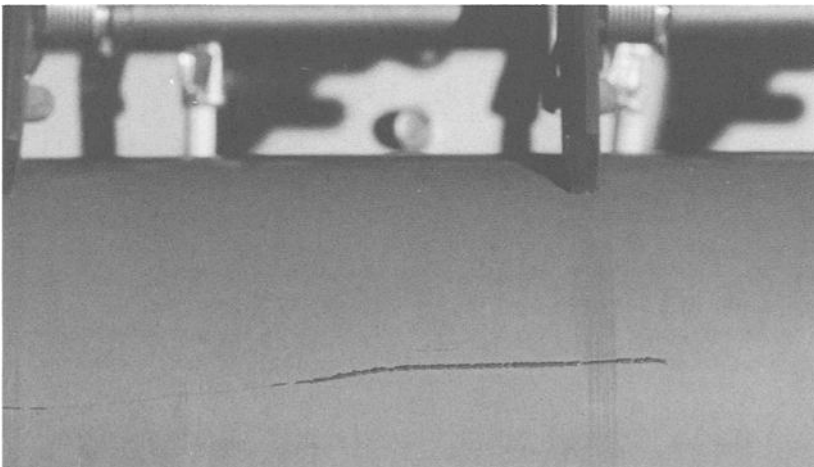
FIG. 1b—Enlargement of the scratch in Fig. 1a has accumulated toner material where the metal is exposed, forming a ridge above the surface of the Teflon except where the separation claw rides over the scratch.

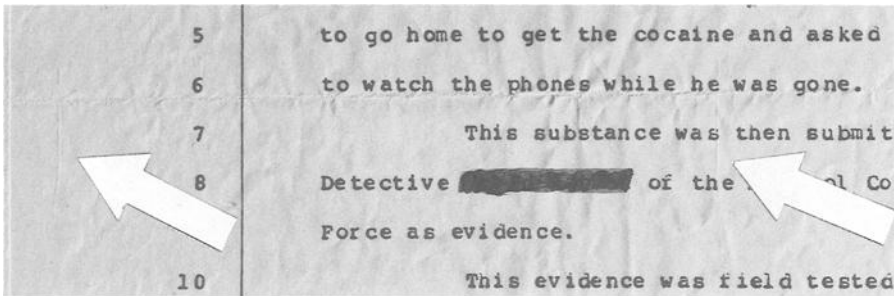
indentation patterns on the questioned copy, with the distance between the marks equal to the circumference of the fusing roller (Fig. 1c).

FIG. 1c—Arrows indicate the positions of indentation lines produced from the scratch in Figs. 1a and 1b. The distance between marks is equal to the circumference of the fusing roller.

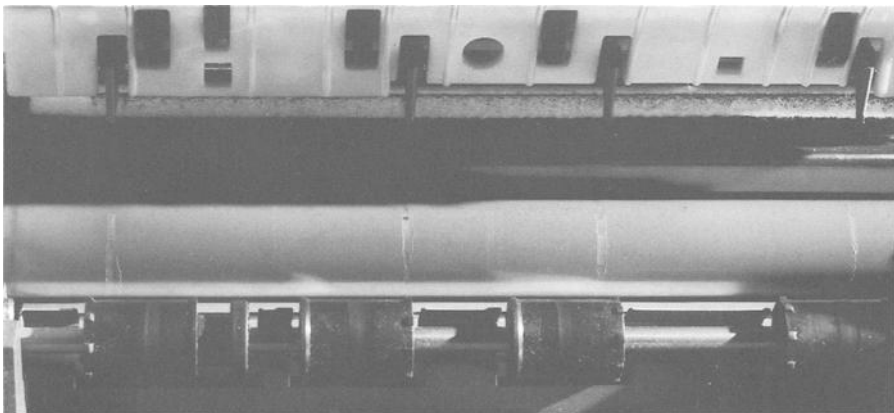
The Canon PC-24 (Copier 8) displayed some indentation lines on the copy as a result of wear from the separation prongs on the fusing roller. The indentation lines appeared in the same relative positions as those in the Canon PC-24 (Copier 7), but they lacked the individuality displayed in Fig. 2. This type of general wear, when observed, would greatly reduce the number of suspect copiers, but it should not be considered unique to a single machine. In conjunction with "trash marks" in common, this type of wear would strongly suggest that the questioned document was in physical contact with the photocopy machine.

FIG. 2a—Canon PC-24 (Copier 7): Wear damage to the Teflon coating on the upper fusing roller is caused by the rubbing of the separation prongs.

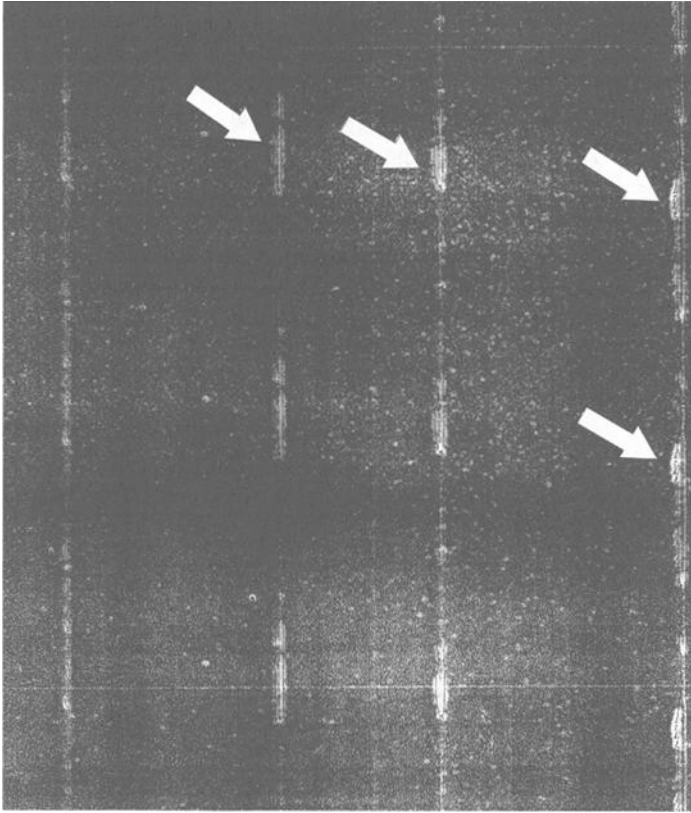
FIG. 2b—Transparency copy made with the lid open, showing the uneven fusing of the toner as a result of the damage depicted in Fig. 2a. The pattern is reproduced three times on an 11-in. (28-cm) page.

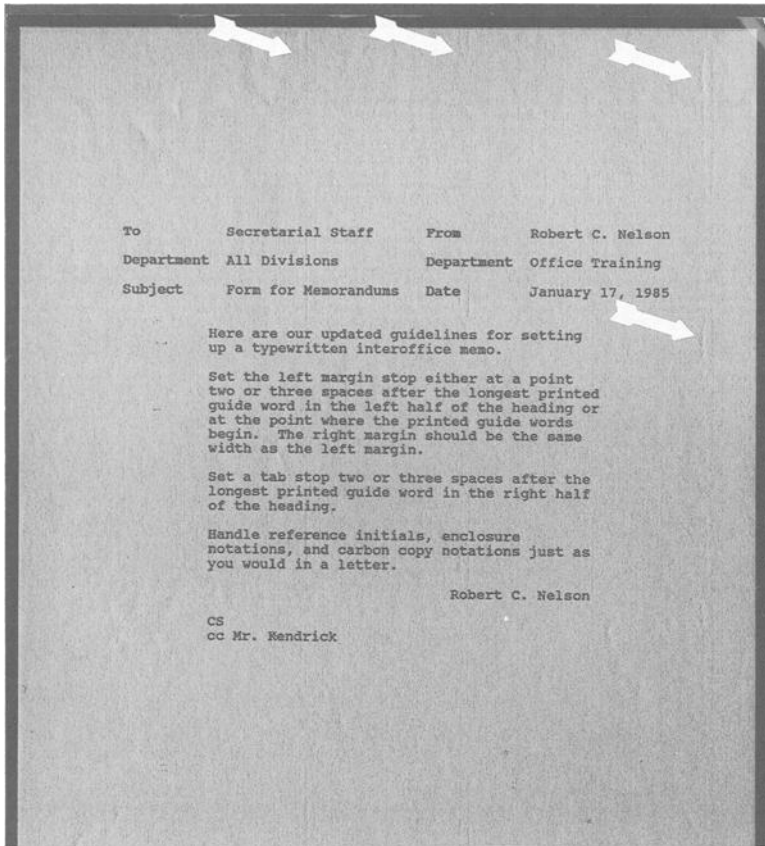
FIG. 2c—Copy paper photographed with side lighting, showing a pattern similar to that in Fig. 2b but in the form of three vertical rows of indentations produced from the worn fusing roller in Fig. 2a.

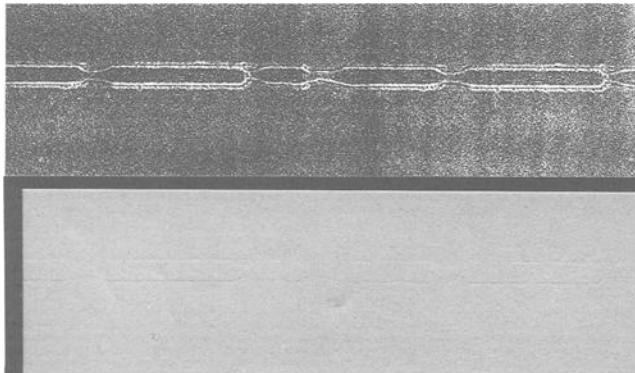
FIG. 3—Konica 2803ZMR (Copier 13): Fusing roller damage from separation claws produced three rows of distinctive patterns. Shown is a portion of one row on copy paper (above) and on a transparency copy (below).

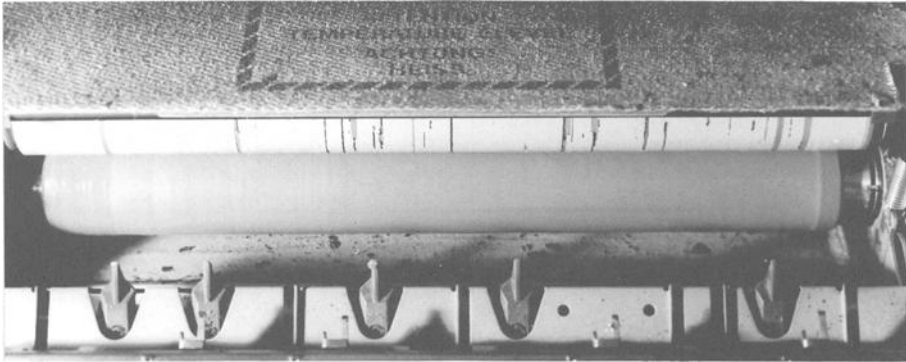
FIG. 4—Canon NP-210 (Copier 4): The peeling of the Teflon coating on the upper fusing roller is extensive, and copies display an abundance of indentations. The separation claws account for only a portion of the total wear exhibited. This fusing roller continues to fuse toner to the page and produce clean copies; therefore it will probably not be replaced by the service technician.

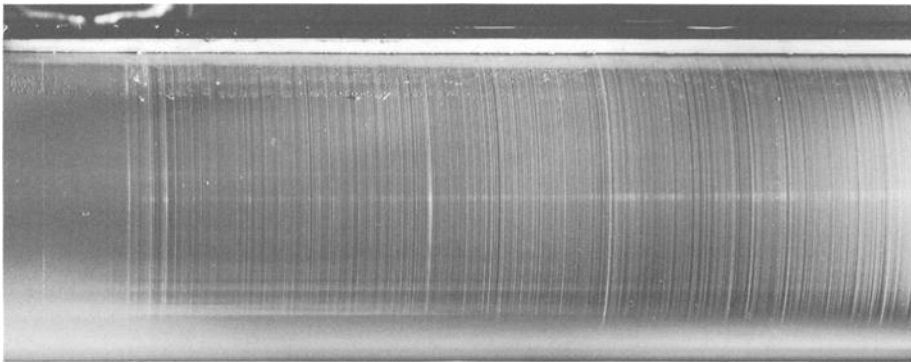
FIG. 5—Canon NP-150 (Copier 3): The striated condition of this fusing roller is probably the result of exposure to the hardened debris from a dry dirty wiping pad above. This roller produces copies with a distinctive pattern of furrows and ridges.
