## Correlation of Trauma and Cause of Death to Accident Reconstruction: A Case of a Flight Accident Report

**REFERENCE:** Min, J.-X. and Jia, M.-Z., "Correlation of Trauma and Cause of Death to Accident Reconstruction: A Case of a Flight Accident Report," *Journal of Forensic Sciences*, JFSCA, Vol. 37, No. 2, March 1992, pp. 585-589.

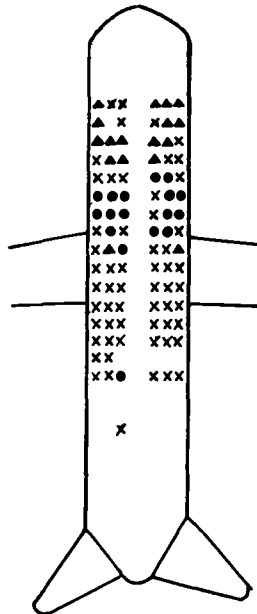
As summarized in Figs. 1 and 2, there were 45 victims who died from head injuries in Flight B-2812, which was parked at the apron; these victims were seated in seats No. 16 through 25. Through postmortem examination it was established not only that the injuries of the passengers on the left side of the plane were more serious, but also that there were more multiple injuries in the passengers on that side. At this point, we may undoubtedly conclude that the left side at seats No. 16 through 25 was the site of impact. For the Flight B-2510, the majority of the victims were seated in seats No. 3 through 18. The results of investigation present some quite significant phenomena: the passengers who had seats No. 3 through 6 mostly died from head injuries; those in seats No. 7 through 10 commonly survived; and the passengers who died from fire or gas inhalation were usually concentrated in seats No. 11 through 18. These findings strongly suggest that (1) while crashing into Flight B-2812, Flight B-2510 still maintained a high speed (approximately 200 km/h) and a large deceleration force, which caused the passengers seated in front of the fuselage to receive severe head injuries; (2) after the initial impact or before plummeting to the ground, Flight B-2510 had broken apart in the middle of the fuselage so that the passengers in seats No. 7 through 10 would have been thrown out the plane through the broken "hole" if not secured by their seat belts; and (3) the plane's further breakup in plummeting to the ground may have obstructed the broken hole so that the passengers seated at the tail section of Flight B-2510 could not get out and died from fire and inhalation of superheated air and chemical gases.

FIG. 1—Diagram of the passengers' initial seats in Flight B-2510: ●, survived; ▲, died from head injuries; ×, died from fire or inhalation of superheated air or chemical gases.

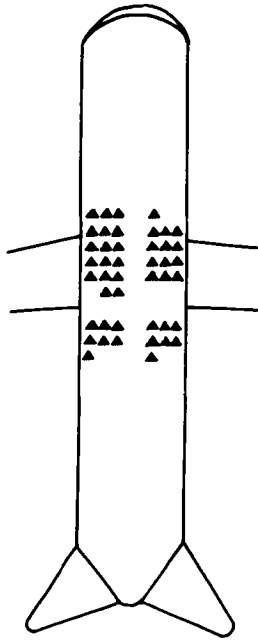
FIG. 2—Diagram of the passengers' initial seats in Flight B-2812: ▲, died from head injuries.
