CASE REPORT

A Particular Case of Oxidation Colors on Bulb Filament After a Car Crash

REFERENCE: Baudoin, Ph. and Lavabre, R., "A Particular Case of Oxidation Colors on Bulb Filament After a Car Crash," *Journal of Forensic Sciences*, JFSCA, Vol. 41, No. 2, March 1996, pp. 304-309.

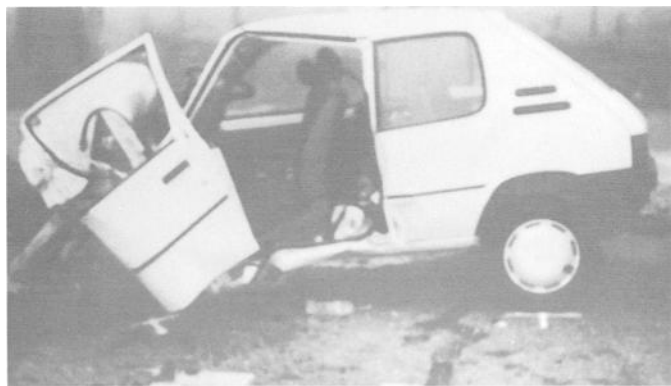
m/s) crashed, without slowing, into a heavy truck trailer coming from a cross road. Visibility at that moment reached roughly 50 m. The collision was particularly violent (Fig. 1). The truck driver who had not obeyed the stop sign said he had not seen the coming car. The 32-year-old female car driver, seriously injured, when questioned, after a three day coma, told the investigators she had indeed turned on the lights of her vehicle but couldn't recall which ones.

FIG. 1—Peugeot 205 XAD car after crash.

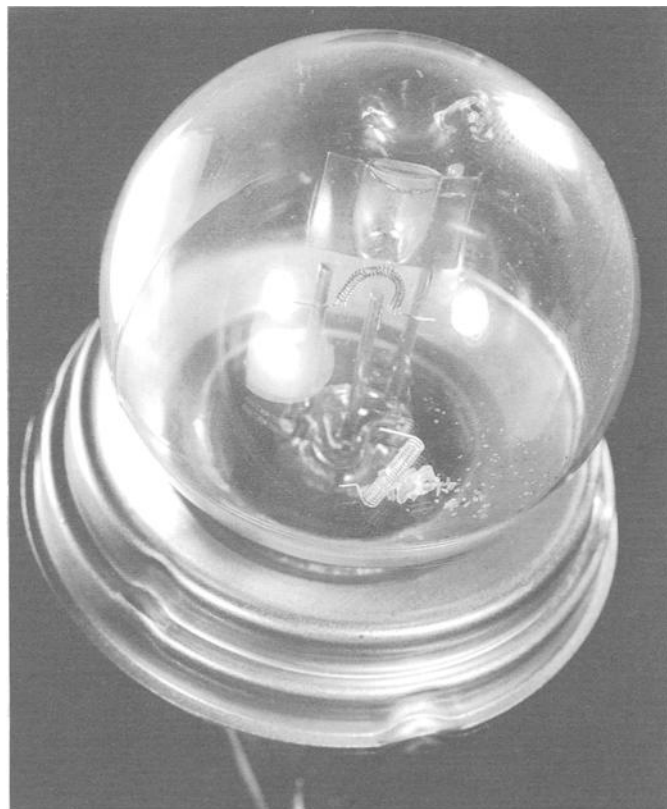
FIG. 2—Philips R2 bulb (European headlight) from the front right optical set.

still had its glass bulb, but a small half millimeter hole could be seen at the top (Fig. 2). Several glass particles were within the bulb. The high-beam filament coil was still attached on its original support while the low-beam filament coil was broken at its two extremities and it laid free in the bulb.

It is thus reasonable to believe that the hole at the top of the bulb was caused by the crash. However, if this is not the case (a pre-crash hole exists), the lights could not have been turned on during or after the crash. Furthermore, since no deposit can be seen on the glass bulb, the hypothesis that the hole was present before the crash is rejected.

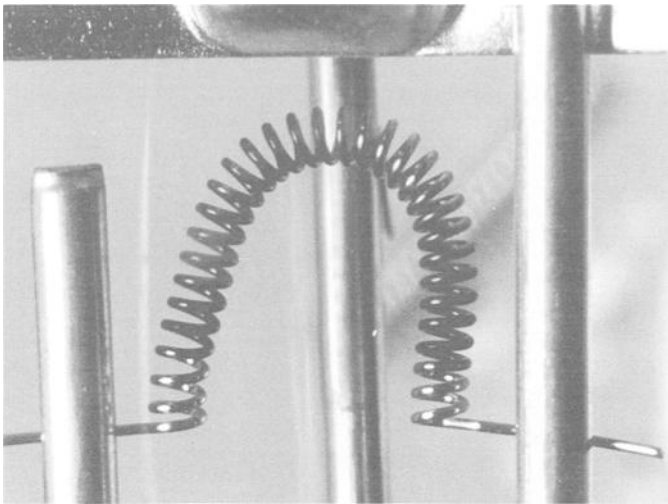
- no tungsten oxide deposit could be found within the bulb,
- no deformation nor oxidation coloring could be seen on the broken low beam filament coil,
- the high beam filament was intact despite a slight incline in its curvature, (Fig. 3).
- a slight iridescent oxidization coloring had occurred on the central part of the high beam filament coil (Fig. 3).

FIG. 3—Iridescent oxidization coloring on the central part of the high beam filament coil.

The high-beam filament coil shows a slight deformation only, not typical at all of a functioning filament which has undergone a violent shock. However, this very slight increase in its curvature cannot be traced to the manufacturing process. In fact, as it stands, the filament could not have allowed the correct centering of the

The high-beam filament coil also shows a slight oxidization, although not very important, this cannot be neglected. The oxidization colors are the same as the ones observed on a filament coil that was not functioning at the time of the bulb breakage but that would have been heated by the incandescence of another filament (3). For a R2 type bulb, the performed tests did not yield such oxidization colors on the high-beam filament coil (see Table 2). This is very likely due to the reflector presence which shields it from radiant heat. Anyway, this explanation is problematical

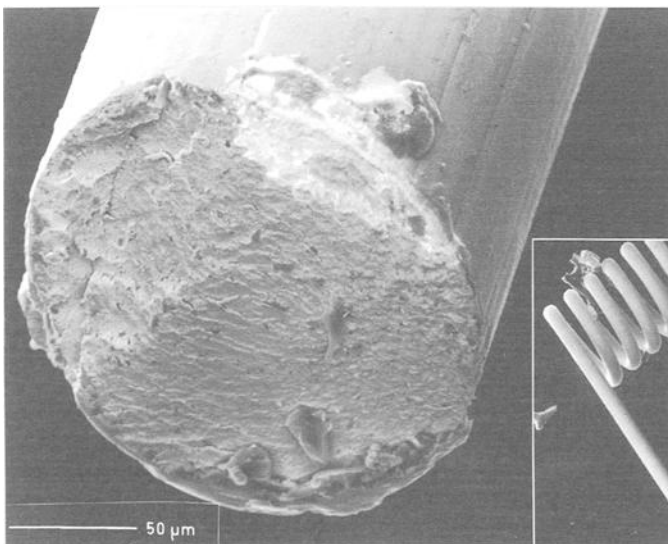
The scanning electron microscopy of low-beam filament coil clearly revealed brittle fractures of transcrystalline type (Fig. 4) (4,5).

FIG. 4—Clear brittle fracture of transcrystalline type of the low-beam filament coil.

The observations regarding the low-beam filament from the Philips R2 bulb are as follows: no deformation, no visible oxidization, brittle fractures when "cold" (SEM). Accordingly, we can then conclude with confidence that the filament coil of the low-beam was turned off at the time of the accident.

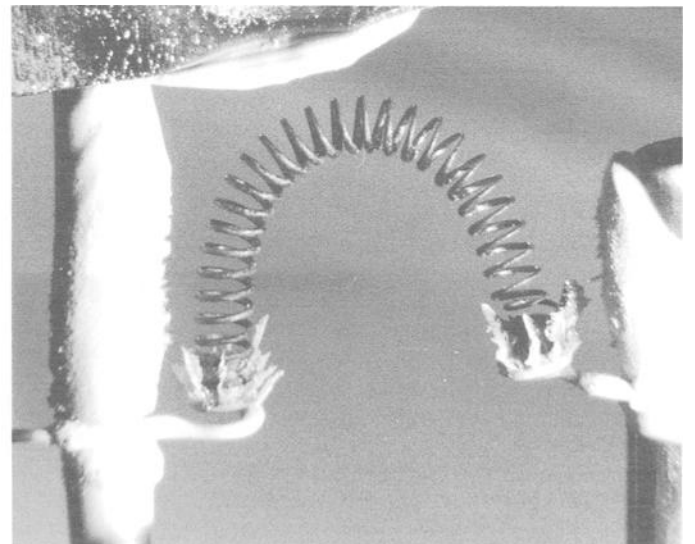
A few seconds after applied voltage and after the blackening of the filament coil and the deposition of some fine particulate tungsten oxide, yellow tree-like tungsten oxide groths appear on the two high-beam filament coil extremities (Fig. 5). Narrowings of the filament coil can also be observed in certain cases (Fig. 6). The filament coil fracture occurred near one of its ends (hardly visible on photo 5 because it is hidden by the groths). This fracture was studied via a scanning electron microscope (Fig. 7). It has a rounded shape and it shows under higher magnification a very peculiar surface appearance (Fig. 8). This could be by tungsten recrystallization, which can occur at a temperature very close to the melting point.

FIG. 5—Yellow tungsten oxide tree-like groths on the high-beam filament coil (test #2).

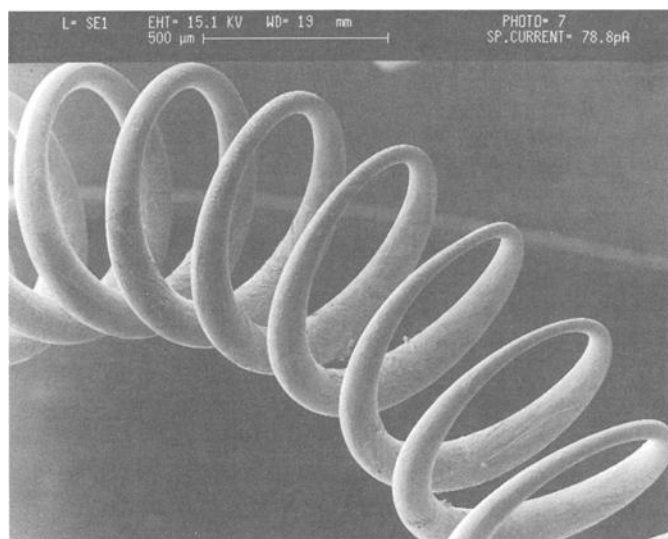
FIG. 6—Narrowing areas on the high-beam filament coil viewed by S.E.M. (test #2).

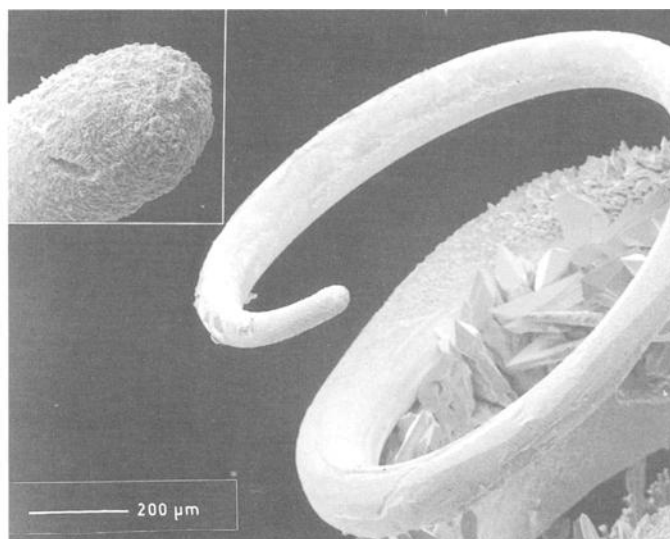
FIG. 7—Fracture of the high-beam filament coil viewed by S.E.M. (test #2).

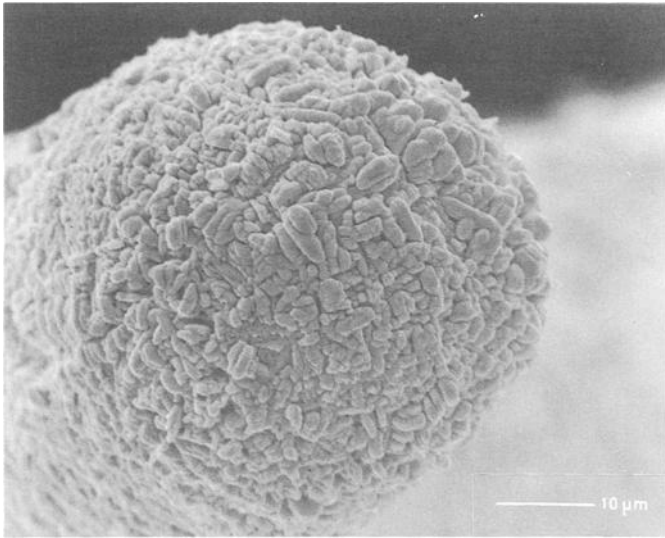
FIG. 8—Peculiar surface appearance of the fracture viewed by S.E.M. (test #2).

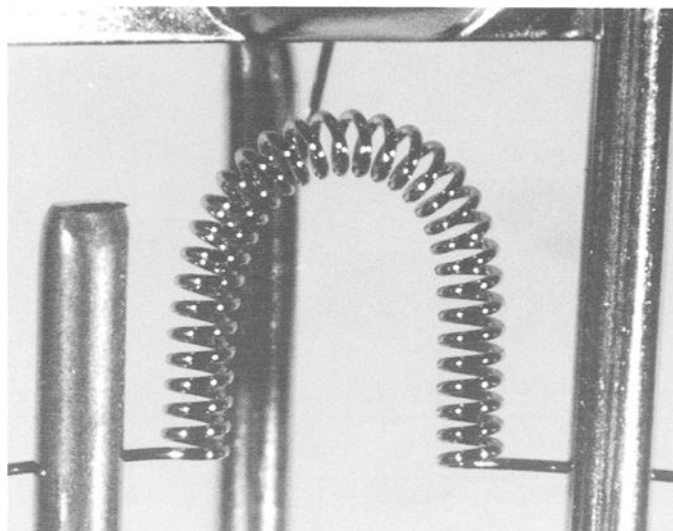
FIG. 10—High-beam filament coil obtained after test #12.

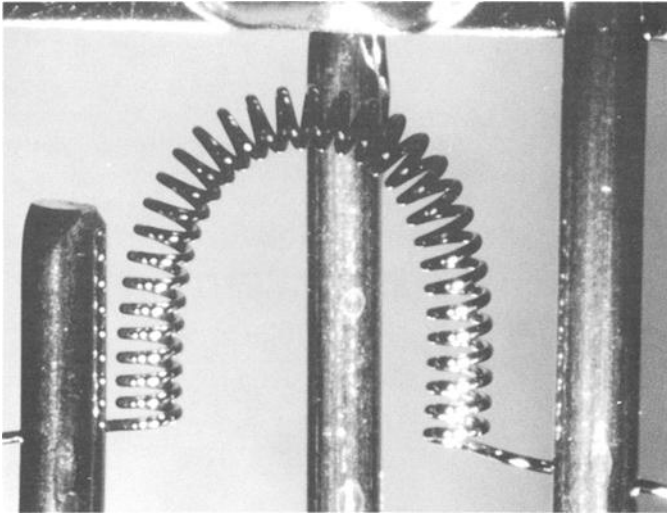
glass during the cool down, the air immediately enters the bulb and oxygen produces the observed oxidization (Fig. 11, tests 16 & 17 on Table 4).

FIG. 11—High-beam filament coil obtained after test #16.
