CASE REPORT

Investigation of a Murder Case Involving Arson

REFERENCE: Tsaroom S. Investigation of a murder case involving arson. *J Forensic Sci* 1996;41(6):1064–1067.

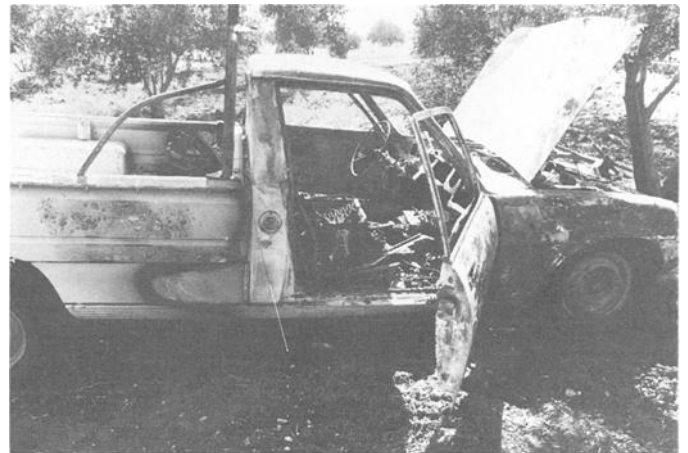
The Van—The next day, we, as the national arson investigation team, arrived at the police station and at the scene. The burned vehicle was a 1982 Peugeot van. The front passenger compartment was totally burned (Fig. 1). The engine compartment, mainly in the upper part, and the two front wheels were extensively burned.

FIG. 1—The front passenger compartment of the van was found burned.

There was nothing left of the dashboard except the metal frame. The padding of the seat was totally burned. The van roof was sunken mainly at the right side. Charred patterns were found all over the driver's compartment from the floor up. All the windows were broken. Pieces of melted glass from the windows were found with pieces of melted aluminum. The handle for the handbrake was not set.

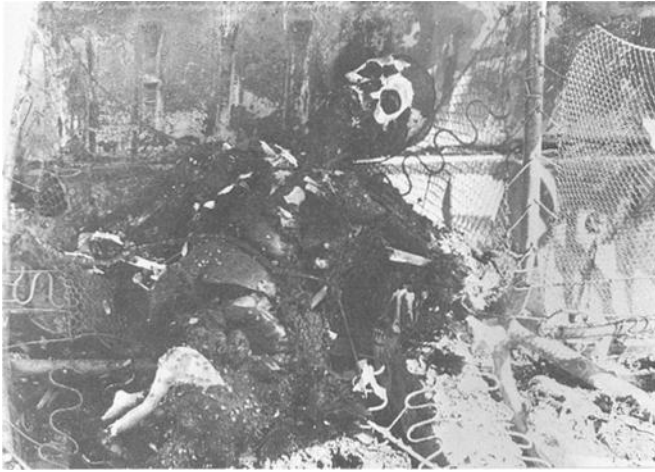
Video Tape—The scene had been photographed by a video tape on the day of the incident. We noticed the massive damage and deep charring of the daughter's dead body (1). The baby's body that was protruded out of the split stomach was slightly burned (Fig. 2).

FIG. 2—The burned body of the woman with an infant protruded out of her stomach.

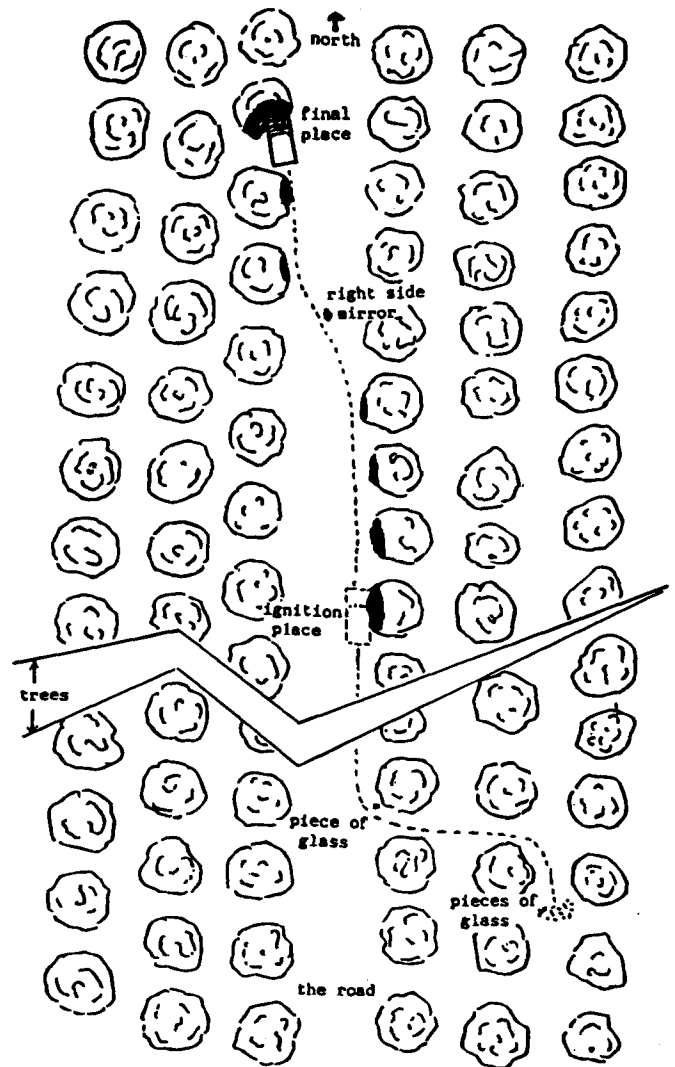
FIG. 3—Scene diagram.

The Scene—The van was found burning near an olive tree in the orchard. This tree grew on the left side of the road which intersects the orchard (see diagram). The tree was badly burned. On the ground under that tree, there were still some charred residues left from the van. The previous olive tree, on the same side of the

road was only partly burned and the third tree on this side was slightly burned. The other trees on that side of the road (the left side) were not affected by the fire. On the opposite side of the road (the right side), about six meters away from the third charred olive tree, there were four more trees that were charred. The first was slightly burned and the last one was more damaged by the fire compared with the other trees on this side. On the ground along this road, there were some pieces of burned plastic that probably fell from the engine compartment and broken glass from the right side mirror of the van (see diagram Fig. 3). About 90 meters away from the place where the van had been found, there were a small clean piece of glass and tire tracks on the ground coming out of the orchard. During further searching, we found a large amount of clean broken small pieces of glass.

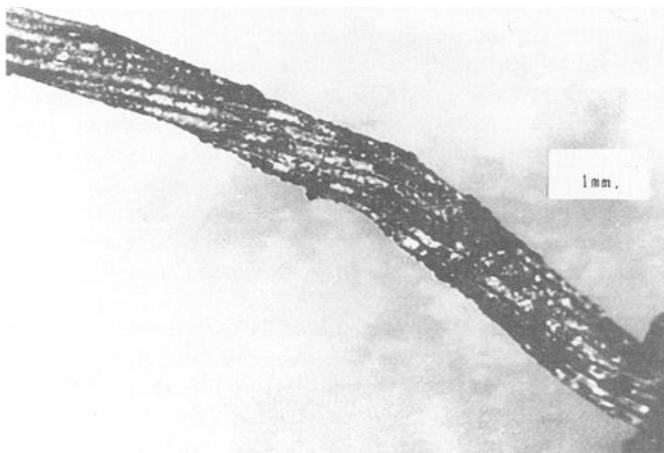
There was only one electrical wire connected to the fuel tank (the wire that comes from the fuel gauge of the dashboard and is connected to its detector of the fuel tank). We examined this wire under a microscope especially near the fuel tank end. We used a Wild M3Z microscope with a Panasonic F15 camera and Sony monitor and printer. Although it was burned, there were no signs of damage or melted spots on the wire and the connector (Fig. 4). We also washed the wire with 5% hydrochloric acid in an ultrasonic mixer and photographed it once again (Fig. 5).

FIG. 4—An 1-mm electrical wire end (near the connector), magnified 15 times.

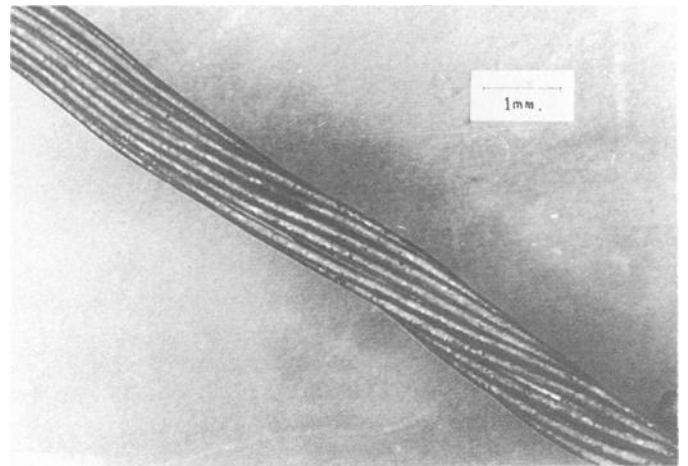
FIG. 5—The same part of the wire as in Fig. 3 after acid treatment.

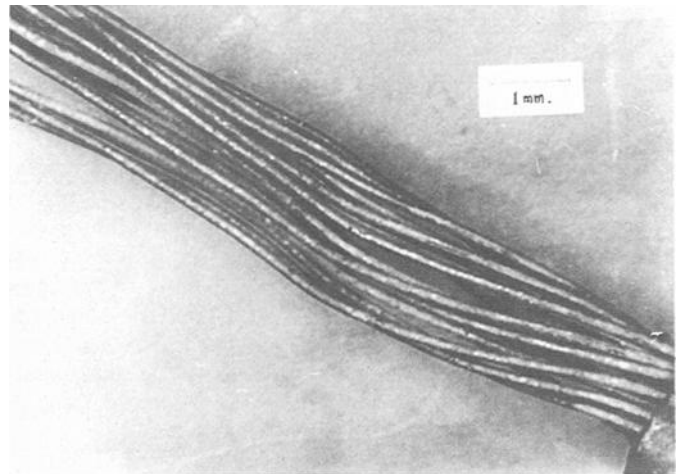
It was also seen that the individual strands of the wire were separated from each other, and thus, no internal heating was involved (Fig. 6). As a control, we used an electrical wire (of the same kind), and we induced an electrical spark by using a 12-V

FIG. 6—The strands of the wire were separated from each other.

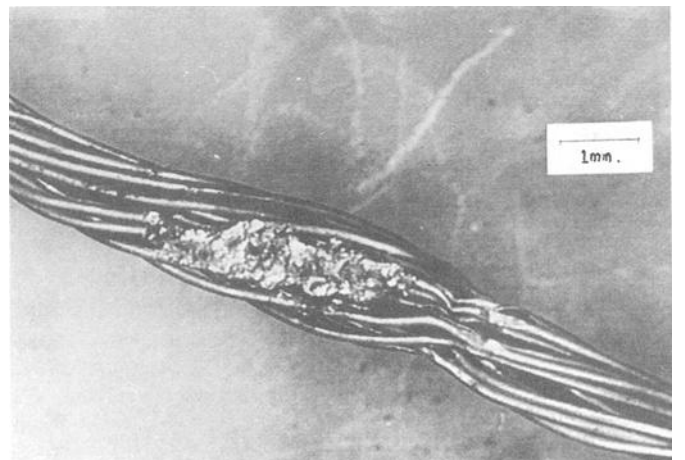
source from a vehicle and striking it onto the vehicle body (5). In the latter case, the damage was quite apparent (Fig. 7).

FIG. 7—Reference wire after an electrical spark.
