TECHNICAL NOTE

Donald J. Van Kirk,¹ P.E., MSEM, MBA; John P. Sas,¹ E.I.T, BSME; and Paul N. Cross,¹ B.Sc.

When Is 100% Inspection Not Enough? An Analysis of Three Pickup Truck Front Wheel Assembly Failures

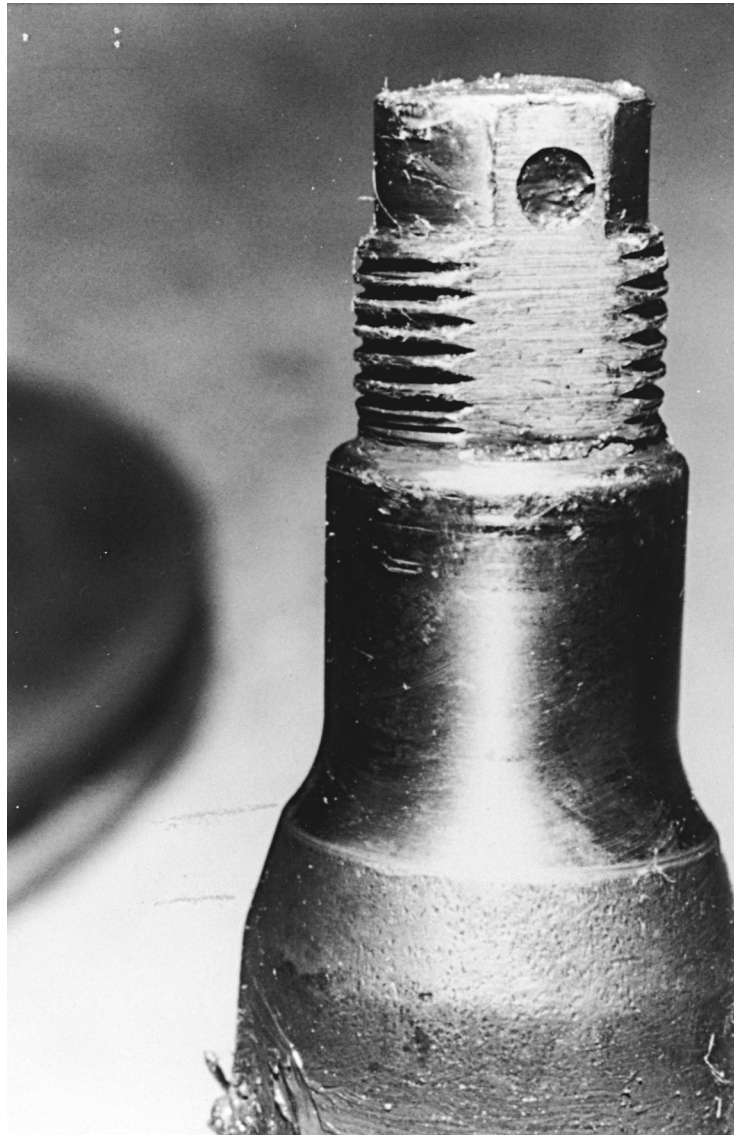
FIG. 3—Typical accident spindle from a vehicle that lost a front wheel.

How does a front wheel assembly come free of the front spindle of a truck? Since the adjusting nut jams the assembly against the shoulder of the spindle it either has to be unthreaded or pulled off of the spindle, damaging the threads. Figures 3 and 4 show a spindle from an accident vehicle. Note the hole is round, with no deformity, and full of grease. There is little or no damage to the threads except where they slid along the ground. The adjusting nut damaged the threads near the shoulder as it worked its way off of the spindle. The end of the spindle is relatively soft, as it is not heat-

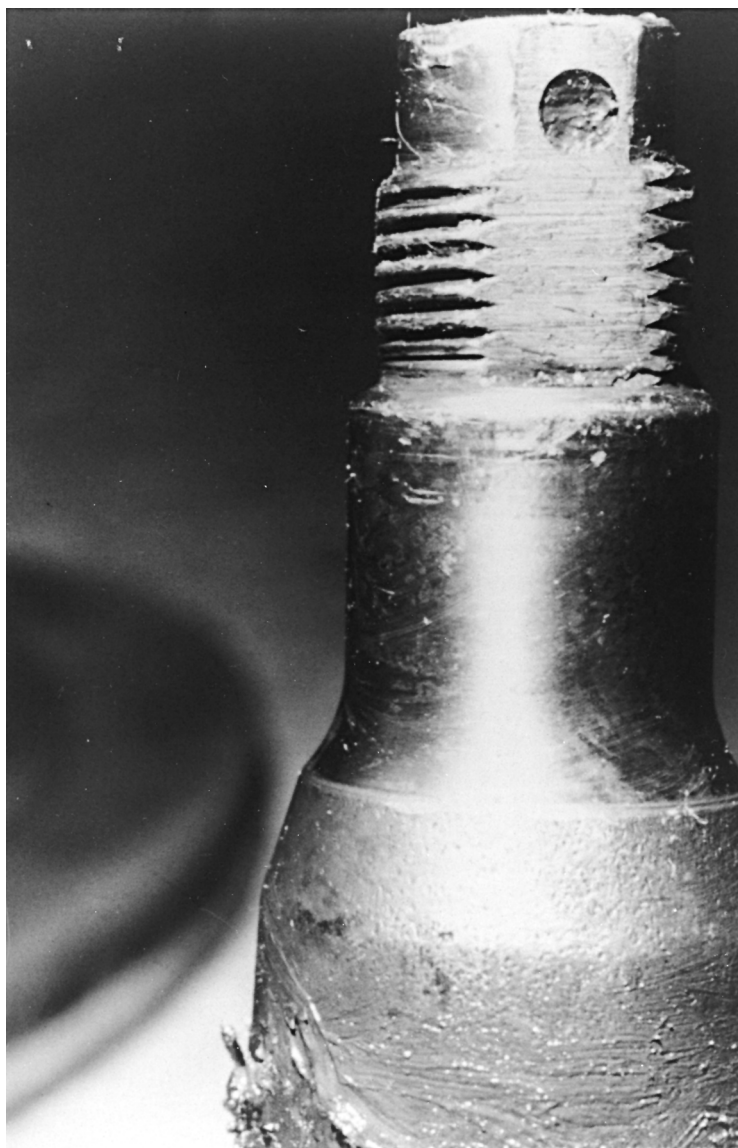
FIG. 4—Close up view of a accident spindle from a vehicle that lost a front wheel.

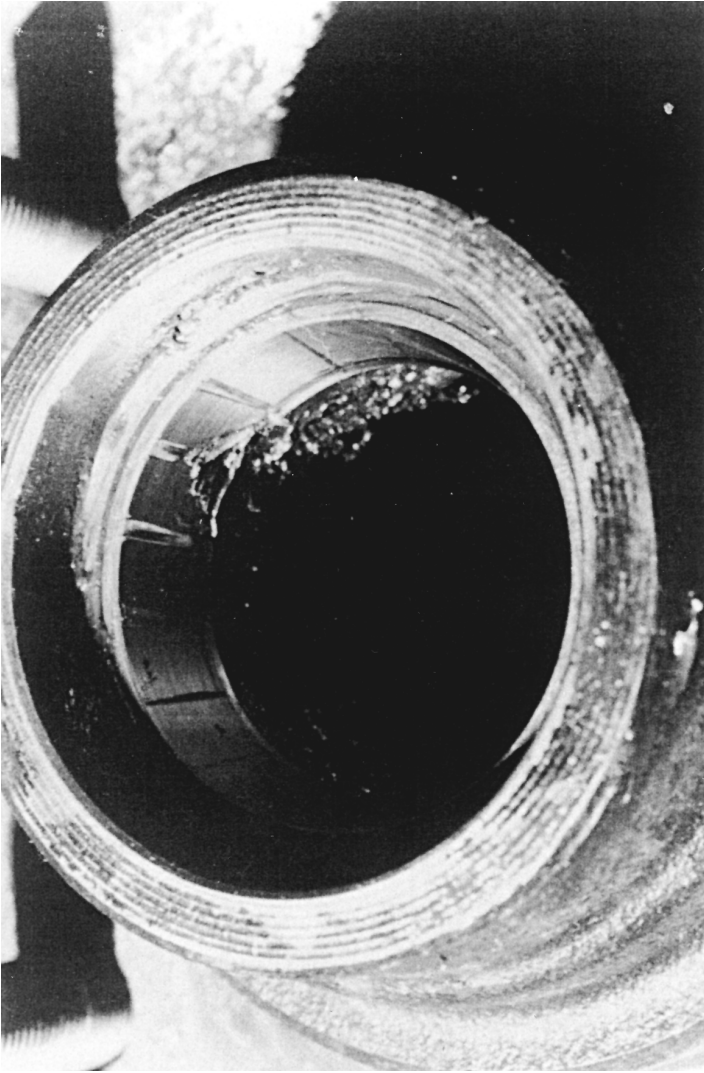
You must also inspect the wheel bearing cones to locate the witness marks that are left from the tapered wheel bearings as the tire and wheel assembly drops off of the spindle. They are easily spotted. Figures 5 and 6 are good examples. An impact to the wheel assembly could not have caused this damage as the witness marks are in the up and downward direction which are not consistent with a lateral or forward force acting on the wheel assembly during an accident.

FIG. 5—Bearing housing showing bearing marks and metal fracture from spindle.

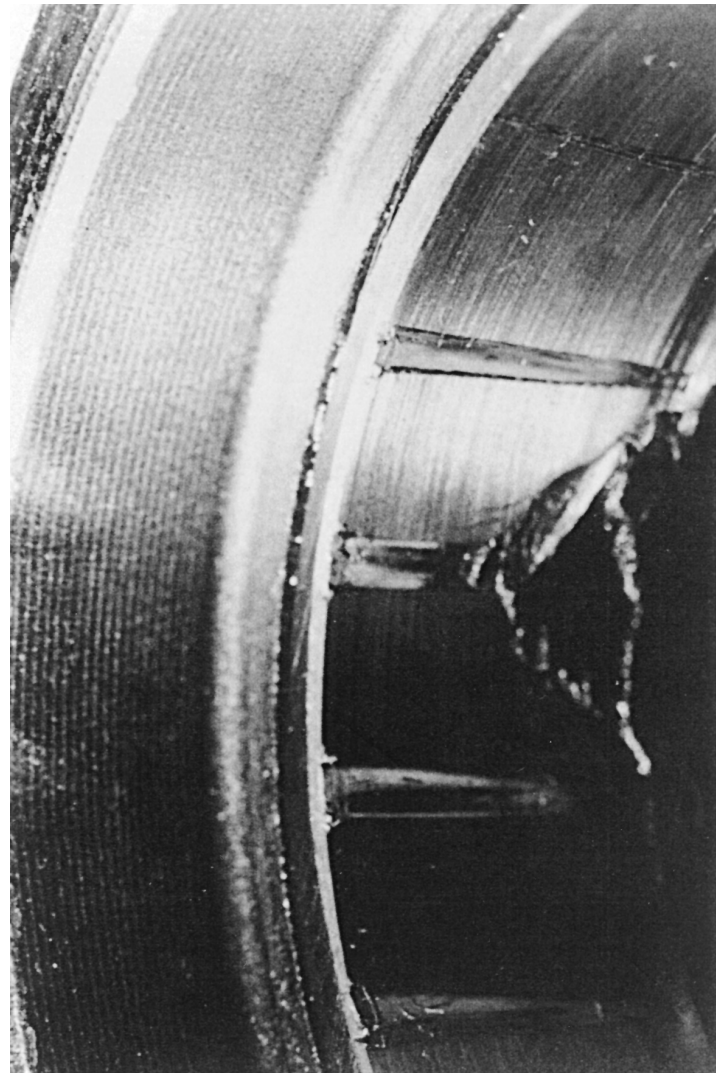
FIG. 6—Close up of bearing housing with bearing impressions.

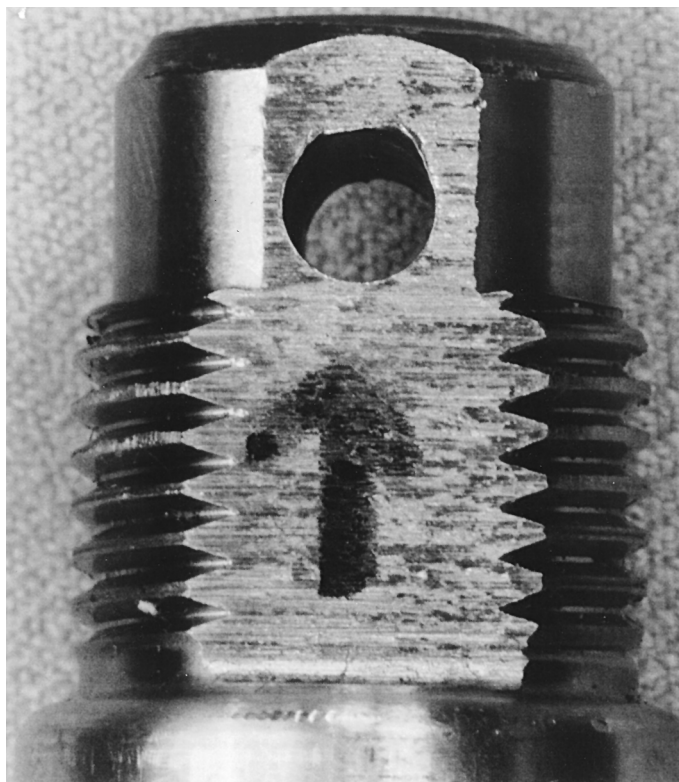
FIG. 7—Close up view of spindle test specimen with deformed hole.

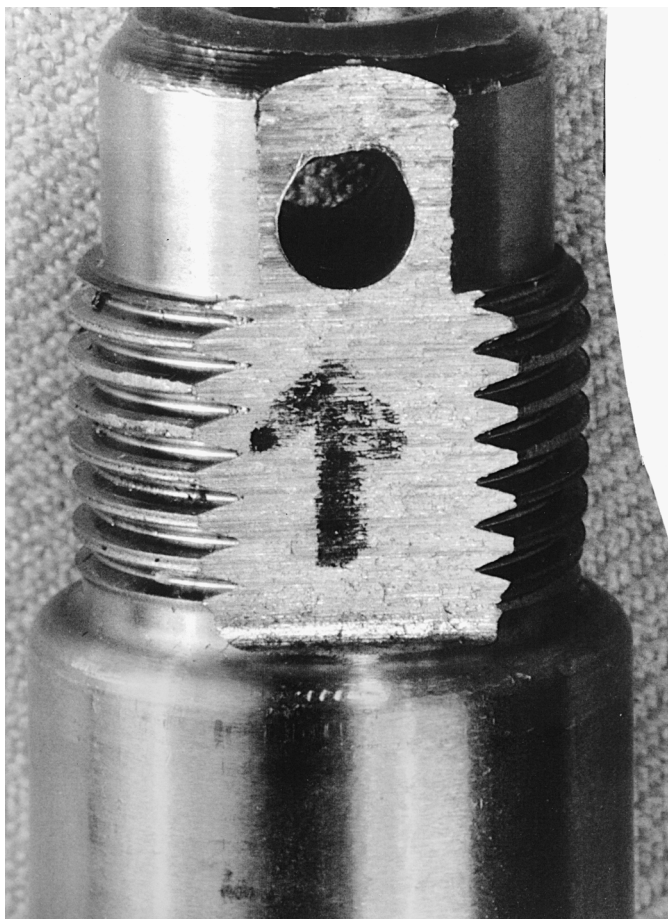
FIG. 8—Close up view of obverse side of test spindle with deformed hole.
