## CASE REPORT

# Examination of Lightbulb Filaments After a Car Crash: Difficulties in Interpreting the Results

**REFERENCE:** Lavabre R, Baudoin P. Examination of lightbulb filaments after a car crash: difficulties in interpreting the results. *J Forensic Sci* 2001;46(1):147–155.

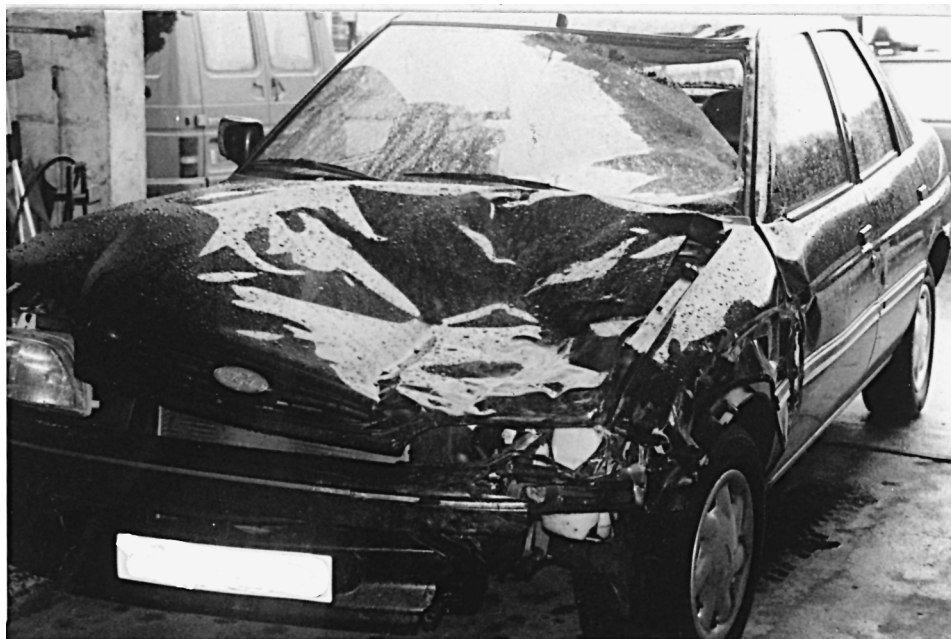
FIG. 1—*The Ford car involved.*

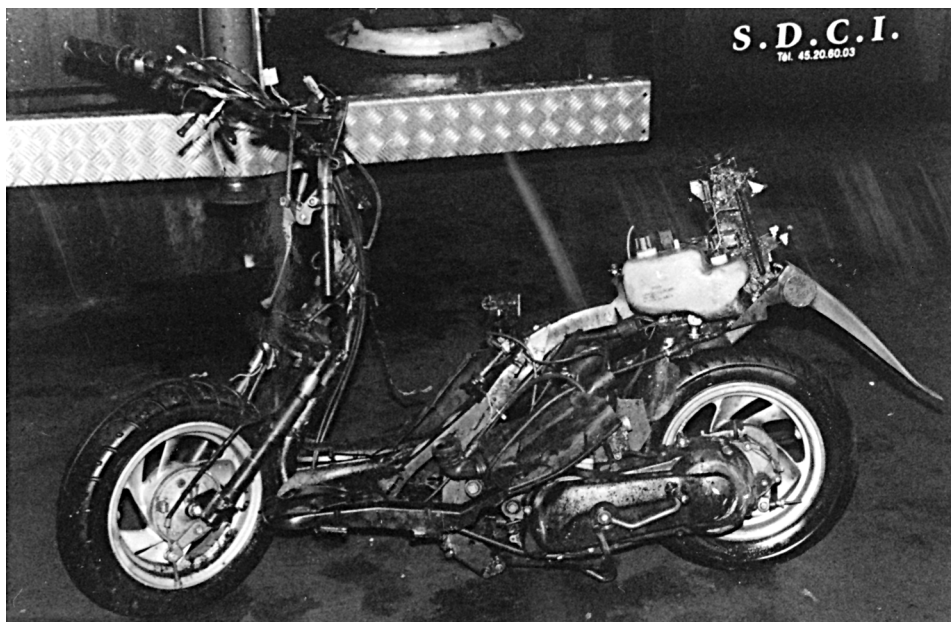
FIG. 2—*The damaged scooter.*

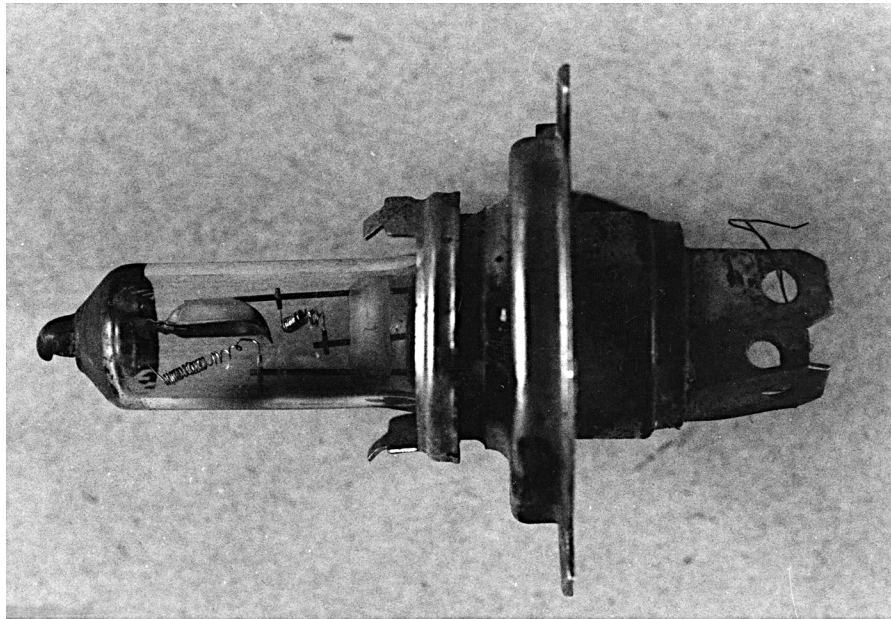
The H4-type bulb found on the roadside (Fig. 3) near the damaged scooter was a much more complex case to analyze. The firm inscription on the bulb base (*NORMA 12V 60/55W H4 • 10 Made in France BO*) proved the bulb was about ten years older than the scooter. Due to the fact that stocks are nowadays systematically kept low at the manufacturer's plant, it seemed reasonable to believe that this bulb was not the original one.

Further verifications were carried out. The bulb possessed a three-part base and two tungsten filaments coils. But the original S3-type bulb had a different base (Fig. 4), a P26s bayonet one, with only one filament coil. So, inconsistencies did appear. The normal working power of the light set of the scooter was 15 W. It would have been overheated in the presence of a H4-type bulb, which has a 55 or 60 W power rating.

FIG. 3—H4-type bulb found on the roadside near the scooter.

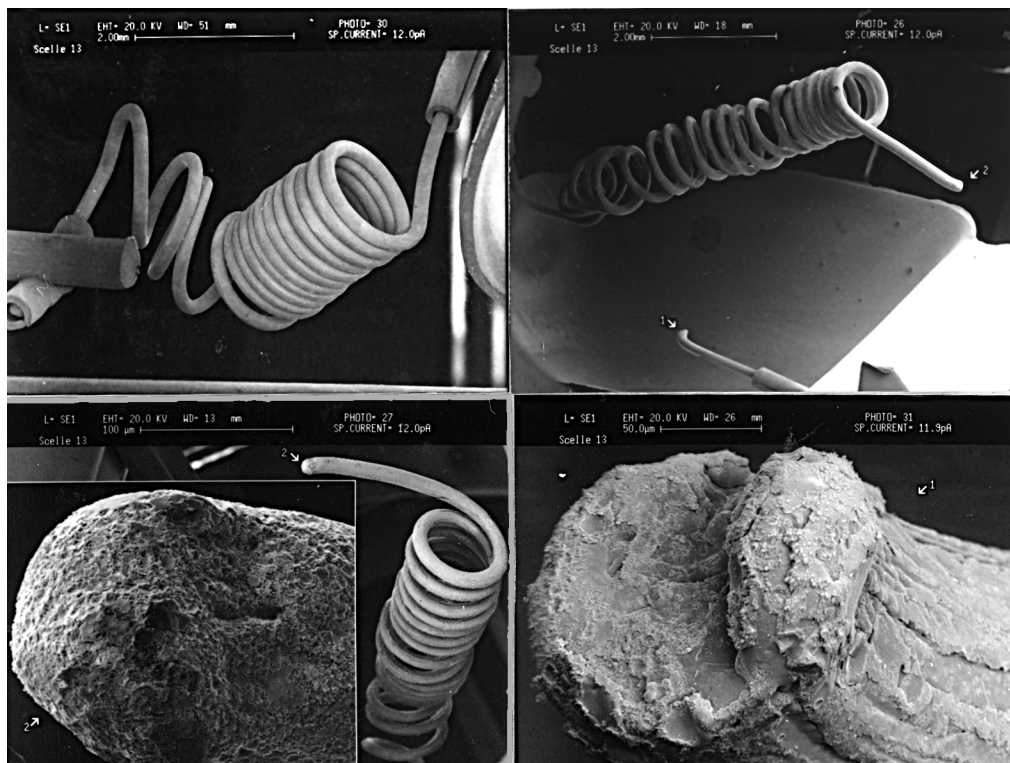
As a consequence we were left with two hypotheses: either this bulb had no link with the crash incident concerned in the investigation, or the electric circuit of the scooter was modified to allow use of the existing bulb. An interview of the victim's relatives ultimately confirmed the second hypothesis. Further examination showed the glass bulb to be intact, its filaments coils to have significant ductile deformations, and the low-beam filament coil revealed a ductile-type fracture (Fig. 5).

FIG. 5—Set of photos of the H4-type bulb of the scooter, viewed by SEM.

Examination of the front lightbulb of the scooter enabled us to see that its electric circuit was modified. In the present case it is impossible for the expert who does not know the origin of the bulb to make a decision on its functioning capacity at the time of the crash. The expert confessed his difficulties to the investigators, who decided to interview the relatives of the victim. It was established that

the bulb came from duplicate equipment and, as a consequence, was very likely new. We can then conclude that both filament coils were functioning at the time of the crash. High beams and low beams were joined. As a consequence, the quality of the lighting called for reservations. The original light set of the scooter was designed for a one-filament light and the electric generator provided about 50 W total power and not the 115 W-power required (55 + 60 W) by this bulb.

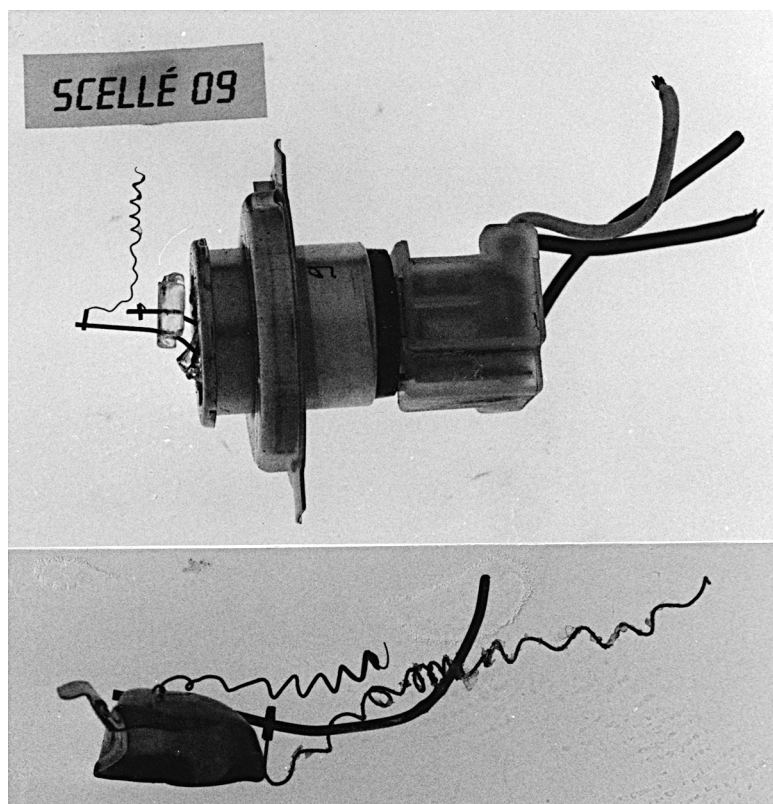
The H4-type bulb removed from the Ford car had lost its protecting glass bulb and was divided into two separate parts: (1) the reflector and half of the low-beam and high-beam filaments coils, and (2) the bulb base and the remaining filaments coils (Fig. 6).

- Both coils had numerous deformations of a ductile type due to stretching (Fig. 6).
- Two types of oxidation could clearly be observed on the filaments coils: a yellow oxide on a black low-beam filament and a black oxidation on the high-beam filament. In the first case the oxidation was due to  $\text{WO}_3$ , in the second to  $\text{WO}_2$  (5,6). The importance of these oxidations proved that the filaments were

FIG. 6—The H4-type bulb removed by the investigators from the Ford car. The bulb, shown as it arrived at the laboratory, is divided into two separate parts.

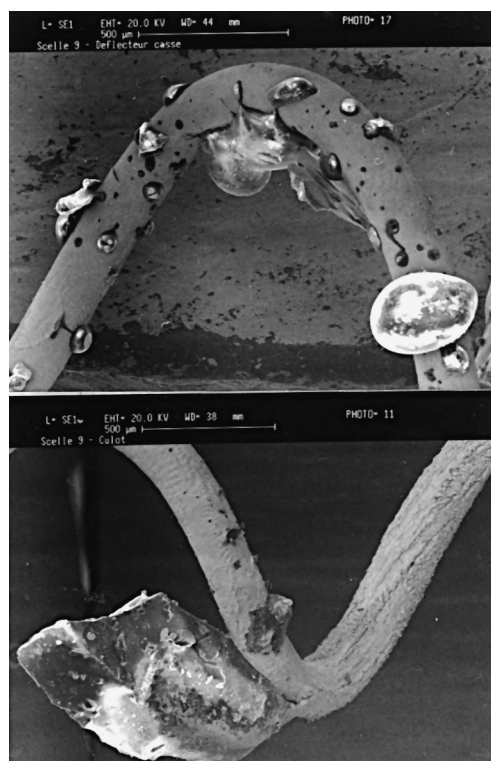
- Numerous vitreous-looking globe-shaped particles with an elementary chemical composition similar to vitreous silica glass (5) were “stuck” on the surface of the high-beam filament coil. This showed that the filament coil was very hot when the glass bulb broke. In contrast, on the low-beam filament coil, only one much larger splinter of a protruding shape could be seen (see Fig. 7), which had locally and superficially melted where it touched the filament. This splinter was also vitreous silica glass. Since there were no other glass particles, it seemed likely that this filament coil was not functioning when the glass bulb broke. Yet it did function after the breaking of the lightbulb. The yellow oxidation on the filament coil surface together with the traces of local fusion on the large glass splinter proved this fact (3,7).

FIG. 7—The high-beam filament (above) shows a multiplicity of small glass hemispheres glued to its surface. The low-beam filament (below) shows only one large protruding splinter on its surface.

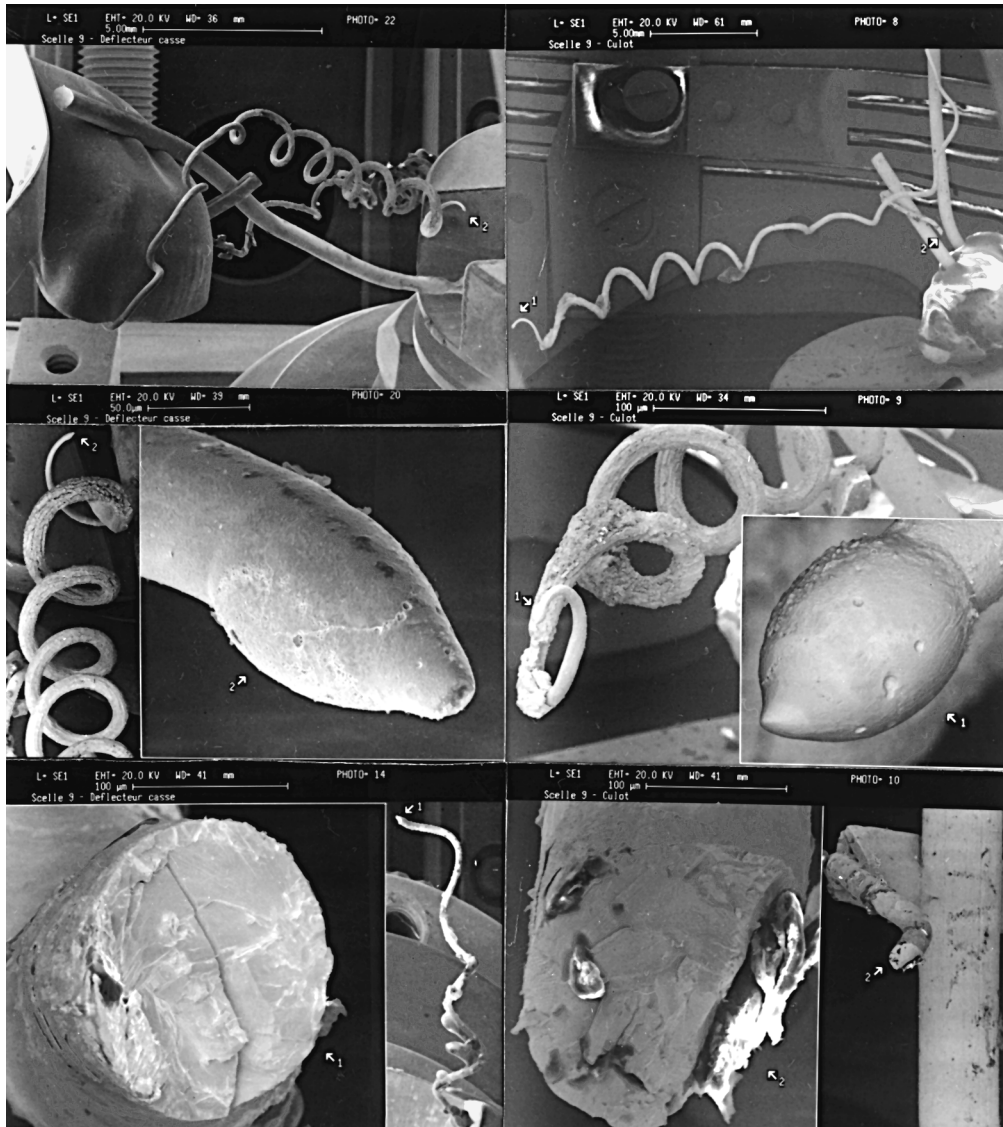
- Examination of the broken points on the low-beam filament coil merely revealed globular fractures of a ductile type with a thinning down at its end, proving that this coil was functioning when it broke—see Fig. 8 (1,5). As for the fractures noted on the high-beam filament coil, they belong to the brittle type and happened when it was cold—see Fig. 8 (1,5). Such observations contradicted those made previously.

FIG. 8—Set of photos showing the different fractures observed on the H4-type bulb of the Ford car. (Left)—The fractures correspond to both the fragments of the low-beam and high-beam filament coils connected to the reflector. (Right)—The fractures correspond to the fragments of the low-beam and high-beam filament coils still connected to the bulb base.

The brittle fracture of the high-beam filament was rejected from consideration in this study as it succeeded the crash and probably happened when the lamp was removed or carried to the laboratory.

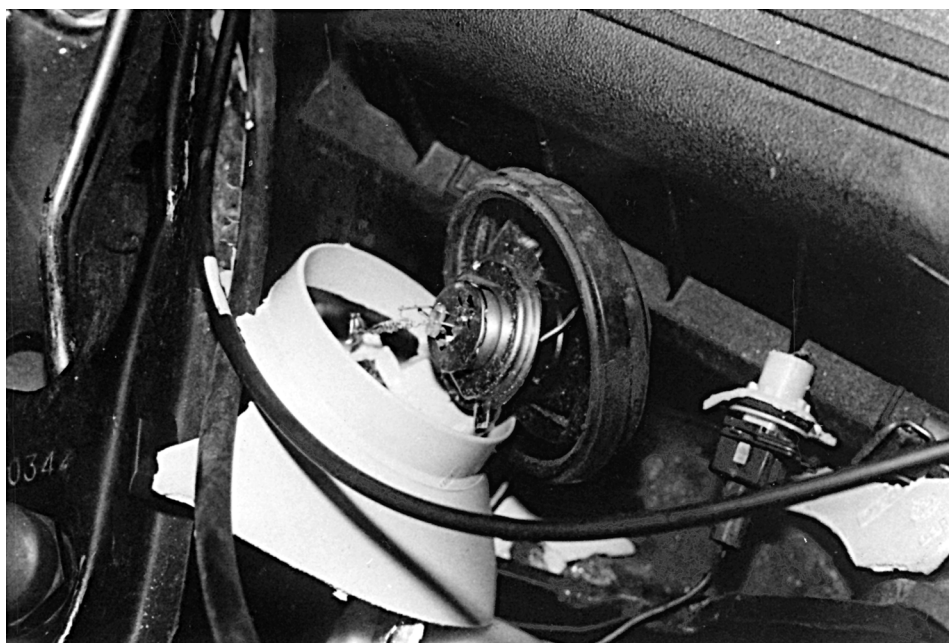
These comments seem incompatible with the results of the study of the breaking point, for the fracture belonged to the brittle type. But thanks to the photos taken at the accident scene, the problem could be solved. The detailed examination of the enlarged photo (Figs. 9 and 10) taken by the investigators before the removal of the

FIG. 9—The H4-type bulb of the Ford car before its removal from the optical set by the investigators.

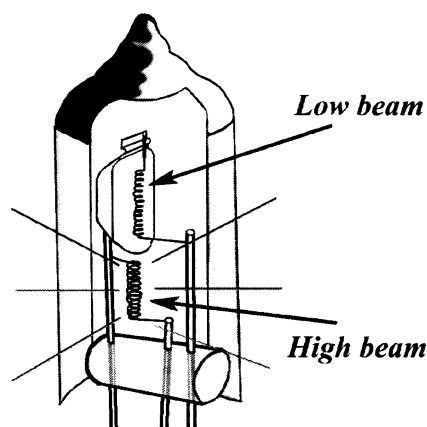
The car ran with its high beams on before the accident (before time 1). See Fig. 12.

FIG. 12—The high-beam filament is supplied with voltage (before Time 1).

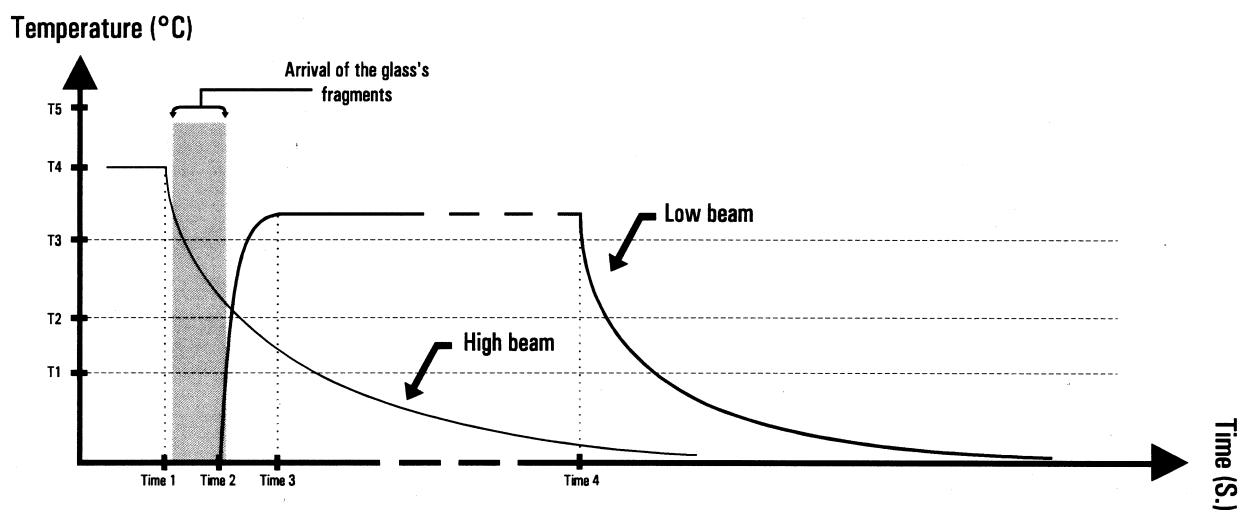
Shortly before or even during the crash with the scooter the selector of the high beams and low beams was operated on the dashboard, either by the driver himself or as a consequence of the shock (Time 1 in Fig. 11). The temperature of the high-beam filament began to cool down and would never warm up again.

FIG. 11—How the H4-type bulb filaments of the Ford car reacted to the crash with the scooter according to time. The curves refer to what really happened, but are only indications.

The high-beam filament, although cooling down, was still hot (it takes its temperature about 4 s to fall below 500°C (5)) when it was hit by fragments of optical glass or of the bulb that melted on touching it. Its temperature at this moment was above the temperature of the melting point of vitreous silica glass, (T3 in Fig. 11), about 1500°C (5). The high-beam filament oxidized and showed a black color (degree of oxidation  $WO_2$ ); its temperature was above the oxidation point of tungsten, (T2 in the figure), or about 700°C.

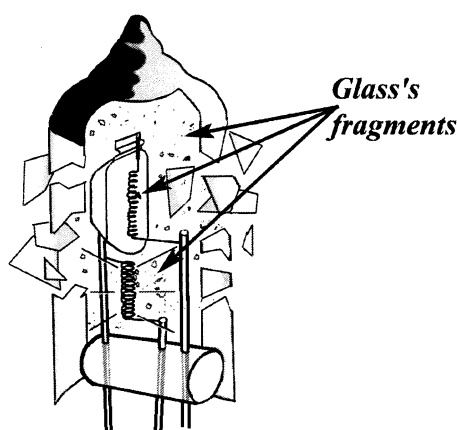
low beams (far less than 1 second). During the collision the scooter crashed into the left front optical set of the Ford car, then the glass orb of the H4 bulb broke (gray band in Fig. 11)—see Fig. 13.

FIG. 13—Time 1 to 2. The selector is switching from high beam to low beam. The glass orb breaks, small splinters of glass come into contact with the filaments.

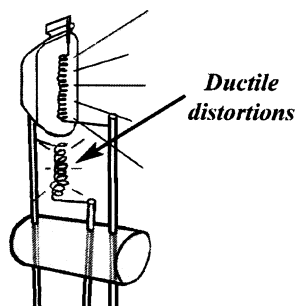
Eventually with Time 2 the working of the selector closed the electric circuit that supplies the low-beam filament. The temperature of this filament quickly rose (until Time 3), whereas that of the high-beam filament continued to cool (Fig. 14). The scooter kept on crashing into the car. One or two of its external parts came into direct contact with the light supports of the car and its filaments. There they caused the ductile-type distortions here noted, the temperature of both filaments rising above the limit between the ductile and brittle phases of tungsten (T1 in Fig. 11), about 200/400°C. As soon as it rose above temperature T2 in the figure, about 700°C,

FIG. 14—Time 2 to 3. The broken glass bulb lets in oxygen. The low-beam filament is supplied with voltage and the high-beam filament keeps on cooling down.

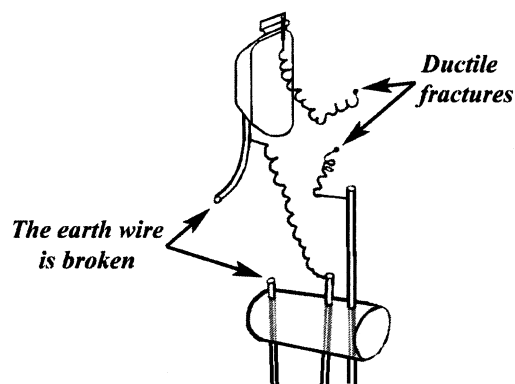
FIG. 15—Time 3 to 4. The filaments are stretched through the shock(s). The still-working low-beam filament eventually breaks with a ductile fracture. The support wire of the reflector is warped and eventually also breaks. The lightbulb can no longer be supplied with voltage. This figure corresponds to the observations made at the time of bulb removal (Figs. 9 and 10).

From Time 3 to Time 4 (Fig. 15) the low-beam filament coil could not reach its normal working temperature T4, about 2900°C. This probably was due to the violent flow of air after the breaking of the protecting glass orb. (See also Fig. 16.)

The low-beam filament finally broke. Either its breaking followed oxidation (a very unlikely hypothesis considering the still regular diameter of its component spirals and the only narrowing area being located at the fracture ends (4)), or it was due to the mechanical action of an external element in direct contact with the filaments, their supports, and the reflector, causing a still visible fracture of a ductile type.

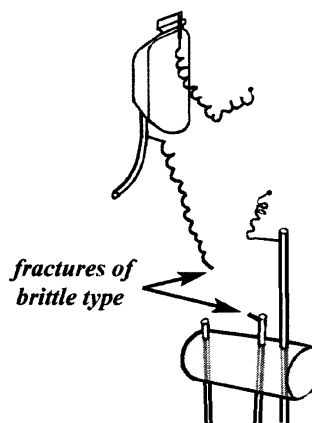
Maximum caution was used to carry and store the lamp, but this was obviously not sufficient to guarantee the best preservation of the sample. As a matter of fact, filaments are excessively brittle when they are old and come from a road accident (5). It appears that the stretched filament acted as a lever with the large mass reflector attached. This made removal and transport to the laboratory without alteration of the exhibit very difficult.

FIG. 16—The front bulb of the Ford car as seen when the sealed material was opened in the forensic laboratory.
