CASE REPORT

An Unusual Oxidation Type on Bulb Filament After a Car Crash Dive

REFERENCE: Baudoin P, Lavabre R, Vayne F. An unusual oxidation type on bulb filament after a car crash dive. *J Forensic Sci* 2002;47(2):377–380.

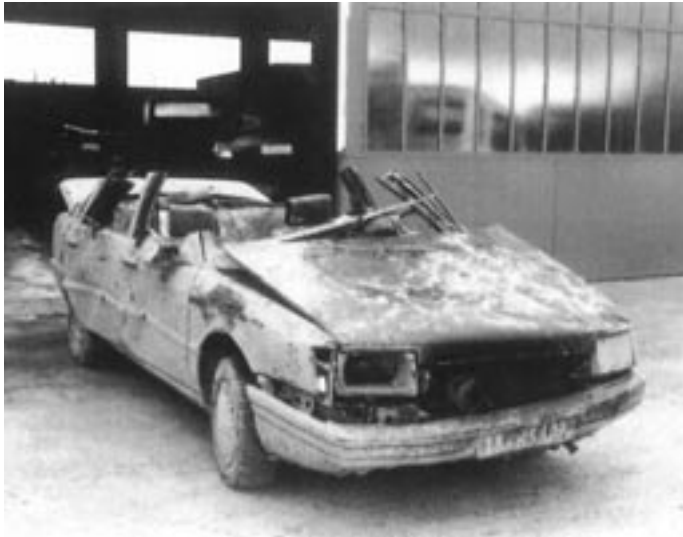
The intact light bulb was easily cleaned. Neither ductile type fracture nor deformation were noticed on either filament's coils. The low beam filament's high degree of crystallization demonstrated an important duration of functioning (1): because the car had not been in a violent crash (not a deep fall and relatively weak damages—see Fig. 1), it was not possible to conclude whether or not the lights were on when the car hit the water (2,3).

FIG. 1—The Renault car involved, after its removal from the gravel pit.

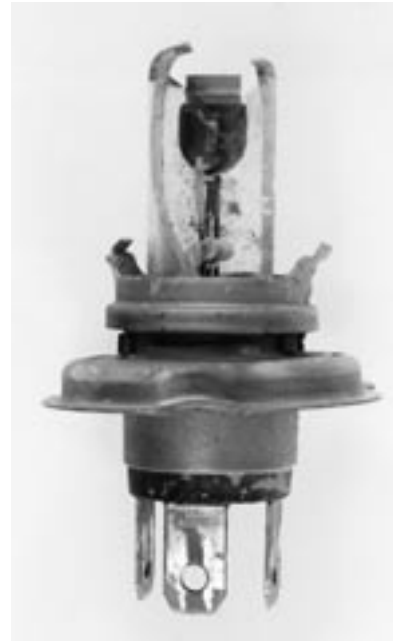
The second light bulb was broken and covered with a thicker layer of mud than the first one. Filament coils were practically invisible. Only a cleaning of the light bulb with ultrasounds in solvent (acetone) succeeded in removing this deposit (Fig. 2).

FIG. 2—H4 type bulb from the broken optical set, before the final cleaning with ultrasounds.

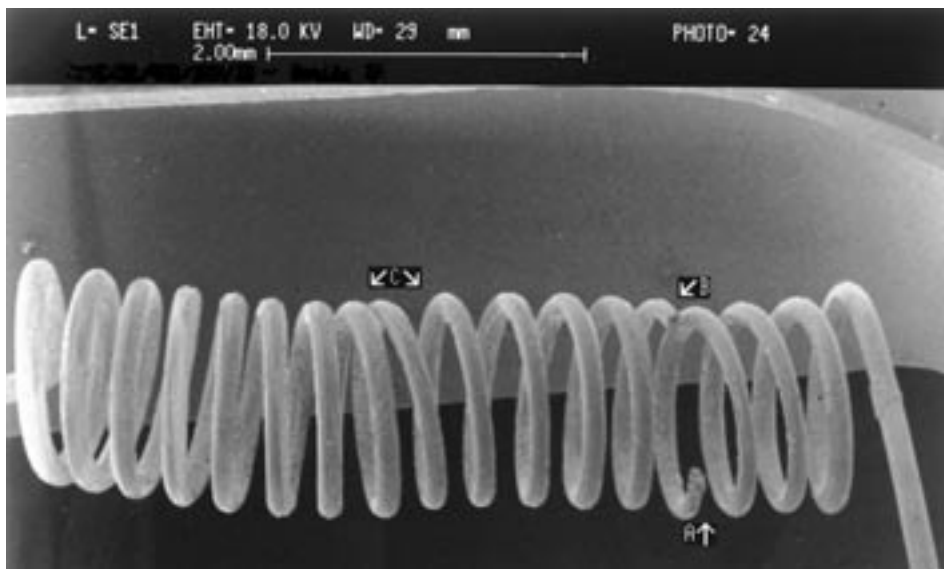
Optical microscopic observations of the high beam filament coil did not show any fracture, oxidation, or significant deformation. Fortunately, the examination of the low beam filament was more instructive. This filament was broken and had a relatively weak deformation of its coil structure (Fig. 3). Moreover, a very deep blue color oxidation was sharply visible on several coil spirals (Fig. 4), which was rather unusual (2–4). The examination also revealed ductile type fractures (hot filament coil) (5,6). Finally, small rounded cavities (40 μm diameter) were observed on the surface of the low beam filament, mainly localized near the fractures (Fig. 5). This was totally unexpected.

FIG. 3—Low beam filament (SEM) showing two fractures (A,B) and a relatively weak deformation (C).

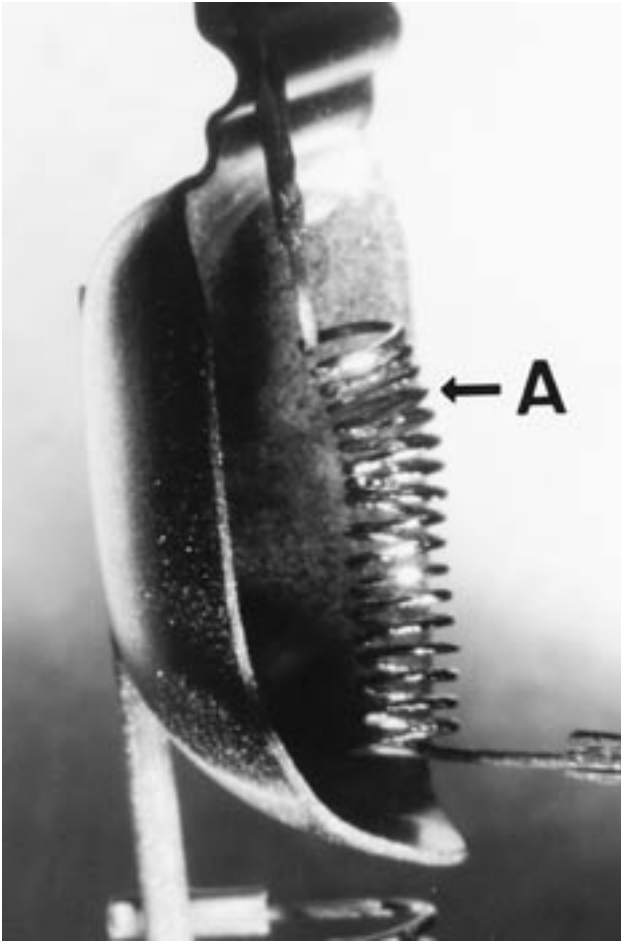
FIG. 4—Deep blue color oxidation (A) on the low beam filament.

On the contrary, the second light bulb allowed us to conclude that the low beam filament was working when the vehicle fell into the water. The filament coil showed ductile type fractures and a very special type of oxidation, which could only be reproduced by keeping a filament working in water and not in atmosphere.

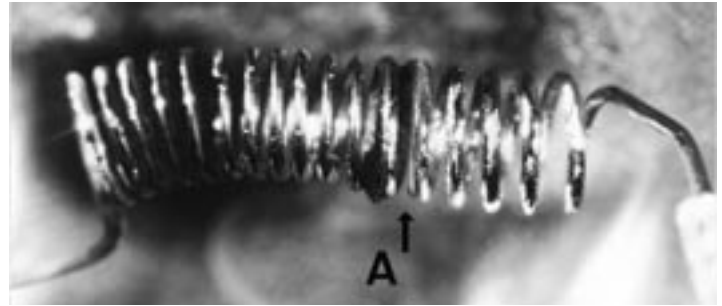
As seen on the filament from the crashed car, a deep blue color oxidation and small rounded cavities were observed on the tested filament using the three light bulbs that did not resist the contact with water (Figs. 6 and 7). However, tungsten excrescences were visible between spires of the test filament coils (Fig. 8). This was not the case of the broken light bulb submitted to the laboratory. In fact, these fragile growths covered with mud and so totally masked might not have resisted our ultrasound treatment. This hypothesis was confirmed by testing the effect of ultrasound treatment on one of the three broken bulbs.

FIG. 6—Deep blue color oxidation (A) on one of the test filament coils.

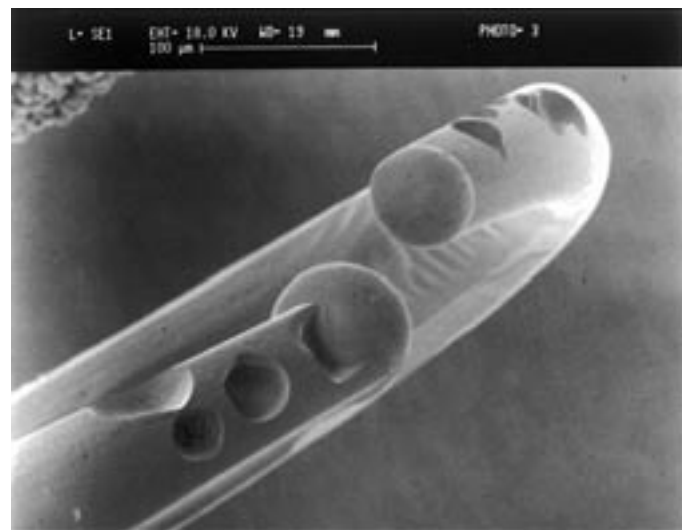
FIG. 7—Ductile type fractures and rounded cavities on one of the test filament coils, view by S.E.M.

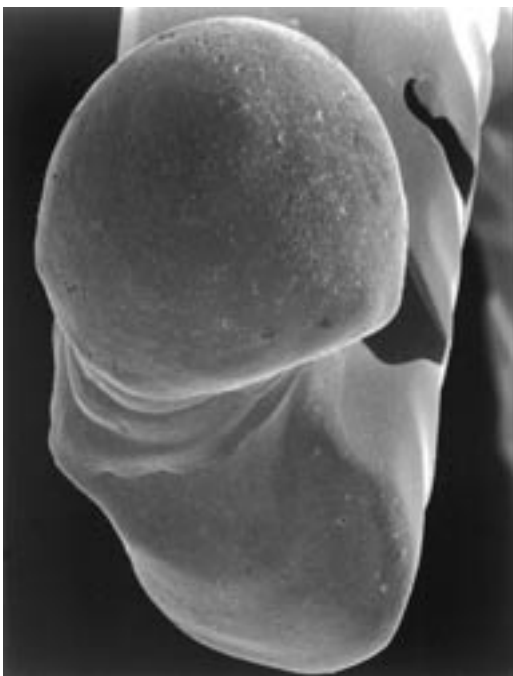
FIG. 5—Ductile type fractures and rounded cavities on the low beam filament, view by S.E.M.

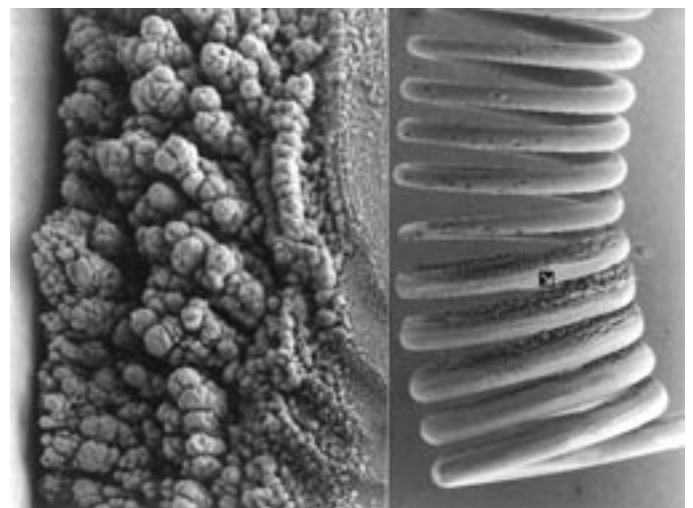
FIG. 8—Tungsten excrescences between spires of the test filament coil.
