Death by Chainsaw: Fatal Kickback Injuries to the Neck

KEYWORDS: forensic science, chainsaw, deaths, accident, kickback

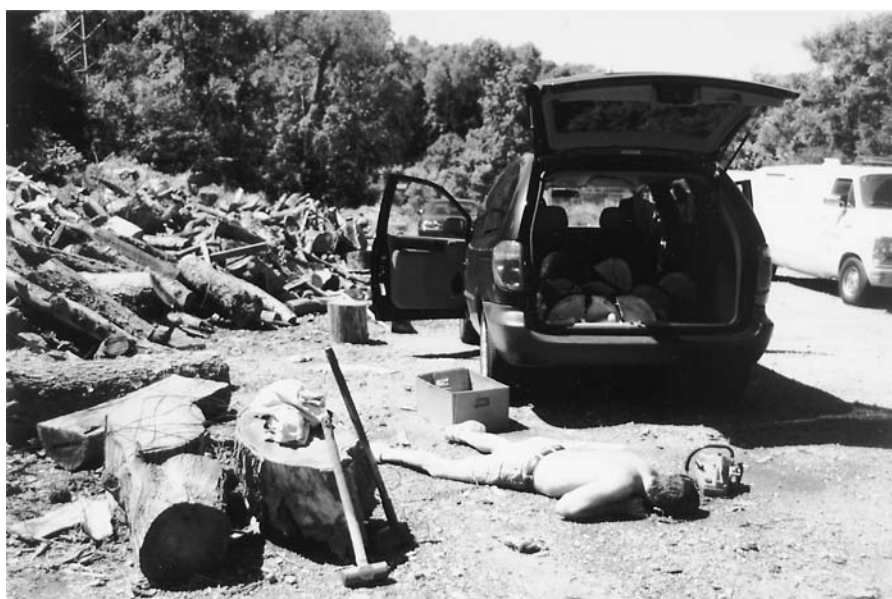
FIG. 2—The undistributed death scene, chainsaw to the left of the decedent.

During the morning hours of August 2002, an employee of a natural gas company was driving through a scrap yard. He noticed an unresponsive white male lying face down behind a mini-van with a chainsaw on the ground next to him (Fig. 2). Local police and the Allegheny County Coroner's Office were dispatched to the location. The van contained neatly stacked firewood with the rear hatch and both doors in the open position. The chainsaw, a gas-powered Craftsman 2114, was lying diagonally forward and to the left of the victim's head (Fig. 3). Examination of the decedent at the scene revealed several cuts of the face and upper left torso. The deepest cut was noted in the neck region. Very little blood was present at the scene, except directly under the victim's head. There

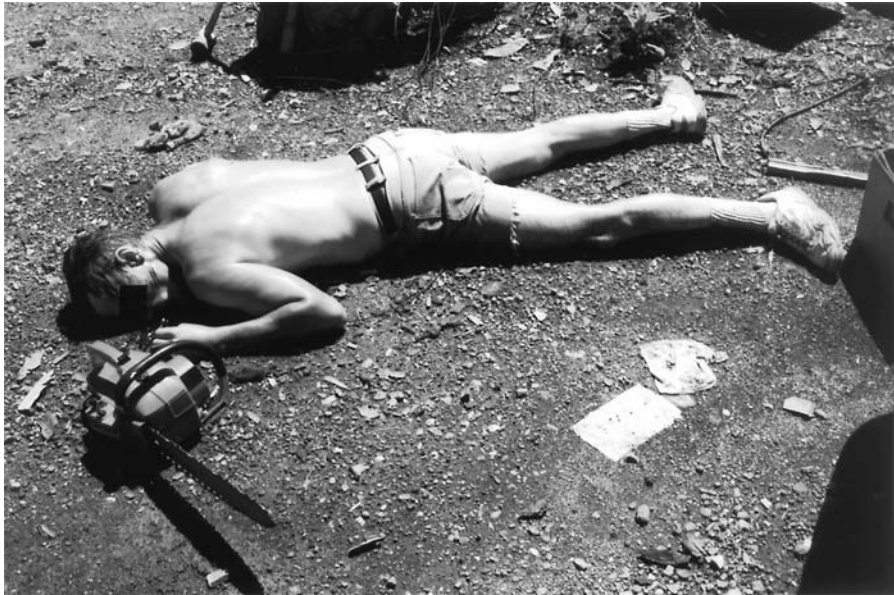
FIG. 3—A close-up of the decedent and the chainsaw.

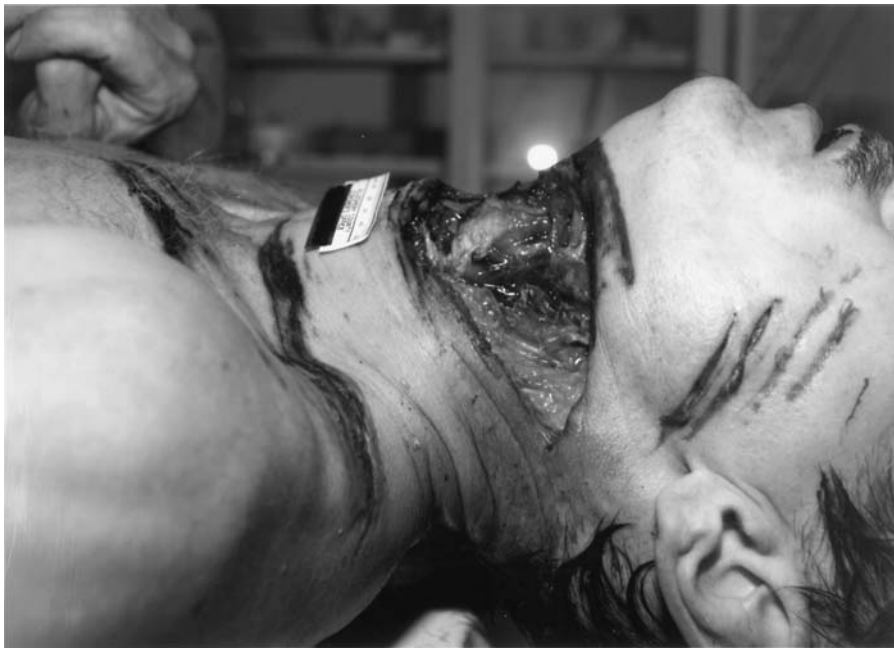
FIG. 4—A lateral view of the head and neck.

A complete forensic autopsy was performed on this 49-year-old well-developed, white male weighing 160 lb and measuring 72 in. The body was cool to the touch and rigor mortis was well-developed and present in all the joints. All physical injuries were confined to the head/neck and chest regions. There were four roughly linear parallel abrasions over the left lateral cheek ranging from 3.5 to 6 cm in length (Fig. 4). A gaping cut of the left anterolateral and lateral neck measuring 11.5 × 4.5 cm was noted (Fig. 4). The cut was located 4 cm below the left ear and 28.5 cm below the top of the head. There were cuts of the skeletal muscles, thyroid cartilage (4 × 0.5 cm), and a transection of the left carotid artery. The lar-

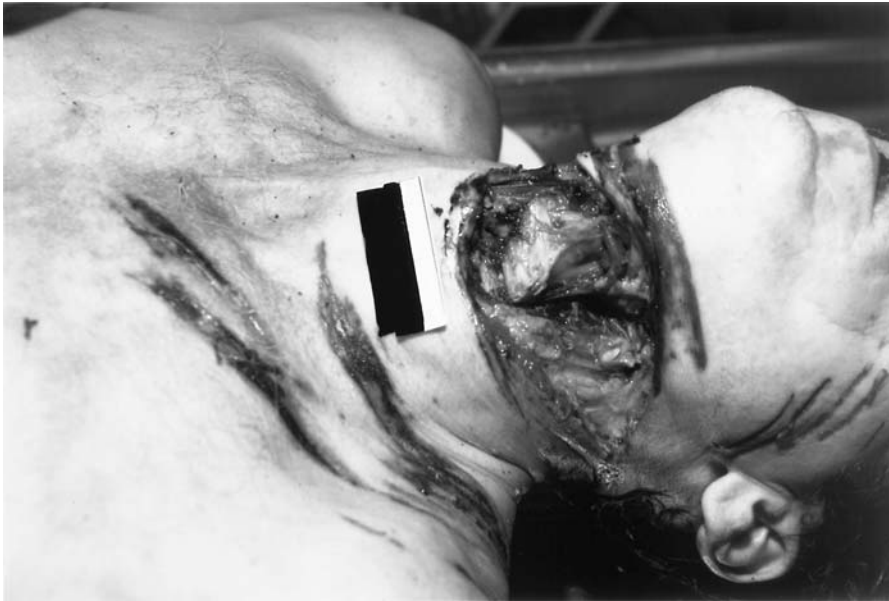
ynx exhibited a cut involving the internal aspect, measuring 1.5 × 1.5 cm. Additional injuries were noted on the chest. There were multiple roughly linear red abrasions over the left anterior shoulder/left upper chest measuring from 1.5 to 14 cm in length and 0.2 to 2 cm in width (Fig. 5). The remaining external examination and the internal organs were unremarkable. The whole blood alcohol level was 0.07%. The cause of death was chainsaw wounds of the neck and head, and the manner was ruled accidental.

FIG. 5—An anterior view of the neck and upper chest.

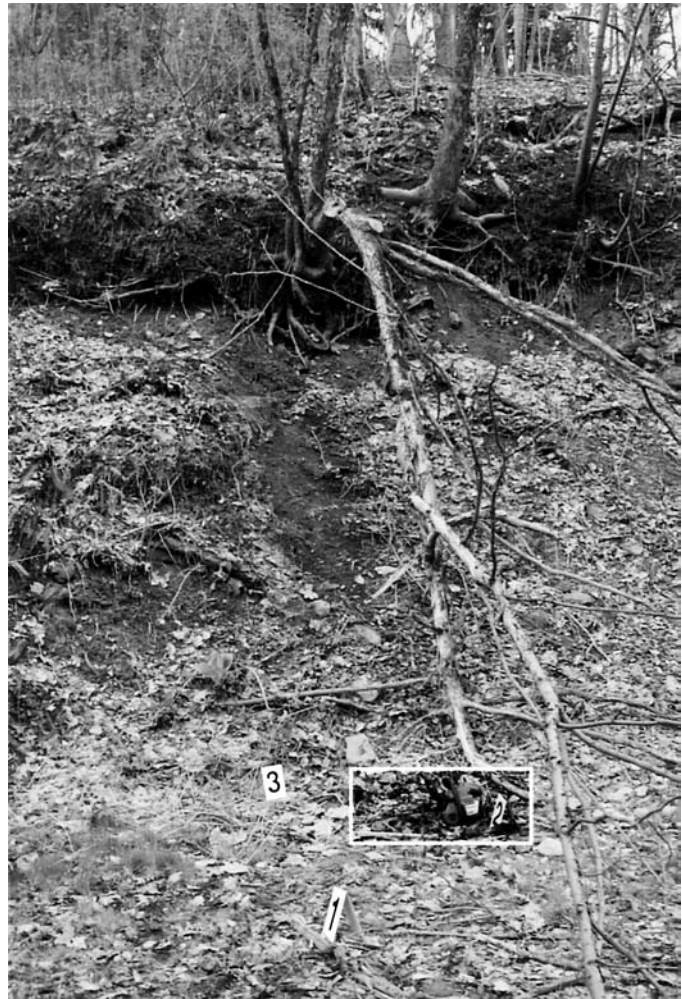
appears that the individual was using a chainsaw to cut down a tree that was growing at an angle over the driveway. The tree was located approximately 15 ft. up a steep ($>45^\circ$) embankment (Fig. 6) approximately 100 ft. from the right side of his house. The tree limb that was being cut appeared to be near the neck or head level of the decedent. There were fresh boot prints in the dirt near the base of the tree and fresh slide marks coming downhill from this spot. The decedent was operating the chainsaw in front of himself and over his head. The decedent was left-handed; therefore, it was most likely that his left hand was on the trigger with the right hand on the bar. It appeared that the saw “kicked” and swung back, striking the decedent on the right side of the neck. After the injury, the decedent either fell, rolled, or slid down the hill and dropped or laid the chainsaw approximately 17 ft. from the top of the hill. The decedent then proceeded to walk approximately 100 ft. to the rear of the house through a shed and into the garage. No blood trail was seen from the tree to the garage, likely as a result of the decedent applying firm pressure to his wound. This is supported by the fact that his shirt and gloves were saturated with blood. A glove was located inside the garage near the door leading to the basement. A blood smear indicated that the decedent stumbled in the garage. Blood spots were seen on the garage floor going toward the basement door. The distance from the basement door and the bottom of the stairs was approximately 20 ft. Blood also was located in a sink approximately 8 ft. from the bottom of the stairs.

FIG. 6—The accident scene. The box shows the location of the chainsaw.
