CASE REPORT

Yasuaki Hagimoto,¹ B.S. and Hiroki Yamamoto,² Ph.D.

Analysis of a Soldered Wire Burnt in a Fire

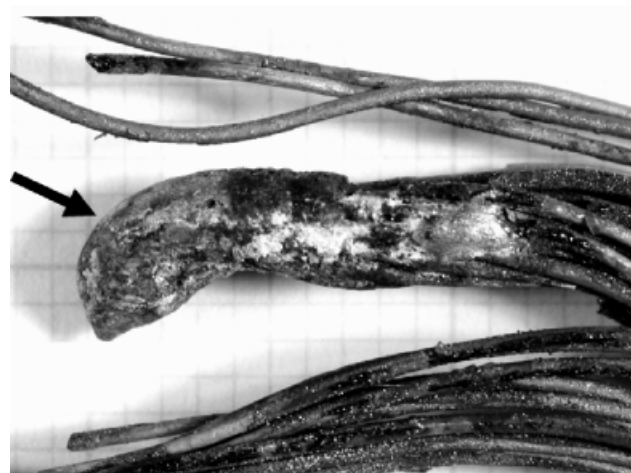
Copper conductors can form alloyed areas with metals such as aluminum, zinc, silver, and solder in fires (2–4). The cross-section of the bead in Fig. 1 was uniformly silver-colored, indicating that the copper conductor had become alloyed over the entire area of the bead. Figure 2 shows an SEM image of the cross-section of the bead.

FIG. 1—A bead found in the fire debris.

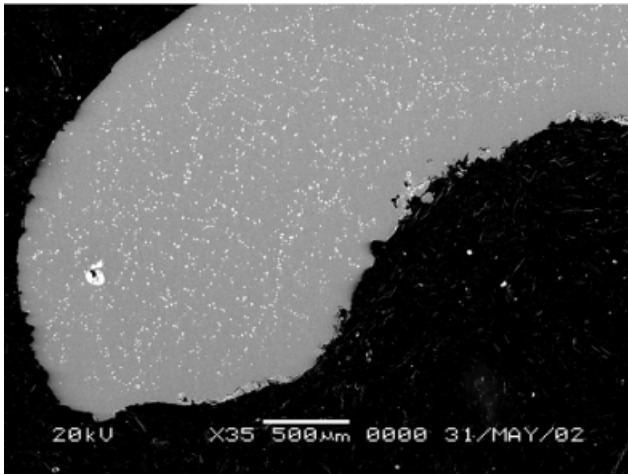
FIG. 2—SEM image of the cross-section of the bead in Fig. 1.

The analysis results indicate that the lead-free region B in Fig. 5 corresponds to the entire cross-section of the bead in Fig. 2. However, the question remains as to why lead is missing from the bead in the factory fire.

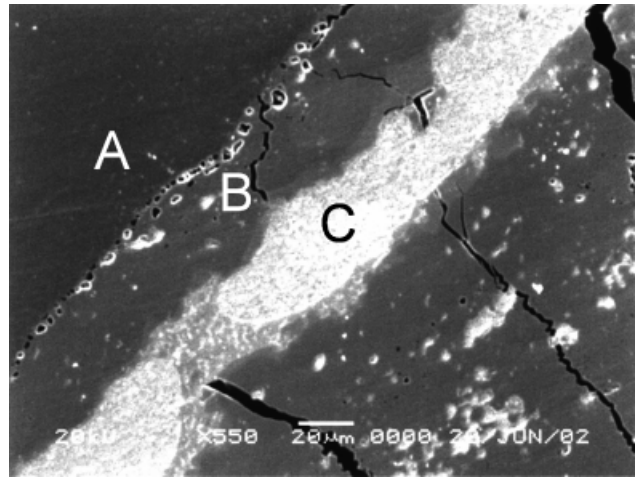
FIG. 5—SEM image corresponding to the squared area in Fig. 4.

Figures 4 and 5 show SEM images of the control sample. The spectra in Figs. 6–8 indicate that regions A, B, and C in Fig. 5 are composed of copper, tin–copper, and tin–lead, respectively. B is a tin–copper alloy that was newly formed between the copper conductor and tin–lead solder.

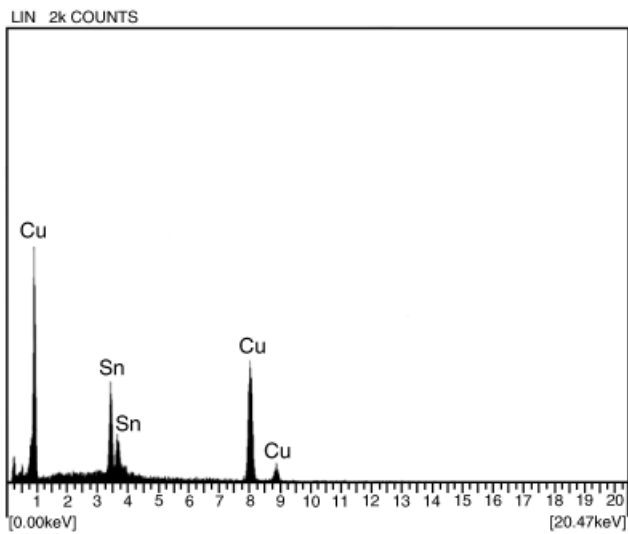
FIG. 3—X-ray spectrum of the bead in Fig. 1.

The X-ray spectrum in Fig. 3 indicates that the copper conductor bead is alloyed only with tin. Lead was not detected in the bead. This suggests the possibility that a lead-free solder might have been used for the connection, while only lead–tin solder was actually used in the factory.

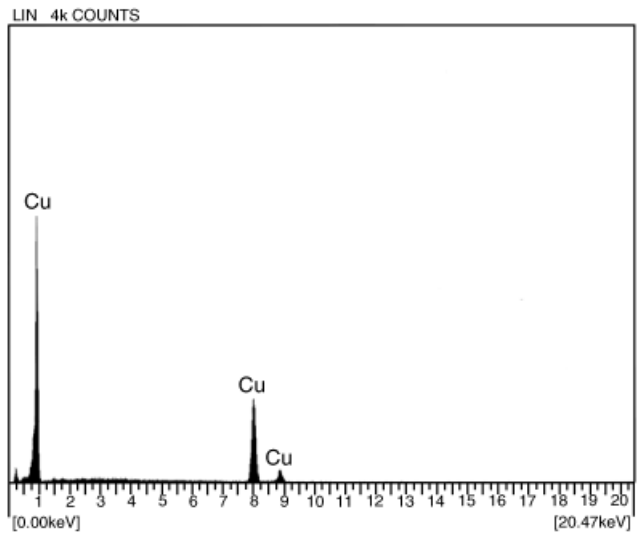
FIG. 6—X-ray spectrum at region A in Fig. 5.

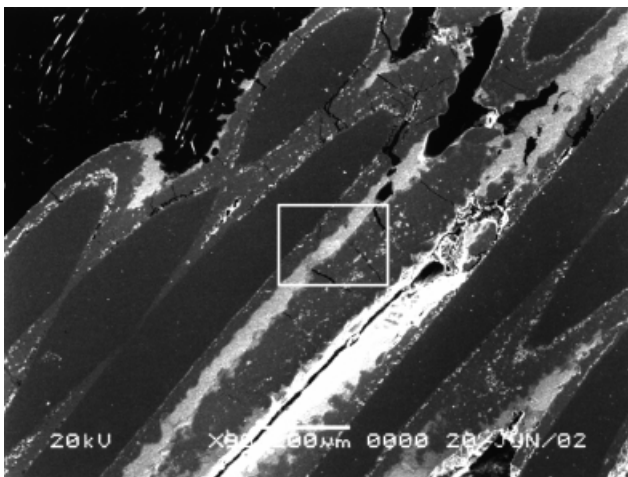
FIG. 4—SEM image of the control sample.

This can be explained by observing that lead remains only at region C in Fig. 5. Note that the white-colored regions in Fig. 4, which correspond to region C, are observed mainly between the inner strands of the wire. That is, more lead vaporizes from the outer strands during the furnace heat treatment than from the inner strands. If the control sample is heated for a longer time, the entire region will convert to tin–copper alloy.

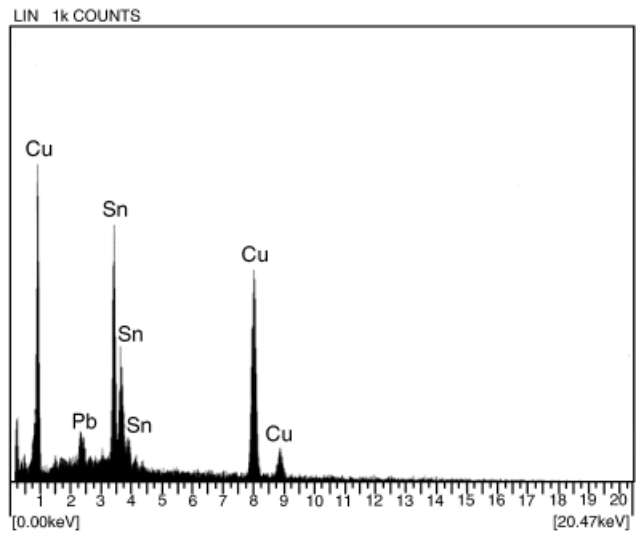
FIG. 7—X-ray spectrum at region B in Fig. 5.

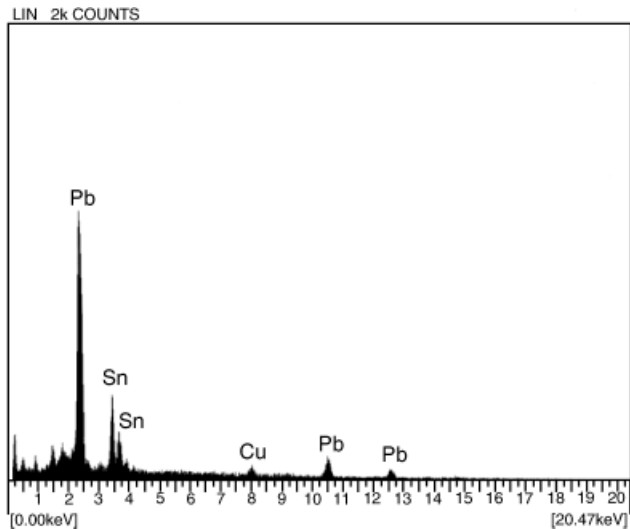
FIG. 8—X-ray spectrum at region C in Fig. 5.
