## CASE REPORT

# Interpretation of Automotive Light Bulb Examination Results: An Intriguing Case

**ABSTRACT:** During the examination of light bulbs from a vehicle involved in a road accident, the headlights did not reveal any evidence regarding whether they were energized or not. Additionally, a police officer turned the lights on after the accident to verify their functioning, thus damaging some of the evidence. By examining the vehicle, it was determined that the park lights could provide answers regarding the conditions of the headlights. After observations, it was concluded that the park lights and headlights were off at the time of the impact. This case report demonstrates how important it is to integrate the circumstances surrounding the case into the interpretation of the results. Nevertheless, it also demonstrates the necessity for examining both the vehicle and all light bulbs in order to reach the most pertinent and proper conclusion.

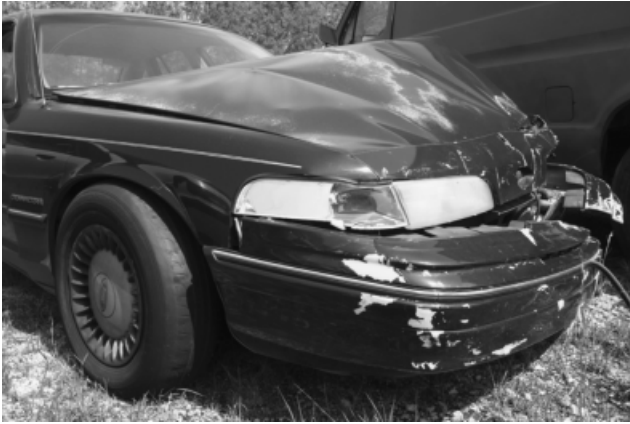
The vehicle presented heavy collision damage in the front, and more particularly in the front left area, as shown in Figs. 1 and 2. The rear end of the vehicle did not sustain any damage. The right front park/turn light assembly sustained some damage. The plastic cover was missing and the light bulb's glass was broken, but both filaments were still present, as shown in Fig. 3. The right front headlight assembly was intact, as shown in Fig. 1. The left front park/turn light assembly was demolished, as shown in Fig. 2. Fortunately, the base of the light bulb was found still attached to its socket and to a small portion of the reflector, as shown in Fig. 4. The left front headlight assembly was missing at the time of the inspection. The plug of the low-beam light bulb was found to be intact with no light bulb attached to it. The base of the high-beam light bulb was found still attached to its connector; however, the light bulb glass, filament, and filament supports were missing. The right front park/turn light bulb, right front headlight assembly, left front high-beam light bulb remains, left front park/turn light assembly, and rear light assemblies were collected and brought to the laboratory for further examination.

FIG. 1—View of the right front corner of the 1992 Ford Crown Victoria showing damage to the right park/turn light assembly.

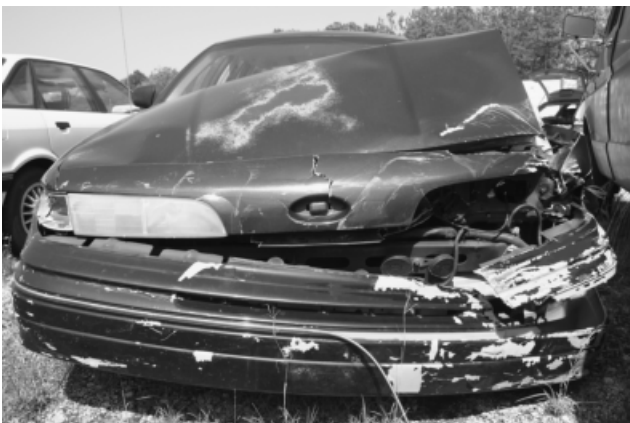
FIG. 2—View of the front part of the 1992 Ford Crown Victoria showing extensive damage to the left headlight and park/turn light assemblies.

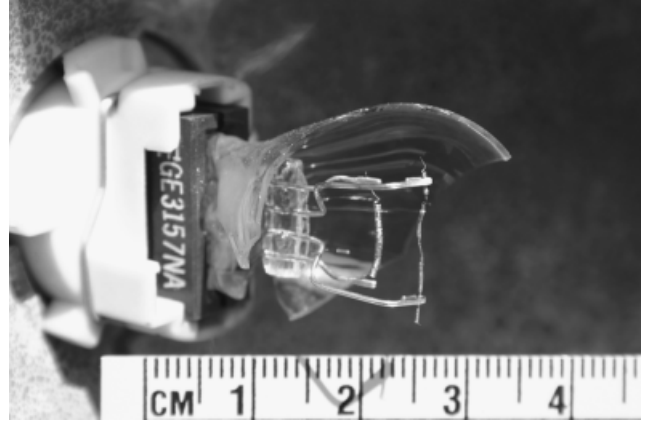
FIG. 3—View of the damaged right front park/turn light bulb.

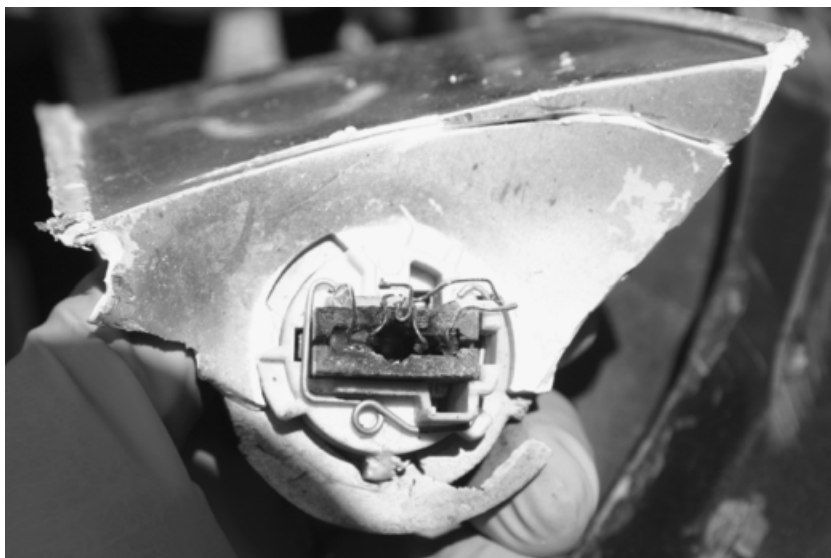
The light bulb is of incandescent double-filament type with a plastic wedge-type base and bears the marking *SYLVANIA* on one side and the marking (only partial reading) *315 . . . 2* on the other side. The author did not obtain authorization to conduct destructive examination; thus, no attempt to remove the base from its socket was made for fear of destroying any evidence. Consequently, it was not possible to observe the markings completely, but it is very likely that the light bulb was an SAE trade number 3157NA, equivalent to the right front park/turn light bulb. The light bulb’s glass is missing and the filament supports underwent heavy mechanical distortion, as can be seen in Fig. 4. The filament of the turn light is completely missing as denoted by the two small portions of tungsten wire remaining in the crimp clamps (identified as “A” in Fig. 9). The lack of authorization to conduct destructive examination prevented the SEM examination of the item. SEM examination of this item would have required the removal of the bulb from its socket or the complete coating of the item, both processes being potentially destructive. Observation under an optical microscope revealed that the two fractures appear brittle, but without SEM examination it was not possible to confirm this observation. Nevertheless, as the filament was not recovered, it is not

FIG. 4—View of the remnants of the left front park/turn light bulb assembly.

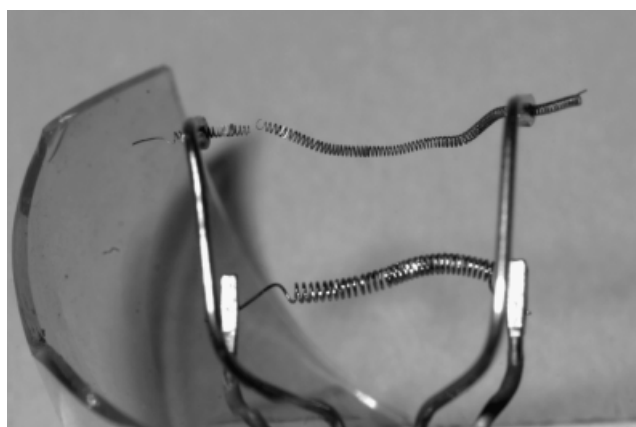
The park filament presents slight distortion and is ruptured close to one of the filament supports, as shown in Fig. 5. Black tungsten oxide is present on some portions of the filament, yellow tungsten oxide is present close to the fracture, and the filament’s diameter diminishes (see Fig. 6) as it approaches the fracture point shown in Fig. 7. Notice the melting of the filament and the distinct globular appearance of the rupture point.

FIG. 5—Macro photograph of the filaments of the right front park/turn light bulb. Notice the park filament ruptured close to the left support. Yellow tungsten oxide is present on each side of the fracture and black tungsten oxide on some portions of the filament itself.

clude that the filament was off at the time of the shock that broke the glass and was not energized thereafter (4). The park filament is not intact, as it ruptured. The globular aspect of the fracture clearly indicates that the filament was energized at the time of its rupture (5). However, the fact that the filament's diameter diminishes toward the rupture and that there is tungsten oxide on each side of the fracture in great quantity indicates that the filament did not rupture due to a shock, but rather by simply burning in the air (6). Also, the complete absence of any glass beads on the filament is not consistent with a filament being energized at the time of the breakage of the bulb (7). This is also supported by the absence of any significant distortion (4). All the observations made on the park filament are consistent with the filament being off at the time of the impact that broke the glass bulb. However, these observations also indicate that the filament was energized (until it burned out) after the glass was broken. The shock that broke the bulb's glass could have been anterior to the accident in question and the park light filament could have burned out much before the accident while the vehicle was being driven and all other light bulbs were properly working. This scenario is possible, but very unlikely, because the turn light filament is intact and was not energized after the glass breakage. If the glass had been broken prior to the accident, it is likely that the right blinkers of the vehicle would have been used at least once, thus damaging the turn filament, which is not the case.

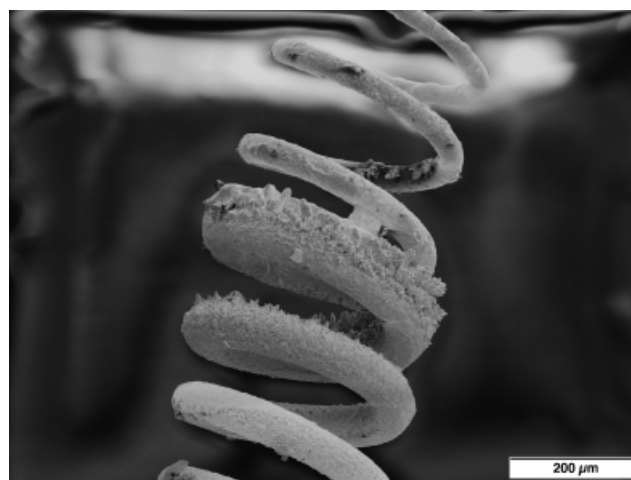
FIG. 6—Scanning electron microscopy photograph of the right front park light filament. It is possible to see that the thickness of the filament diminishes as it gets closer to the fracture (toward the top of the photograph). Also, notice the heavy presence of tungsten oxide deposits on the filament.

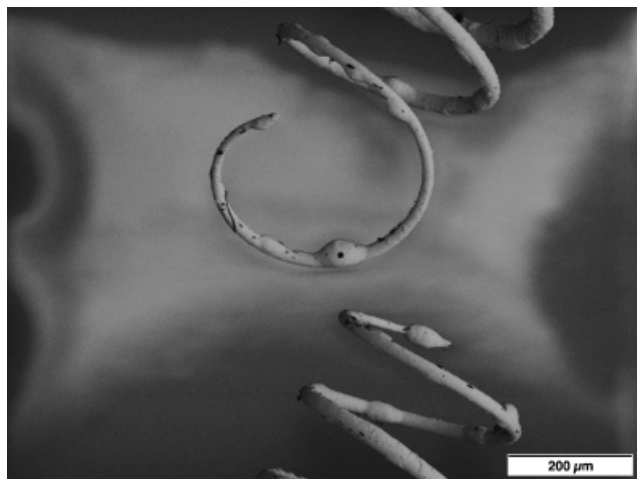
FIG. 7—Scanning electron microscopy photograph of the fracture of the filament from Fig. 6. Notice the thinning and melting of the filament. The fracture surface is of globular type.

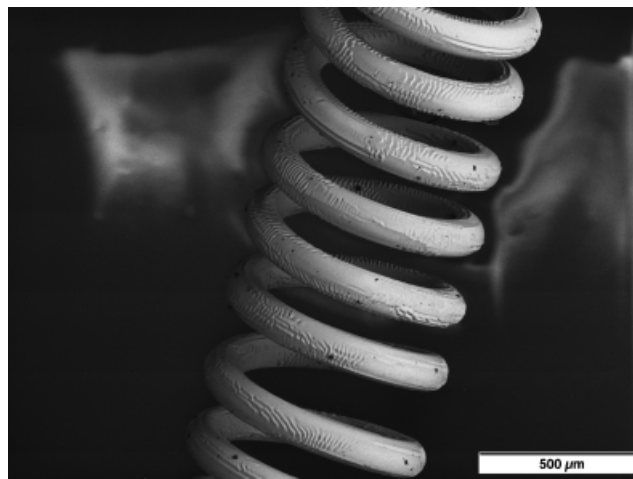
The turn filament exhibits very slight distortion and is intact, as verified with the ohmmeter. The coils are evenly spaced, and the filament’s surface is bright and shiny, free of any glass beads, glass splinters, or tungsten oxide. Significant direct current (DC) notching on the wire surface is present, as shown in Fig. 8.

FIG. 8—Scanning electron microscopy photograph of the right front turn light exhibiting some direct current notching on its surface, but free of tungsten oxide and glass beads or splinters.

The examination of the right park/turn light reveals that the turn filament is intact. This filament is shiny and does not present any glass splinters or tungsten oxide. Thus, it is possible to con-

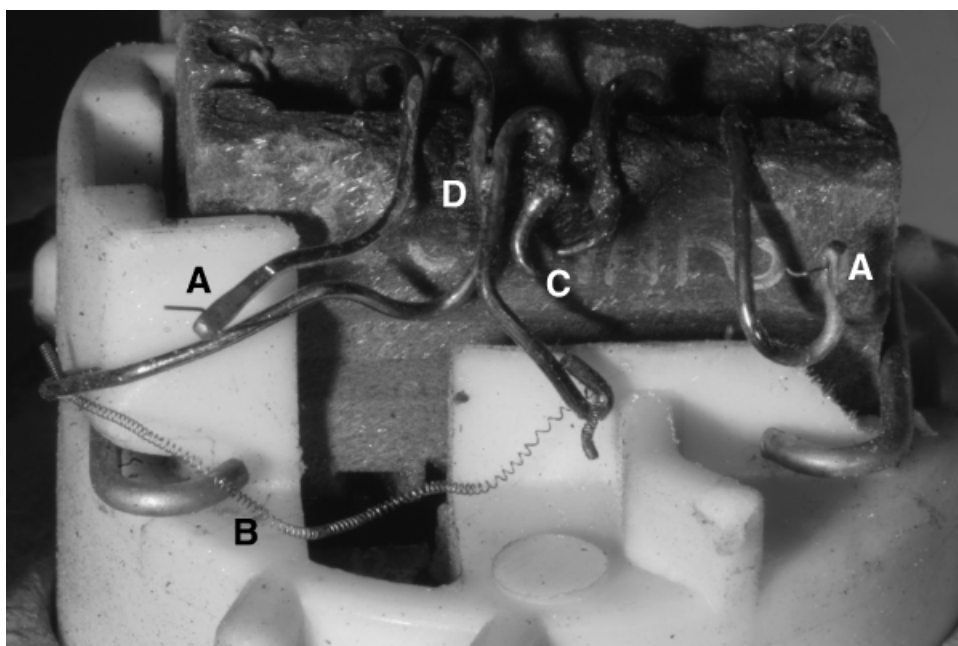
Interestingly, the park light filament is intact as can be seen in Fig. 9, identified by the letter “B.” The filament is heavily distorted and shows a few slight localized discolorations, but is unbroken and does not exhibit any evidence of tungsten oxide (yellow or black), glass beads, or glass splinters. The coils are evenly spaced on the left side of the filament and the filament shows some stretching toward its right side. One of the supports of the park filament is ruptured, as identified by letter “C” in Fig. 9. Evidence of electrical activity is present between the two filament supports. A weld seam and melted portions of the supports are present and are designated by the letter “D” in Fig. 9. Furthermore, the plastic of the wedge base in the area surrounding the melted filament supports is slightly charred.

FIG. 9—Detailed view of the left front park/turn light bulb. (A) Remaining portions of the turn light filament. (B) Intact park light filament. (C) Ruptured filament support. (D) Evidence of electrical activity between the filament supports and plastic wedge charring.

The examination of the left park/turn light reveals pertinent information about the park filament. The fact that the park filament is still intact, does not present any glass beads, glass splinters, or tungsten oxide indicates not only that it was off at the time of the breakage of the light bulb but also that it was not energized after the glass envelope failed. Regardless of whether the shock that broke the light bulb glass was anterior to or due to the accident, it is possible to conclude that the park filament was not energized during or after the accident.

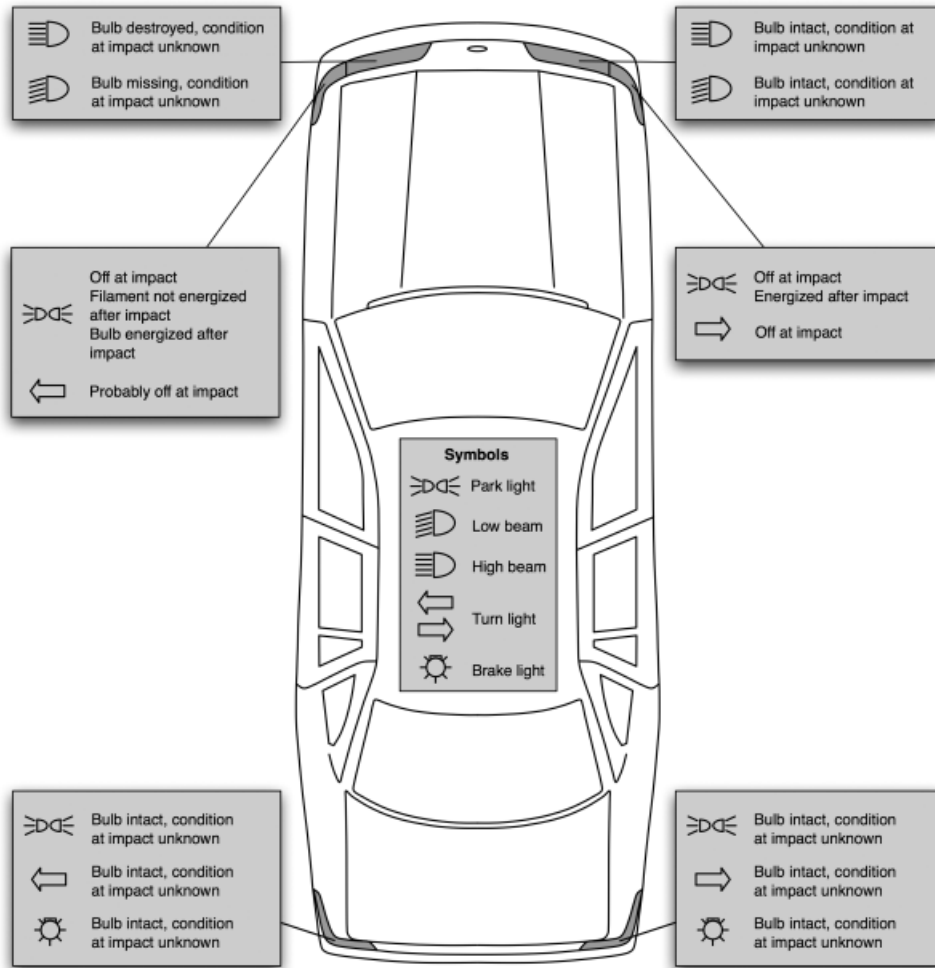
FIG. 10—Summary of the light bulb examination results.

Thus, it is possible to conclude within reasonable scientific certainty that as the park lights were off at the time of the impact that broke them, the headlights were not energized either. Figure 10 summarizes the results. While all the evidence supports this conclusion, a serious discrepancy arises: the police officer stated that he turned the lights on to verify their proper functioning and that they were working. No further detail on which light was verified is available, but the burned-out right front park light is consistent with this statement. On the contrary, the left park light filament is not consistent with this testimony. If the right front park light was energized, then the left front one must have been, too, as the electrical circuit functions properly. The reason for this "discrepancy" is explained in Fig. 9. One of the left front park light filament supports was severed during the impact (see Fig. 9, letter "C"). The mechanical distortion of the filament supports brought them closer together. When the officer turned the lights on, the two conductors arced, as witnessed by the evidence of electrical activity (welding and melting) shown in Fig. 9 right of letter "D." This electrical shortcut prevented the filament itself from being energized, thus preserving its integrity. Therefore, the condition of the left park/turn light bulb is consistent with the lights being turned on after impact.
