CASE REPORT

A Traffic Accident Caused by Fatigue Failure of Axle

ABSTRACT: An investigation of a traffic accident involving a tractor-trailer and a passenger car that were traveling at high speed is presented. The cause was the fracture of a trailer axle. The investigation showed that the fracture was because of the fatigue failure. In addition, cracks were found in the remaining three trailer wheels. Hardness measurements showed that, because of inadequate heat treatment of the metal, they were prone to failure.

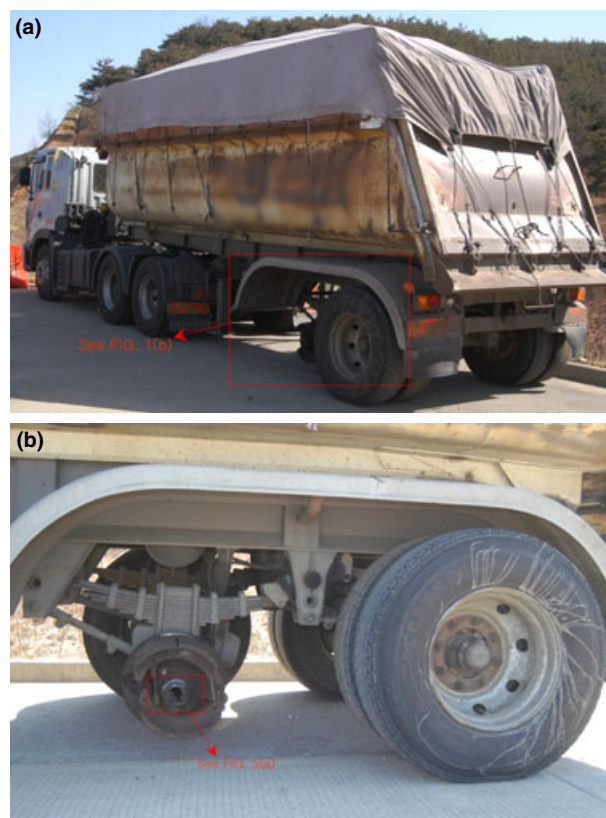
FIG. 1—The trailer with failed axle. The left first axle is completely fractured.

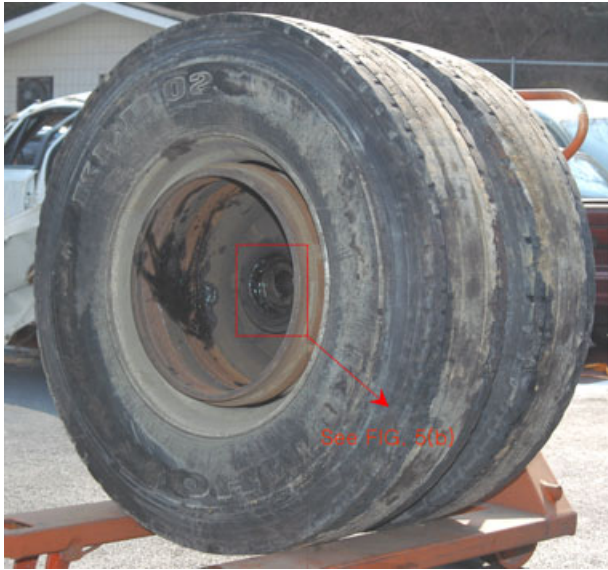
FIG. 2—The failed wheel. The wheel is completely separated from the trailer because of the fracture of axle. The fractured surface of the axle shown in the brake drum is magnified in Fig. 5(b).

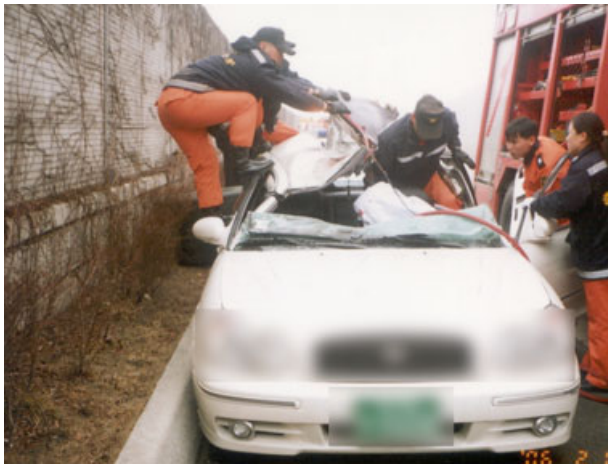
FIG. 3—The passenger car struck by failed wheel (refer to Fig. 2). Windshield and roofs are struck by the failed wheel.

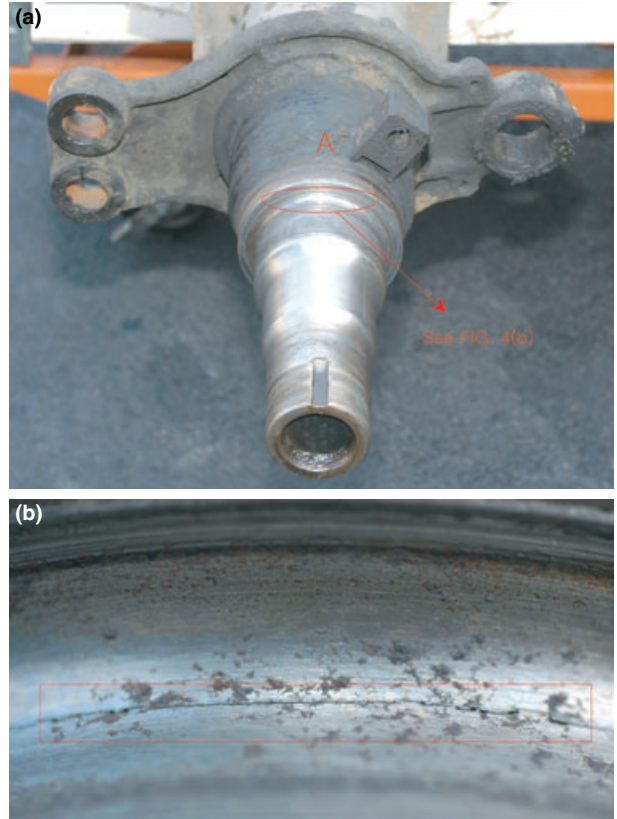
crack on the lower part of other three axles. Figure 5 shows the fractured surface of the failed axle of the trailer and the wheel. The beach marks were clearly visible at both the lower and upper parts. The Chevron mark is shown in the finally fractured mid section.

FIG. 4—(a) Typical shape of the non-fractured axle which is disassembled from the trailer. Crack is formed on the lower (location A) part of the axle. (b) Magnification of location A of Fig. 4(a). Crack is clearly visible along the circumference of the lower part of the axle.

The pattern represents the typical reversed bending moments (2,3). The crack originates at the lower part of the axle and this corresponds to the crack location shown on other three axles that were not fractured. Multiple ratchet marks are shown on the origin of the fatigue cracks. It is reported that such multiple ratchet marks that merged to form beach mark are indicative of high nominal stress (2,3). Crack locations commonly shown on other three axles also indicate high nominal stress caused by bending. The manufacturing specification of the axles shows that the axles were made by SM45C with quenching and tempering. Chemical analysis was done on the specimen cut from the cross section of the axle by using an emission spectrometer. Table 1 shows the specified chemical composition of SM45C along with the results of chemical analysis, and there was no peculiarity in the mix.

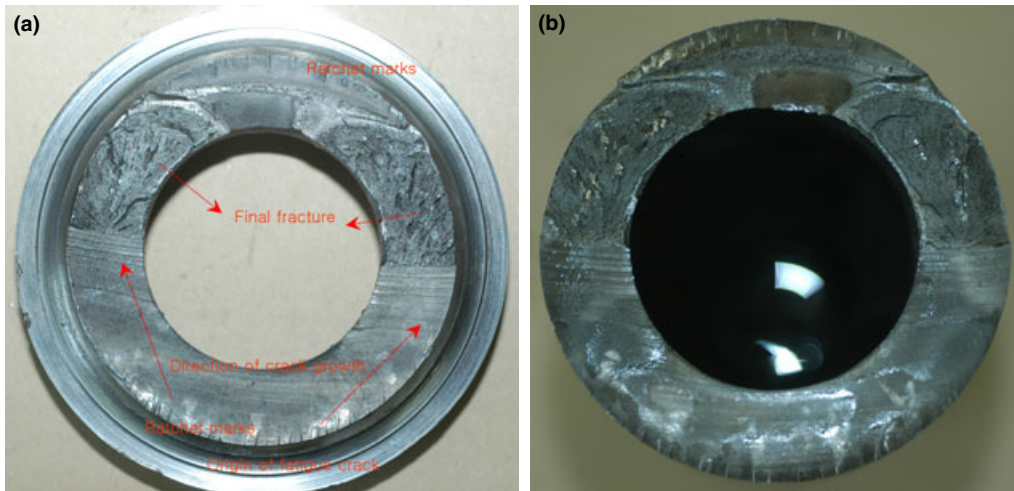
The fractured surface of the axle is given in Fig. 5. The fatigue cracks develop from both the lower and the upper part of the axle.

FIG. 5—(a) The fractured surface of the axle (trailer part). (b) The fractured surface of the axle (wheel part). The beach marks are clearly visible both at the lower and upper parts.

Hardness measurements (Rockwell hardness Scale C [HRC]) were carried out on the three specimens along the cross section, and the results are commonly 12–13 HRC. From the specification, the hardness of SM45C with heat treatment is 15–28 HRC. The measured hardness shows that the axle was poorly heat-treated.

The cause of high nominal stress is the material itself that is lower in strength than specification or the overload of the trailer. From the hardness measurement, we reached a conclusion that the poor heat treatment is the major cause of the failed axles.
