Fatal Accident Cause and Conclusion

ABSTRACT: The Toolmarks Laboratory prepared a report concerning a traffic accident involving the death of a road workman. The driver of the vehicle that hit the workman claimed that the wheels had failed to respond when turning left at a roundabout. A traffic investigator photographed the rack and pinion assembly of the steering system, which was subsequently removed and brought to the Toolmarks Laboratory. The rack and pinion assembly of the steering system was rebuilt, and examination showed that the system functioned properly. Specifically, the front wheels responded correctly to the steering input. Laboratory photographs of the steering system were taken in two different positions, from the same angles as the investigator's photographs at the scene of the accident. It was clear that the steering system had not been assembled properly in the garage.

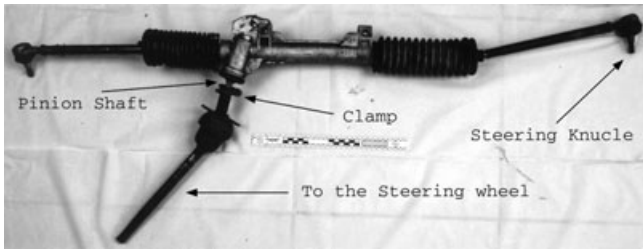
In the Toolmarks Laboratory the disassembled steering system was rebuilt (Fig. 1), and its functionality was checked. It was found that the system worked properly with the steering wheel responding correctly. This seemed to indicate that the accident was caused by a human error. Taking into account, however, the police traffic investigator's report that the steering wheel did not respond when he checked the car after the accident, the difference between the laboratory examination and the investigator's report had to be explained.

FIG. 1—The steering system assembly. The edges knuckle of the steering rack that connect it to the front wheels. In the middle bar housing contains the pinion shaft that connected to the steering wheel.

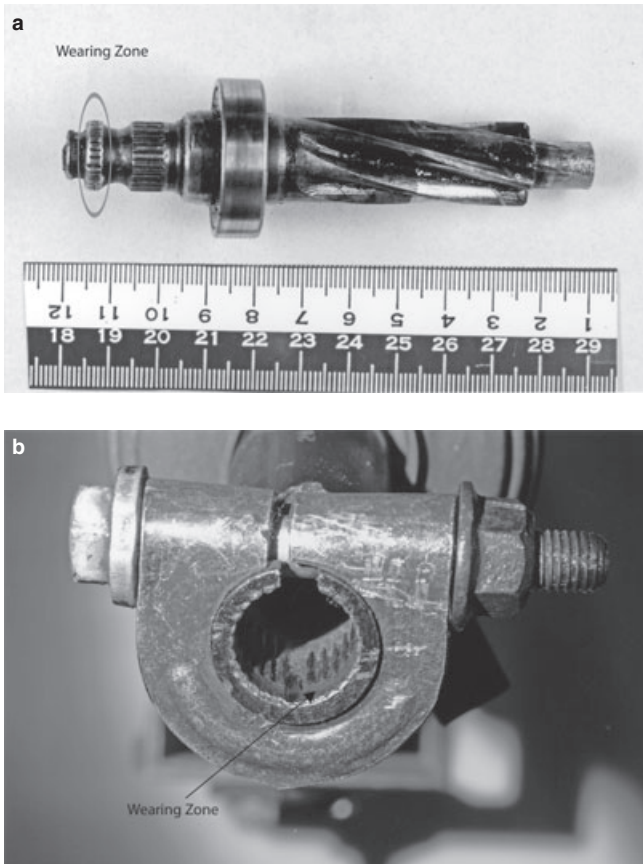
During laboratory examination of all unassembled parts of the wheel system, the forensic expert noticed that the tip of the shift teeth in the rack and pinion (Fig. 2a) and the edge of the clamp (Fig. 2b) were worn. This, however, did not interfere with the functioning of the steering system.

FIG. 2—The worn parts: (a) Pinion shaft—transfers movement from the steering wheel to the steering rack. Also, it shows the worn teeth on the left edge. (b) Clamp—links the steering wheel with the pinion.

As noted previously, wearing of the small teeth of the rack and pinion was observed while examining the assembly in the laboratory.

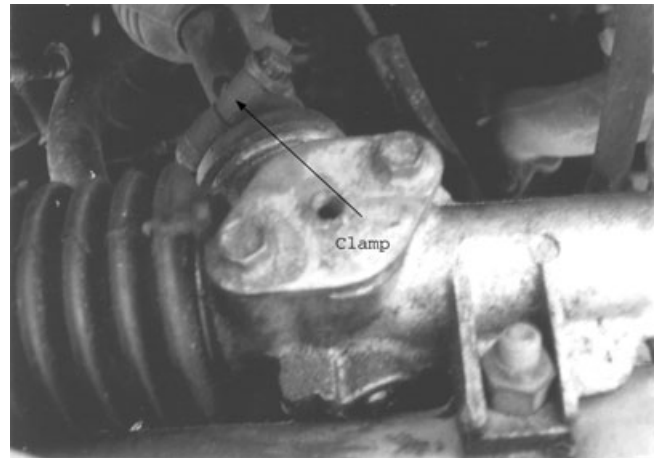
The traffic investigator was contacted, but he was unable to recall details of the wheel position at the scene of accident, and which part of the steering system he considered had not functioned properly. The forensic expert received photographs of the car, including the overall view and one picture in which the rack and pinion position is shown. The photograph did not include a scale, and the worn place was not visible (Fig. 3).

The photographs taken at the scene of the accident were taken from a low angle, hence the bolt tightening the clamp fastening the rack and pinion assembly was not shown clearly. It was, therefore, impossible to determine from the photographs, whether the rack and pinion had been improperly assembled by the garage, thus causing a mechanical malfunction, or whether the accident was caused by human error.

FIG. 3—Photograph taken at the scene of the accident.

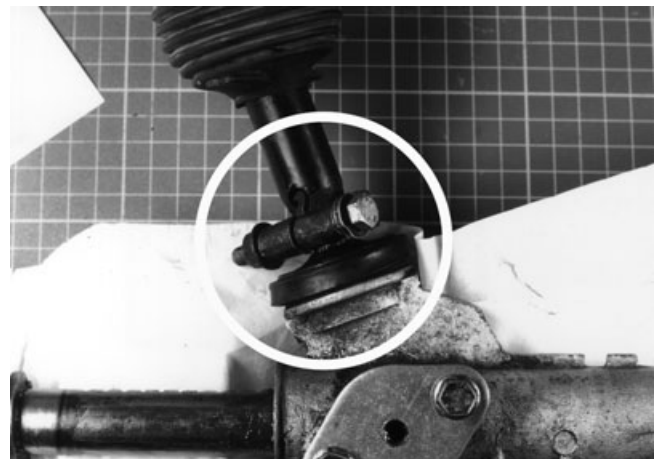
FIG. 4—Photograph of the steering system assembly (upper view). The wheel system is assembled properly, with the bolt screwed all the way.

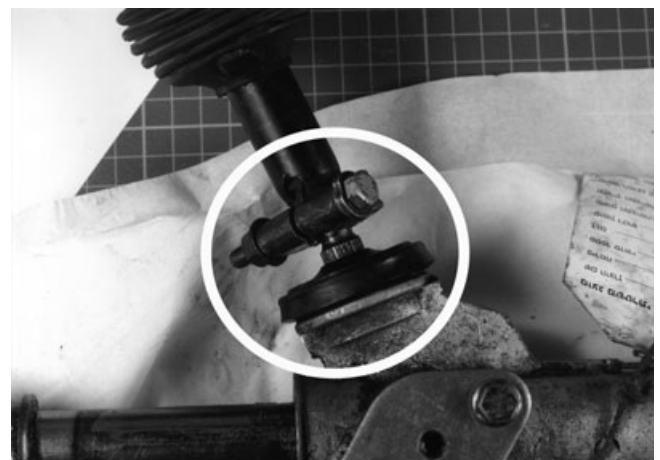
FIG. 5—Photograph of wheel system (upper view). The steering system is assembled incorrectly with the bolt screwed only at the tip of the rack and pinion.

places the teeth of the rack and pinion at the tip, so that they are pressed hard on the edges, which causes the teeth to wear out.)

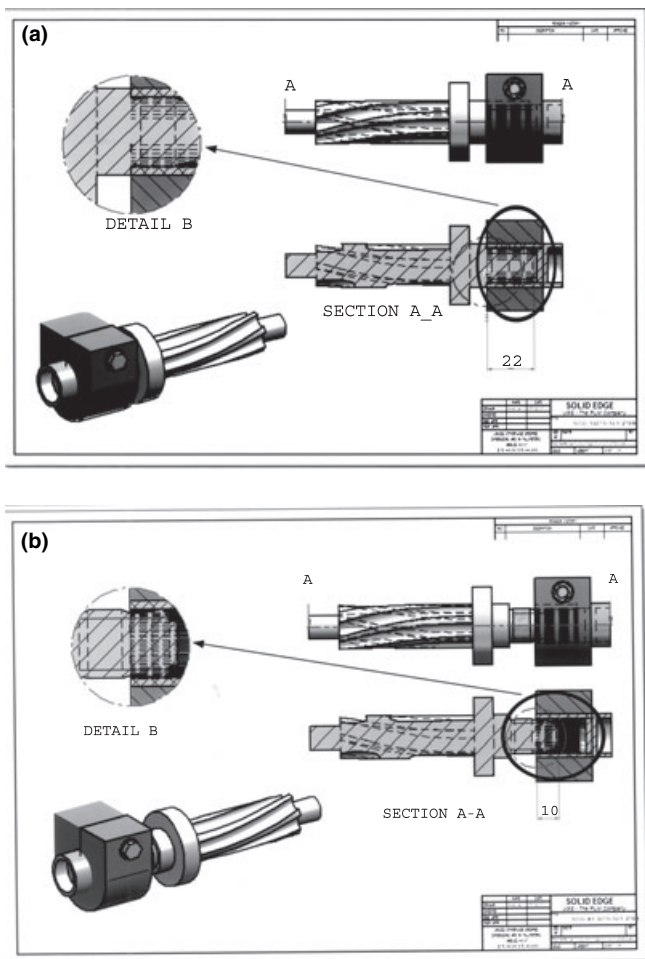
FIG. 6—The cross-section of rack and pinion in which both are assembled: (a) Correctly, (b) Incorrectly.

those taken at the scene of the accident by the traffic investigator. The incorrect assembly is shown in Fig. 4 and the correct assembly in Fig. 5. The cross-section of rack and pinion in both assembled positions is shown in Fig. 6. It was demonstrated that in the incorrect assembly (Fig. 6b), the clamp bolt was screwed only at the tip of the rack and pinion, with narrow teeth only 10 mm in width. This wears faster than correct assembly (Fig. 6a) with a width of 22 mm (scales taken from the duplicate photographs that were taken in the laboratory).

The evidence from the laboratory photographs showed that the rack and pinion assembly was not put together properly in the garage. As a result the small teeth wore out slowly until the steering system did not respond, in accordance with the claims of both the driver and the police traffic investigator.
