**CASE REPORT****ENGINEERING SCIENCES***Jen-Hao Chi,<sup>1</sup> Ph.D.***Metallographic Analysis and Fire Dynamics Simulation for Electrical Fire Scene Reconstruction**

**ABSTRACT:** This study demonstrated the use of metallographic analysis and NIST's Fire Dynamics Simulator (FDS) program to identify the cause of an actual electrical fire. A severely carbonized steel plate and a cable with a bead were found inside a damaged switchboard from the debris of a factory fire. By metallographic analysis, the copper spatter on the steel plate was found to imply a short circuit has occurred and that this was the probable ignition source of the fire was supported by the presence of a small amount of copper oxide and by the cavities with the tree-like grain microstructures in the bead. The heat estimated to have been released per unit area of the switchboard in question (approximately 236.29 MJ/m<sup>2</sup>) served as key input data for applying the FDS simulation of the blaze. The simulation indicated that thermal insulation polyethylene (PE) played an important role in the rapid fire spread.

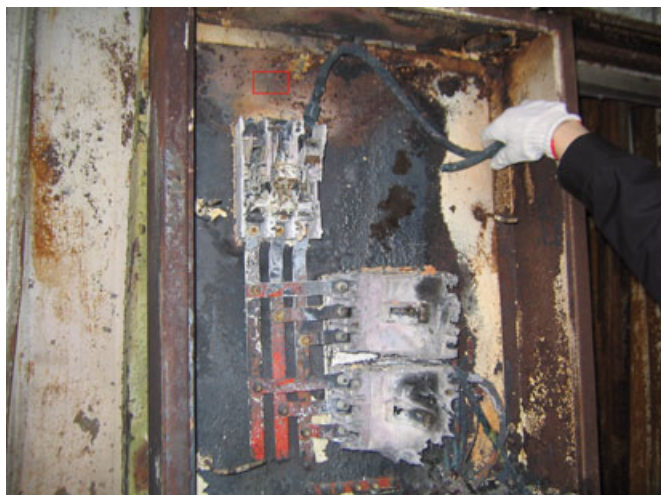
The examined factory fire occurred in October 2006 in Taiwan. Substantial fire debris was collected from the fire site and visually examined. Notably, one switchboard from the site exhibited significantly more damage compared with the others from the site. Figure 1 shows the carbonization of the inner steel plate and three molded case circuit breakers (MCCB) of this switchboard. Figure 2 shows an electrical cable with a bead at one end that was found inside the switchboard. The bead would have been produced when high temperatures melted the electrical cable, which then resolidified into a bead upon cooling (5). That the electrical cable was shown to have been exposed to very high temperatures provided a clue as to the ignition source in this fire (6). This was the starting point for the various research performed in this investigation.

FIG. 1—Fire damage inside switchboard. The rectangle region of the steel plate was removed for metallographic analysis.

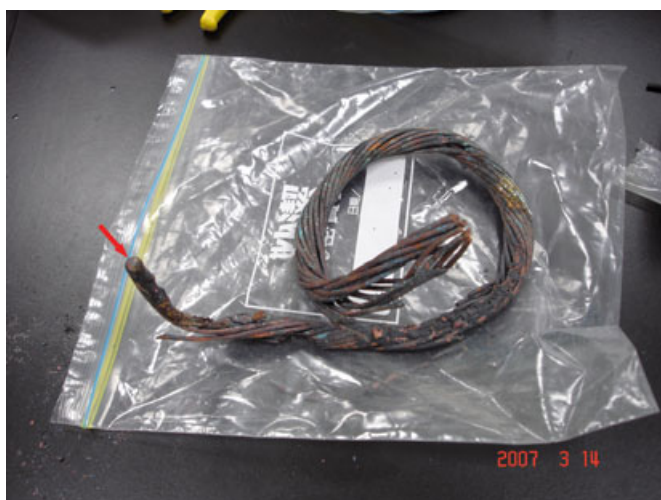
A bead also appeared at the end of cable (2) (Fig. 2). The beaded area had a larger diameter than the original cable did and had a smooth yet nonglossy surface. Another series of metallographic studies examined the cross-section of the bead at the end of the cable, after it was removed with an abrasive cutter (ISOMET

FIG. 2—View of cable with bead at the end (arrow indicates), the cross-section of the bead was used for further metallographic examinations.

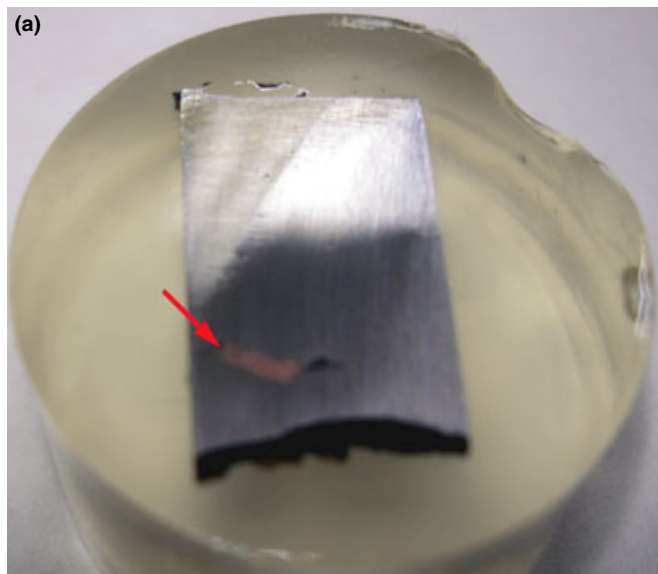
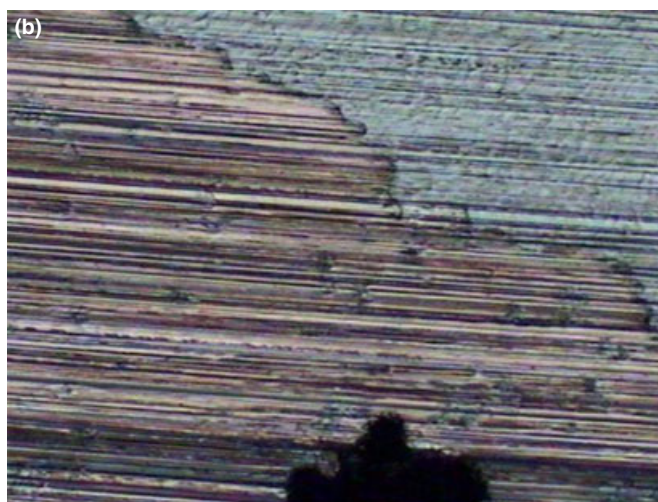
The steel plate near the contact of the burned MCCB and the cable was cut into samples and mounted in resin. After they solidified, a variable speed grinder-polisher (EcoMet<sup>®</sup> Twin; BUEHLER, Lake Bluff, IL) was used to grind and polish the samples for further metallographic examinations. Microscopic study indicated that one steel plate was covered with copper spatter (Fig. 3). Hypothesizing that this spatter on the unmelted steel plate came from a spark-induced melting of the copper wire (5), we concluded that the most likely source of ignition was a short circuit at the contact of the cable and the MCCB.

FIG. 3—Specimen consisting of a portion of the steel plate backing the damaged switchboard. (a) Copper spatter on the steel plate (arrow). (b) Microscope image of copper spatter.

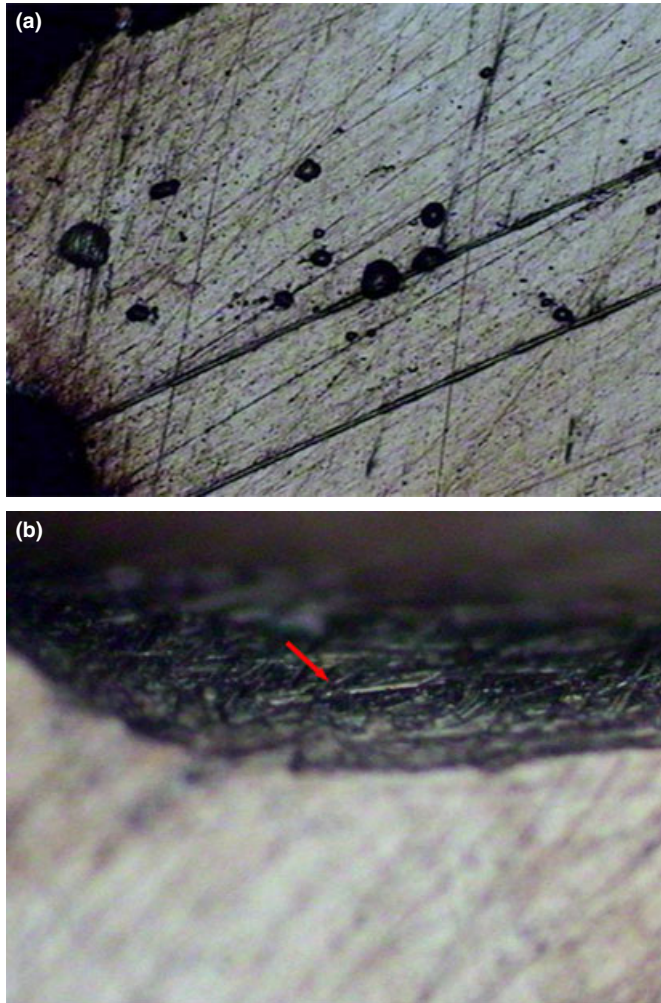
1000; BUEHLER). Figure 4a shows the fragmentary cavities and the small amounts of copper oxide ( $\text{Cu}_2\text{O}$ ) on the cross-sectional surface. Further microscope study under high magnification (1000 $\times$ ) revealed tree-like elongated grain microstructures within the cavity (Fig. 4b). According to a study by Yu (3), these characteristics indicated that this bead should be a primary molten mark. We infer that the transient high-temperature arc produced by the short circuit ignited the nearby combustibles and induced further spread of the fire, immediately after which the temperature in the area of origin decreased. Because the cable at the short-circuit site melted and then resolidified within a short period of time, gases were entrapped in the resulting copper bead, leading to the formation of small fragmentary cavities. Entrapped oxygen also generated a small amount of  $\text{CuO}_2$  on the surface of the bead (7). Additionally, recrystallization caused by the temperature swing would have converted the original equal-axis fiber-like microstructure of the copper wire into an anisotropic tree-like grain (7,8).

FIG. 4—Primary mark of the bead. (a) Metallographic section of the bead (200 $\times$ ). (b) Tree-like microstructures with elongated grain (arrow) (1000 $\times$ ).

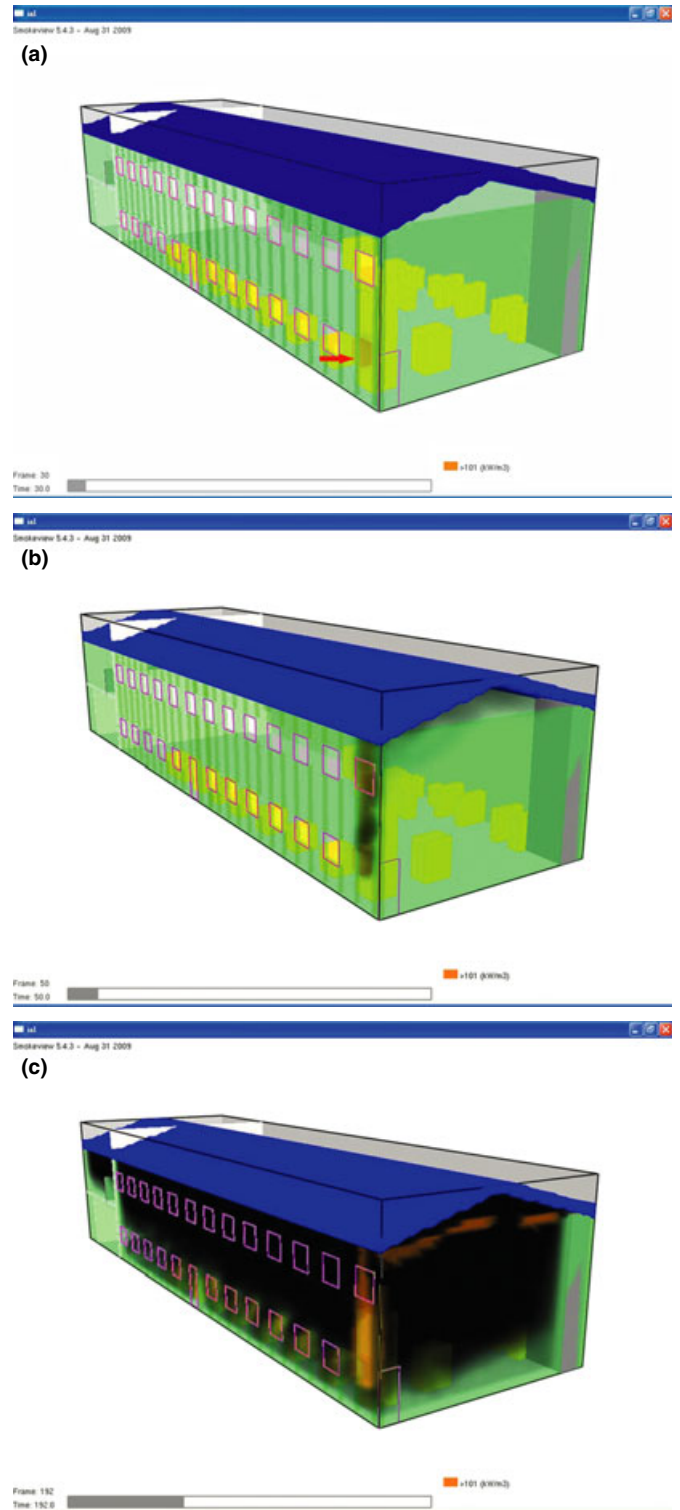
listed in Table 1. This figure was input to the FDS program to generate the simulation, which showed ignition smoke to be emitted from the switchboard about 30 sec after the short-circuit spark discharge, as shown in Fig. 5a. Figure 5b shows the simulated spread of the fire from the switchboard and indicated that during the first minute after ignition, heat was rapidly transmitted through the thermal insulation polyethylene (PE) inside the back wall on which the switchboard was mounted. The simulation also indicated that the smoke from the fire ascended to the factory ceiling, where it began to accumulate. Owing to the flammable PE, the flames and smoke quickly spread out to the factory's ceiling and surrounding areas. Figure 5c shows the FDS simulation, indicating that flash-over occurred about 3 min after the spark that ignited the fire. Figure 6 shows the severe smoke damage to the ceiling steel, which was consistent with the simulation results. The factory where the fire started was only 30 cm away from neighboring factory buildings, and many flammable articles were heaped between the factories. Therefore, when the fire reached the PE inside the iron sidings, it easily spread to these articles. From there, the fire rapidly spread to the neighboring factories, compounding the loss.

FIG. 5—Computer simulation of fire scene. The configuration of the factory building was input to the Fire Dynamics Simulator program, including door and windows (hollow rectangles), machinery equipment (light parallelepipeds), duct (gray parallelepiped), the switchboard (arrow), and the polyethylene (PE) thermal insulation inside the wall (not shown). (a) Smoke filled the switchboard and started to emit from the switchboard (arrow indicated) at 30 sec after ignition. (b) Transmission of heat along the wall (with the PE thermal insulation inside it) at 51 sec after ignition and ascent of smoke to the ceiling. (c) Rapid spread of smoke to factory areas at 192 sec after ignition.

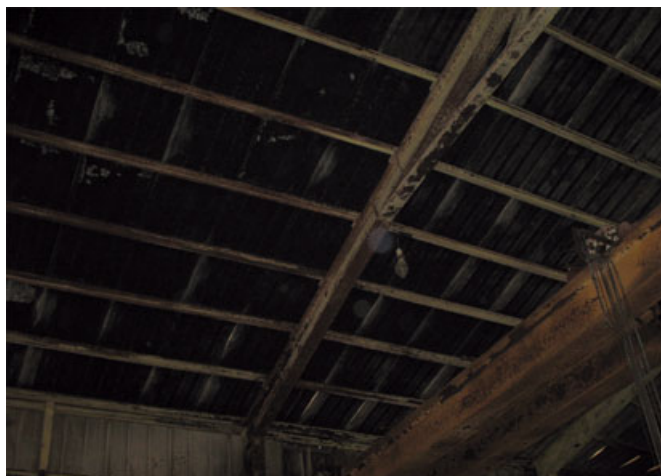
FIG. 6—Smoke damage of ceiling.
