Case History

EXPLOSION DURING DISTILLATION OF 4-CHLORO-2-METHYLANILINE

At 9.39 a.m. of December 4th, 1973 a residue still of a vacuum distillation plant burst in the Kashima factory of Asahi Electrochemical Industries Inc. The accident occurred during the stripping of CMA (m.p. 30°C , b.p. 240°C) from higher boiling residue. Three operators were killed and two seriously injured.

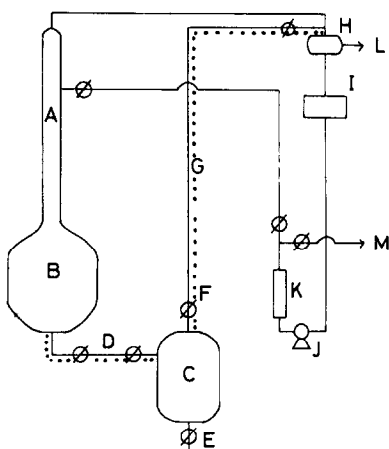
Fig. 1. Diagram of distillation plant.

The distillation plant is shown in Fig. 1. Crude CMA is charged to the steam heated rectifying still B where it is distilled until contents have been reduced to approximately $\frac{1}{3}$ of the original charge. The residual material is then transferred to the steam jacketed agitated residue still C and distilled to recover remaining CMA until the viscosity of the residue reaches a certain value. The temperature in the still is about 160°C at a pressure of 70 Torr. When the distillation is completed the still is isolated by closing valve F and the vacuum broken with nitrogen. The residue is discharged through the discharge valve E.

At 9.39 a.m. the residue still ruptured at the lid flange. The lid was blown upwards causing extensive damage. At the time of the explosion, a black smoke was observed around the still and a white smoke around the vapour line. There was no fire. A pungent odour could be detected near the still after the explosion. The bursting pressure of the still was calculated to be 18 kg/cm^2 .

- The transfer line and the vapour lines (dotted lines Fig. 1) were filled with black porous tar (tar A).
- The ball valve (Figs. 3 and 4) showed deterioration and cracks in the teflon covered packing and a part of internal asbestos gasket was missing indicating a source of air leak.

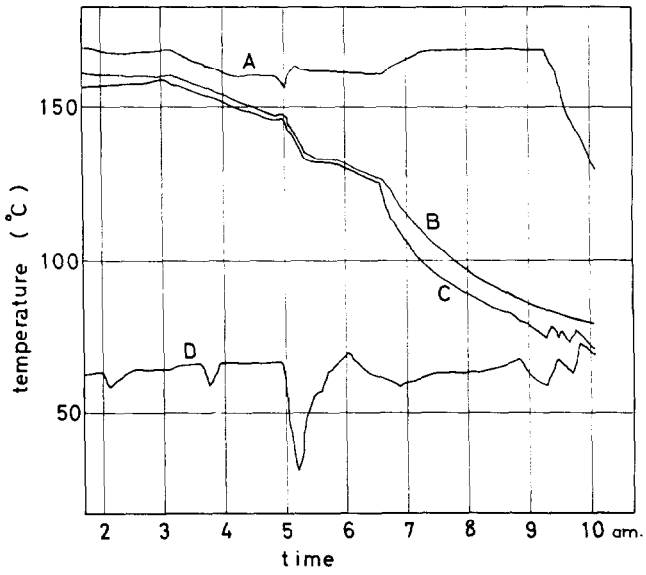
Fig. 2. Temperature record before explosion.

- There was no evidence of fire in any part of the plant and the conclusion was that the rupture was due to gas pressure in the still.
- The temperature record Fig. 2 shows that contaminated CMA passed from the rectifying still to the residue still at 9.15 a.m. as a result of the operator opening the transfer line valves some 5 minutes after the agitator stopped.

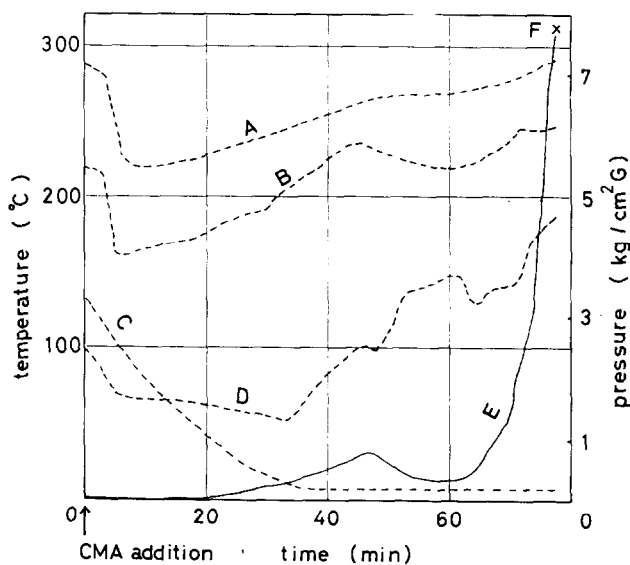
Fig. 5. Temperature and pressure records of first experimental run.

Air was blown into a mixture of 500 g of tar and 250 g of 2/9 CMA for 30 minutes at 180°C in a 2 litre flask. The unreacted CMA was removed by distillation under vacuum. The residual tar is referred to as 2/9 tar. When the temperature of the residual tar reached 290°C, 550 g of 2/9 CMA were added to the residue and the contents sealed at atmospheric pressure. Figure 5 shows the temperature and pressure record. The flask burst after 75 minutes due to pressure of HCl gas. The tar from the upper part of the vapour line showed also much the same pressure curve as 2/9 tar.

The experimental results show that 2/9 tar, or 2/9 CMA alone, do not produce any gas. A mixture of 2/9 tar and pure CMA shows the same pressure

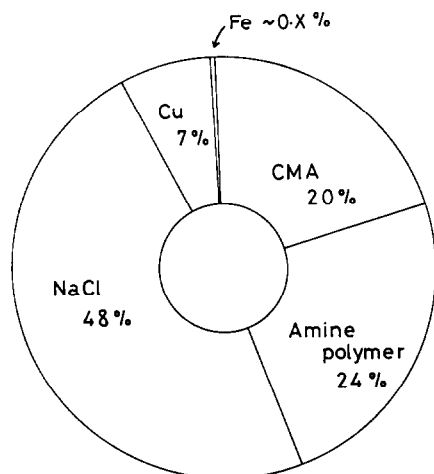
Fig. 6. Composition of tar.

curve as a mixture of tar with impure CMA. The gas produced in all cases was HCl. The contents of the tube expand with the evolution of HCl by a factor of 10. Further experiments were conducted to establish which of the tar components was responsible for the gas evolution. The composition of the tar is given in Fig. 6. NaCl, NaOH, amine polymer, Fe powder and Fe_2O_3 do not react with CMA. Fe compounds may react but without the evolution of gas. On the other hand tests carried out with Cu powder, Cu_2O , CuO, CuCl and CuCl_2 showed that each produced CMA—HCl salt but only CuCl_2 generated HCl gas. The pressure curve for CuCl_2 —CMA mixture is similar to that of 2/9 tar and 2/9 CMA system (Fig. 7). Basically there is no difference between the formation of CMA—HCl salt and HCl gas. HCl gas produced will react with CMA to form salt as long as free CMA is present. CuCl_2 is obviously capable of producing more HCl than the other Cu compounds.

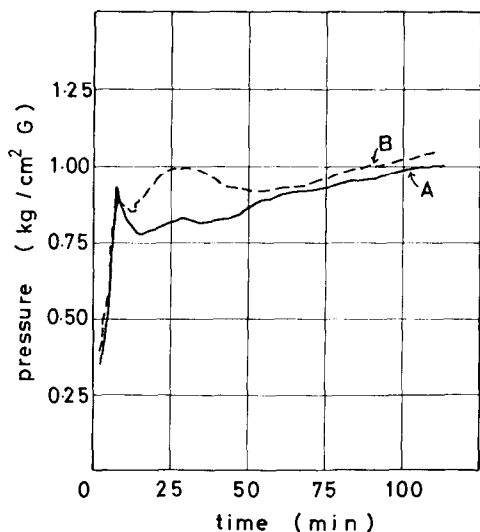
Fig. 8. Pressure curves for two tar-CMA systems.

under standard conditions produced a pressure curve similar to that for 2/9 tar and CMA (Fig. 8).

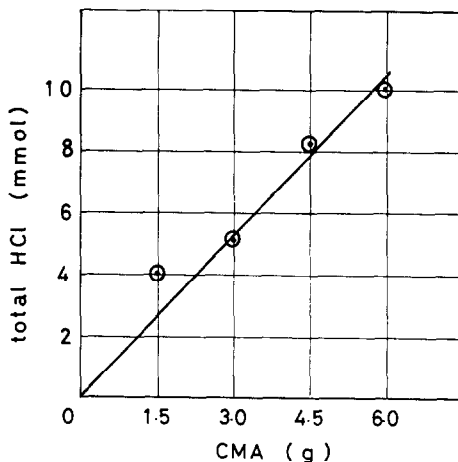
Fig. 9. Quantity of HCl generated.

Further experiments were conducted in which various amounts of CMA were reacted with 3.3 mmoles of CuCl_2 . The results in Fig. 9 show that the amount of HCl generated as CMA-HCl salt and HCl gas is proportional to the quantity of CMA employed.

The estimated quantity of material present in the still at the time of rupture was approximately 600 kg. The Cu content of tar type A was ca. 7.5% so that the amount of Cu in the still was 45 kg, or 700 g moles. The ratio of CMA to Cu in the tar corresponds to that of 3 g CMA in Fig. 9 giving 5 mmoles of HCl per 3.3 mmoles of Cu^{++} . This would be capable of producing $5/3.3 \times 700 = 1050$ g moles of HCl, assuming that all the Cu ions were in the divalent state.

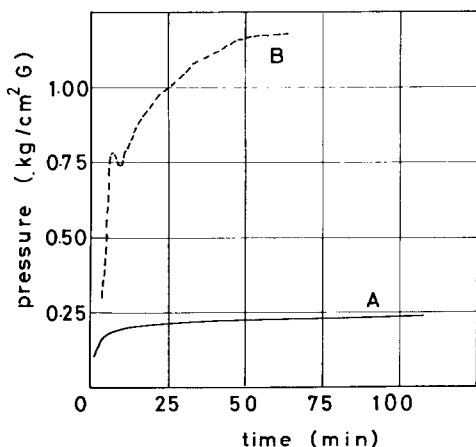
Fig. 10. Pressure curve for CuCl_2 -CMA reaction.

reaction rate of CuCl_2 with CMA was also investigated (Fig. 10). An Arrhenius plot is shown in Fig. 11. It is seen that the reaction rate at 160°C , the normal operating temperature is very low. It is estimated that the reaction temperature necessary to produce enough HCl to burst the still in 24 minutes, the time elapsed between CMA entering the still and the explosion, would be in excess of 260°C .
