CORROSION PROBLEMS IN Ti/KClO<sub>4</sub> LOADED DEVICES WHEN SUBJECTED TO HUMIDITY ENVIRONMENTS\*

T.M. MASSIS, J.T. HEALEY, D.H. HUSKISSON and W.G. PERKINS  
Sandia National Laboratories, Albuquerque, NM 87185\*\*

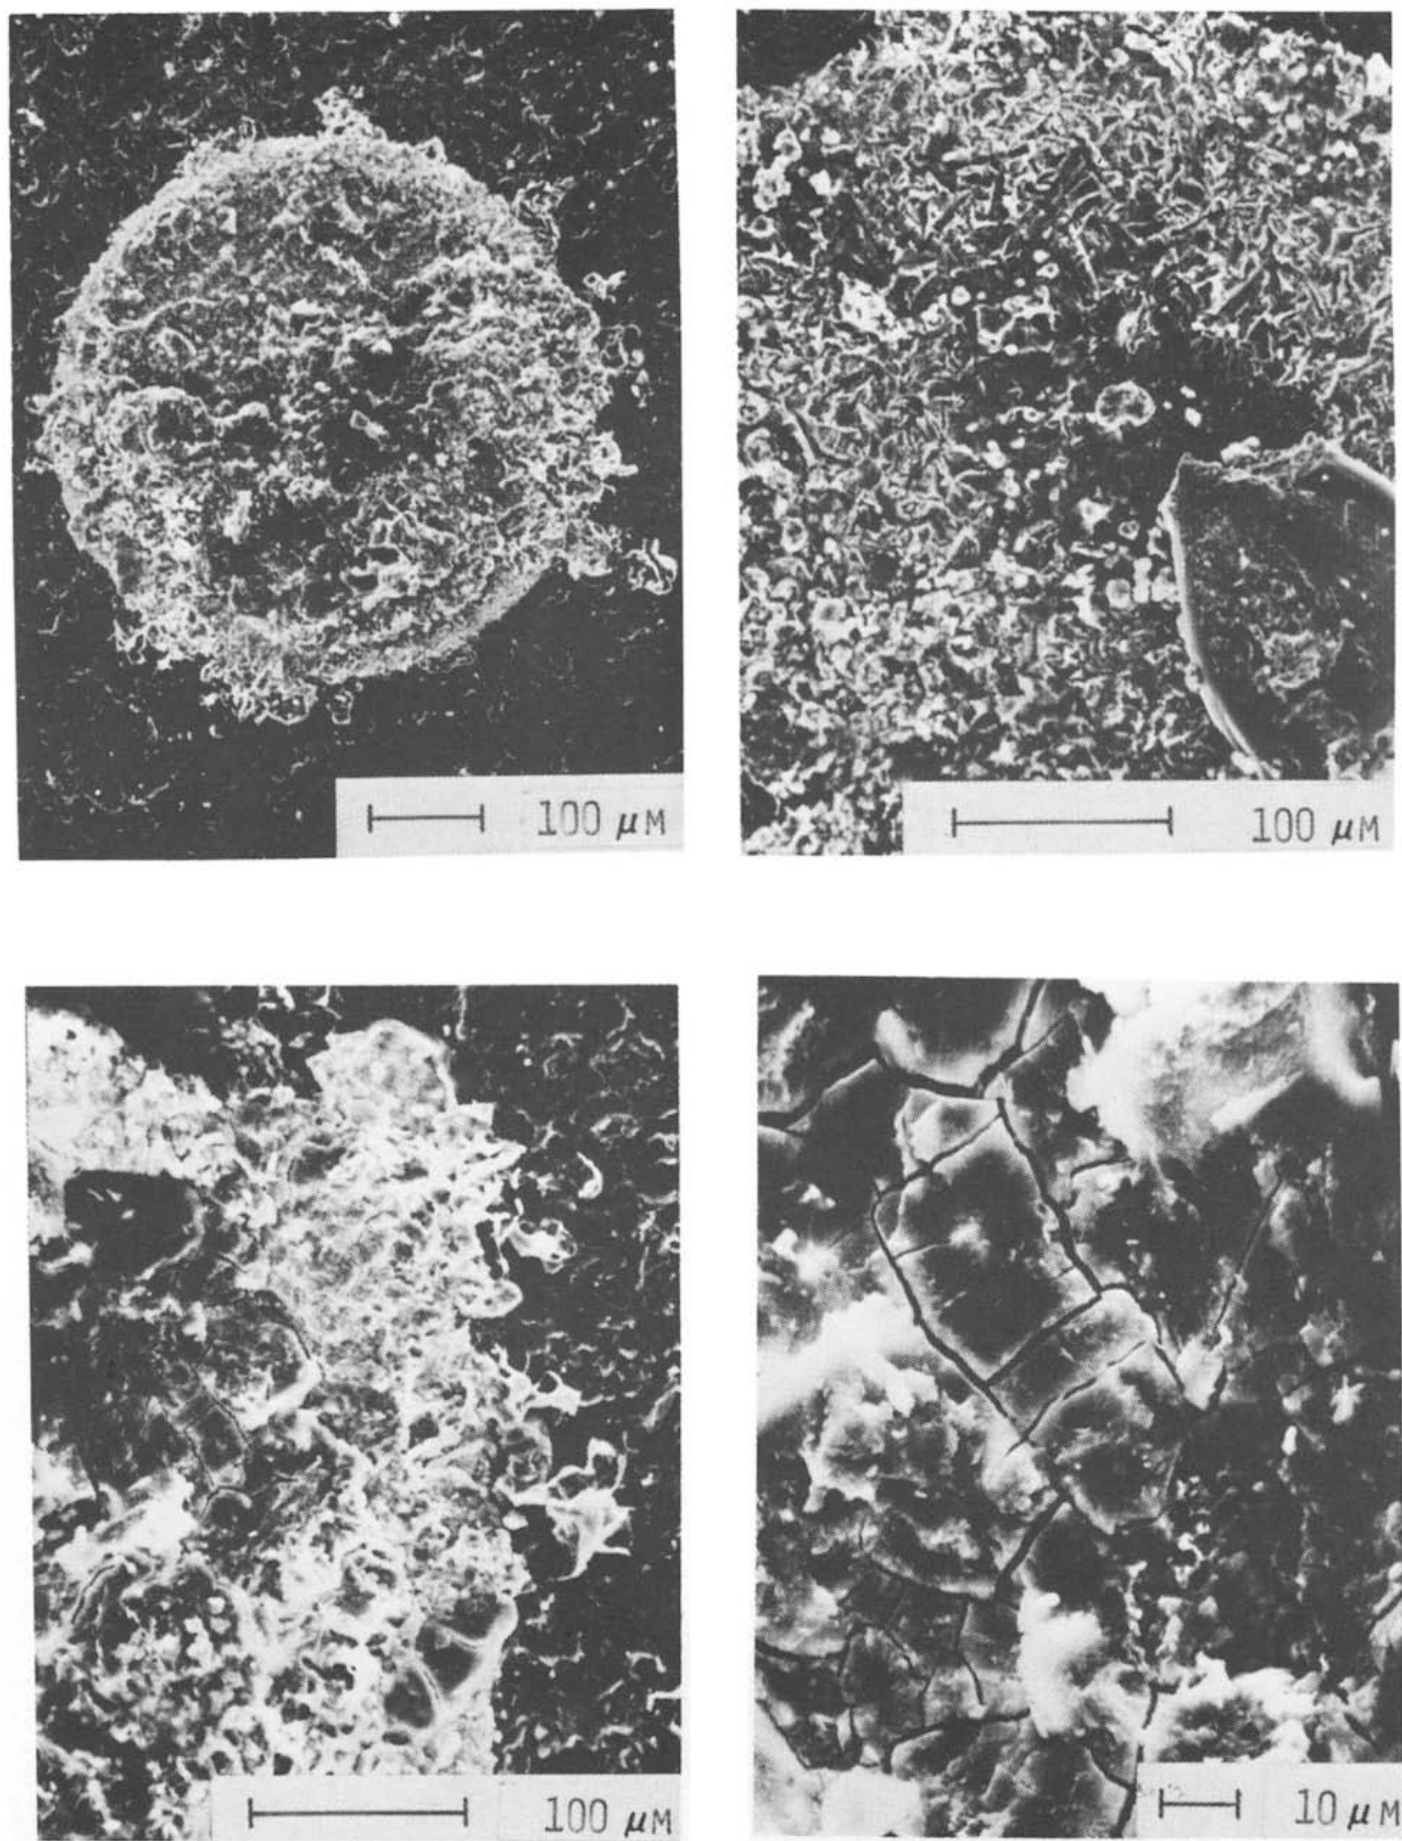
Optical and scanning electron microscopy (SEM) of the previously mentioned lot of igniters revealed nearly 100 percent corrosion of the electrode pin surfaces as shown in Figure 2. In nearly half the units, the bridgewire was detached from the electrode pin at the weld interface. Evidence of pin corrosion in the weld area was apparent (Figure 3). No corrosion of the bridgewire was observed except for an isolated area near the weld. Energy dispersive x-ray analysis ( $Z \geq 11$ ) of the pin corrosion product revealed major concentrations of the Kovar pin constituents with minor concentrations of chlorine.

Fig. 2. SEM of electrode pins from corroded igniter lot

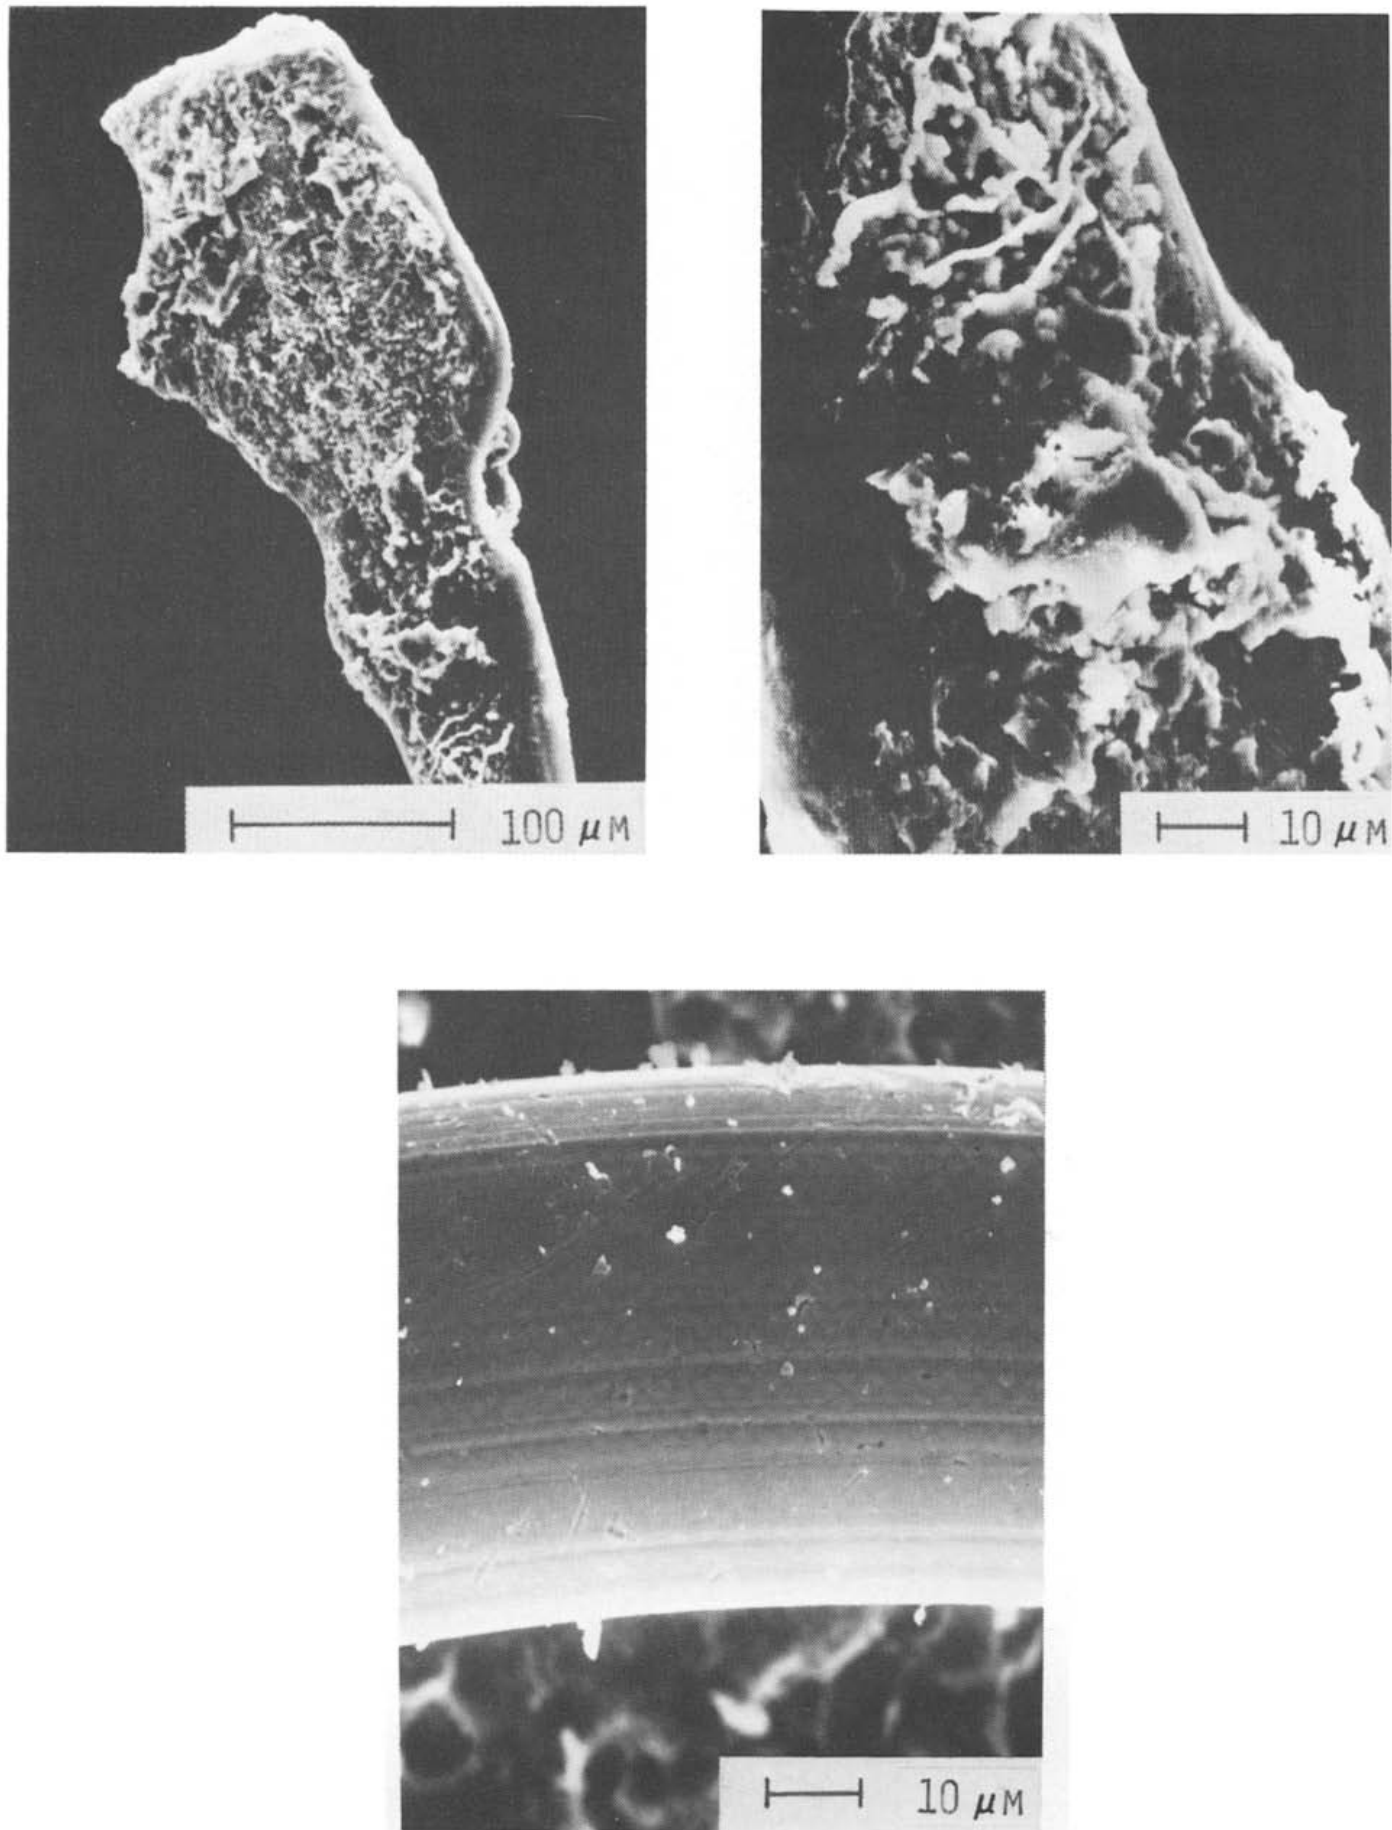
Fig. 3. SEM of bridgewire and weld interface from corroded igniter lot.

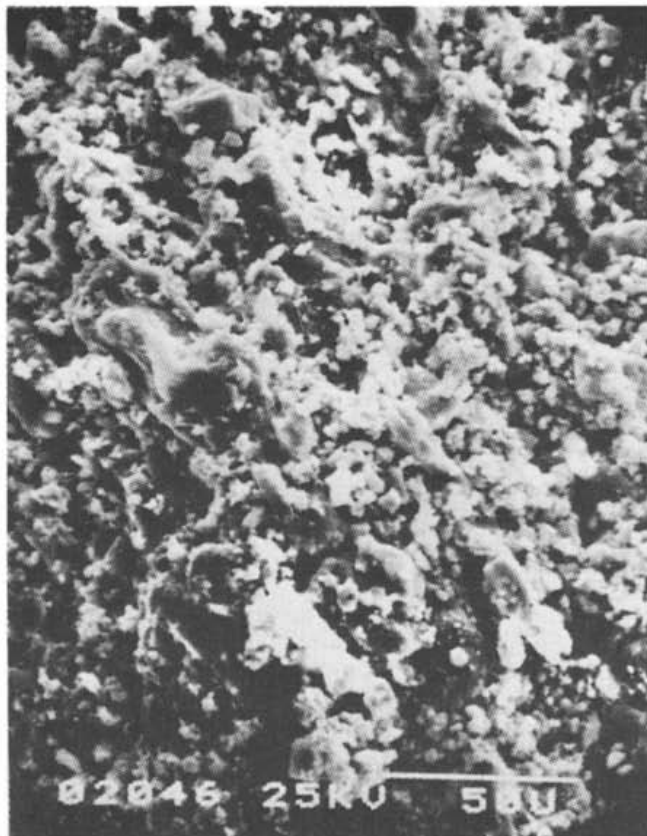
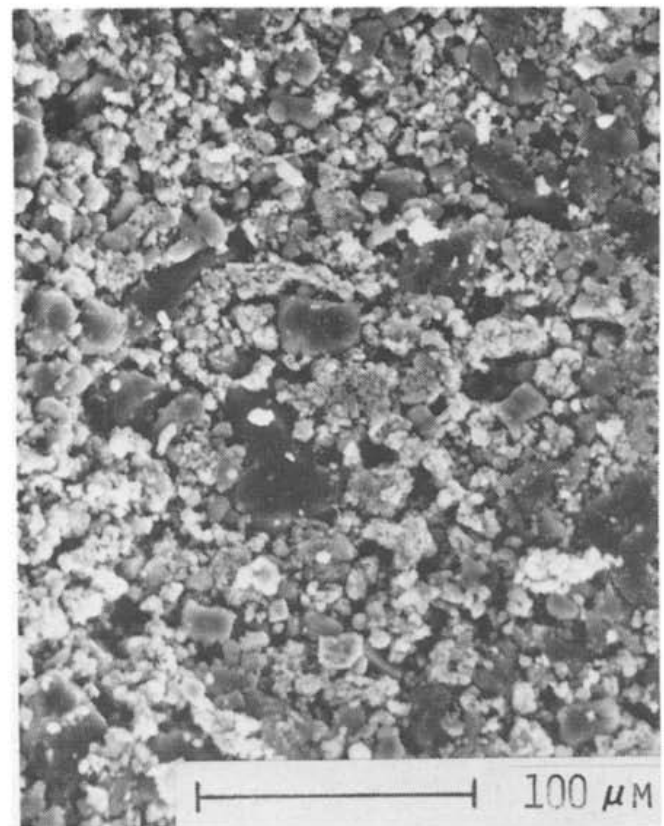
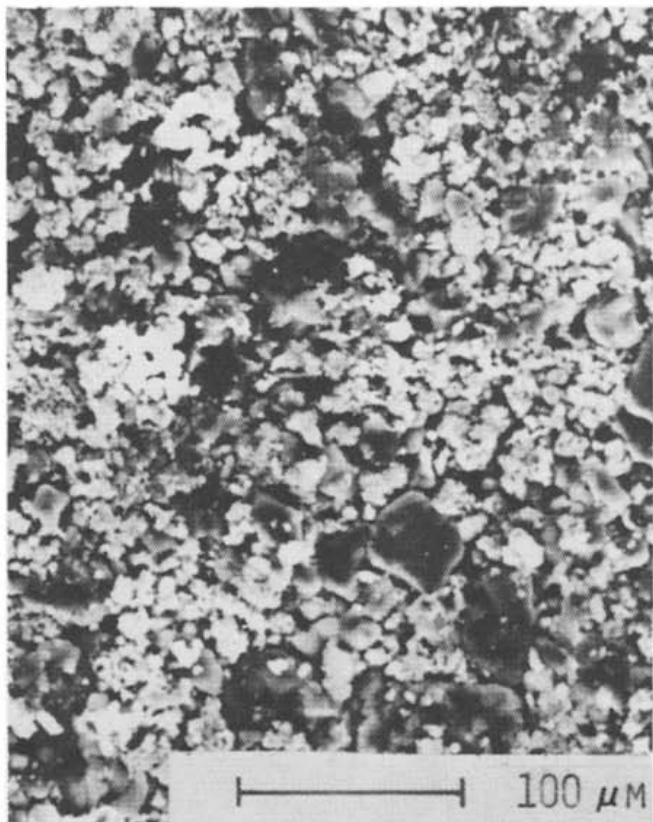
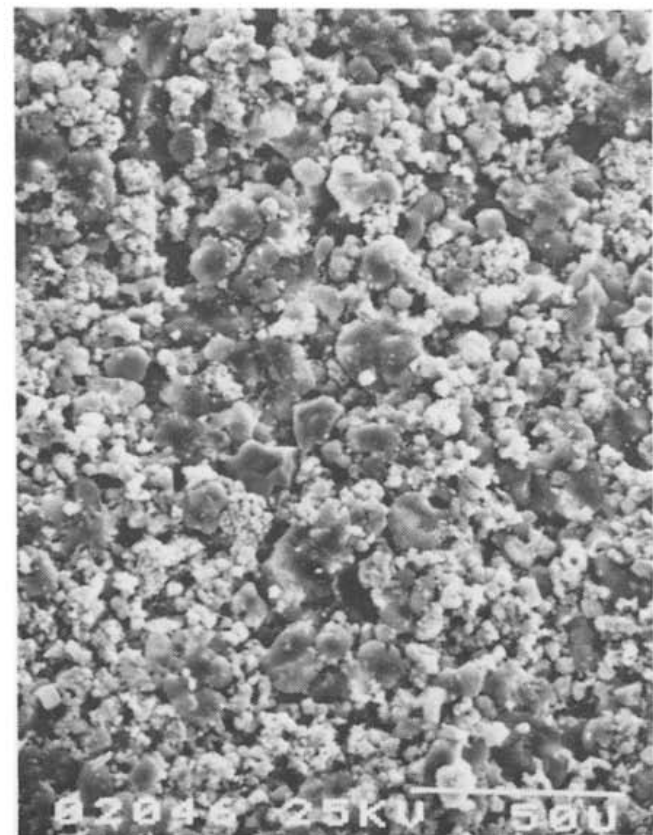
Examination of the pyrotechnic powder interface in contact with the electrode pins revealed no morphological alteration of the potassium perchlorate (KClO<sub>4</sub>) when compared to the bulk powder away from the pins as shown in Figure 4. This is contrast to the previous observations with the Ti/KClO<sub>4</sub> valve actuator where morphological alteration of the KClO<sub>4</sub> was observed whenever corrosion was present (ref. 4) Based on this observation, it was concluded that the pyrotechnic blend, and in particular the KClO<sub>4</sub>, was not playing a primary role in the corrosion mechanism of the igniter.

Fig. 4. SEM of Ti/KClO<sub>4</sub> powder from corroded igniter lot (bulk and pin interface).

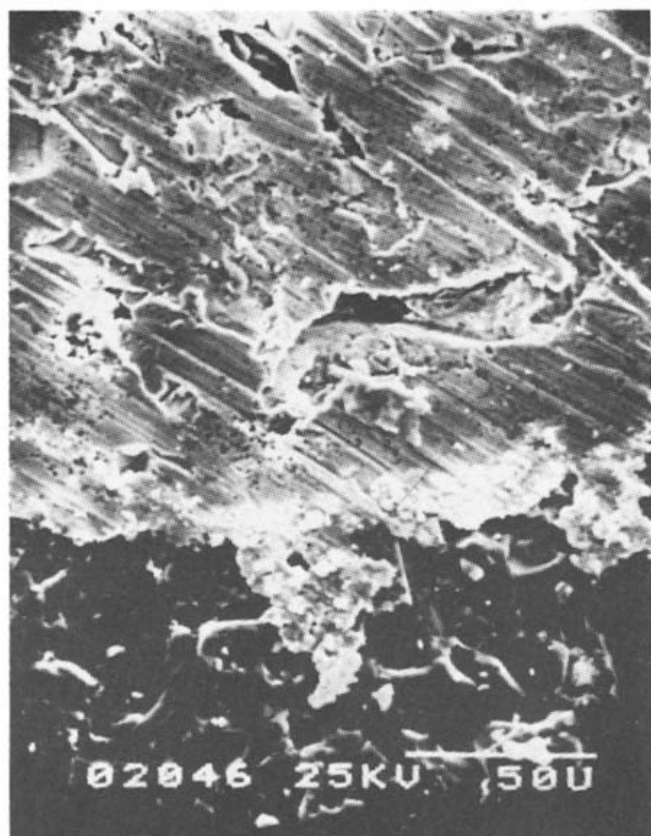
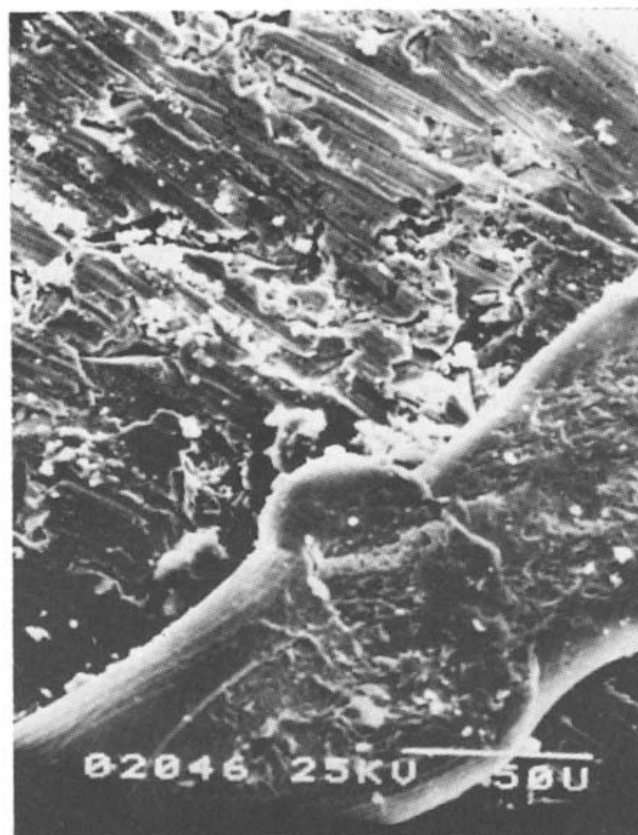
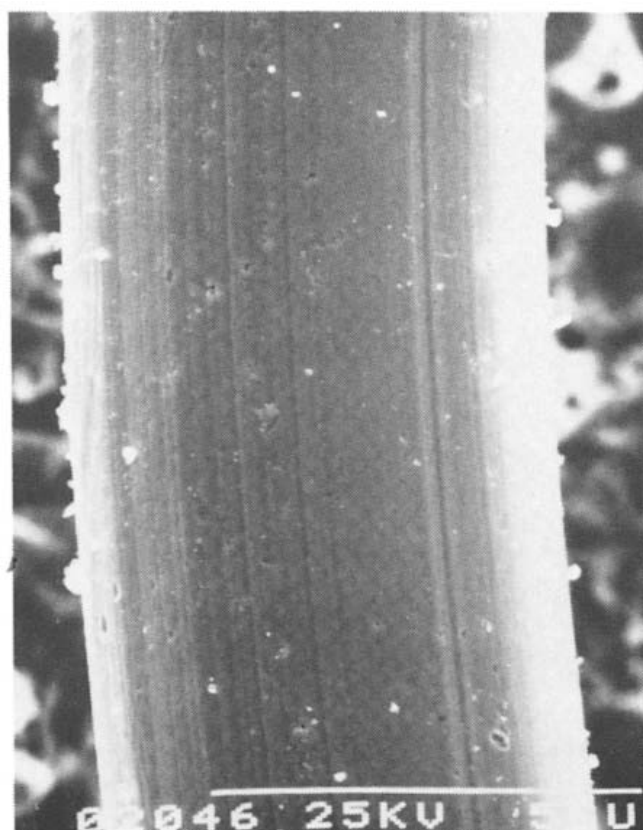
Further evaluation of other production lots of the igniter produced prior to this lot revealed levels of corrosion ranging from none in some lots to the occurrence of small, isolated corroded areas in other lots. No corrosion of the weld areas was apparent. Except for one bridgewire where a single area of corrosion was found, no bridge-wire corrosion was observed. Figures 5 and 6 are typical SEM photomicrographs of the pins and bridgewires from these production lots.

Fig. 5. SEM of electrode pins and bridgewire from a non-corroded igniter lot.

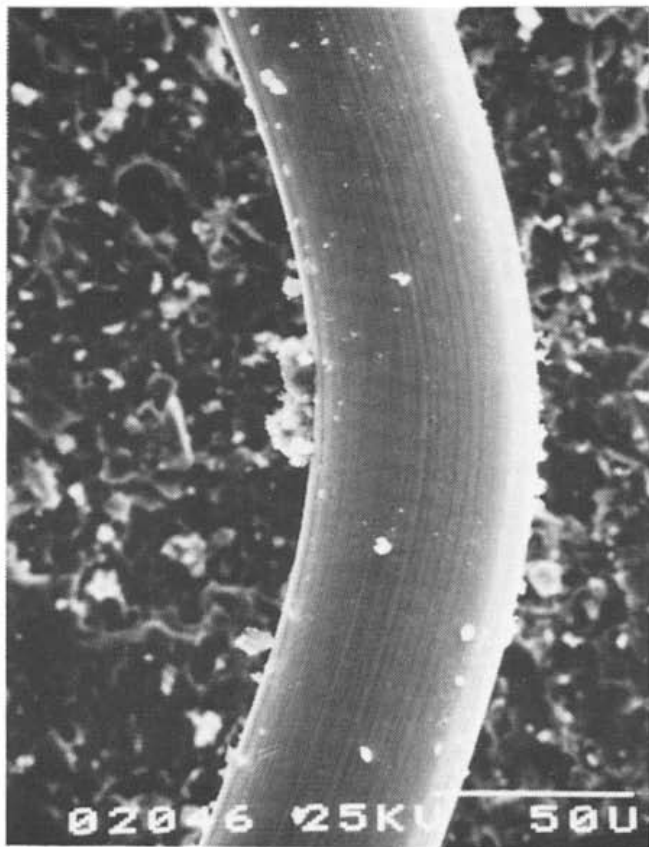
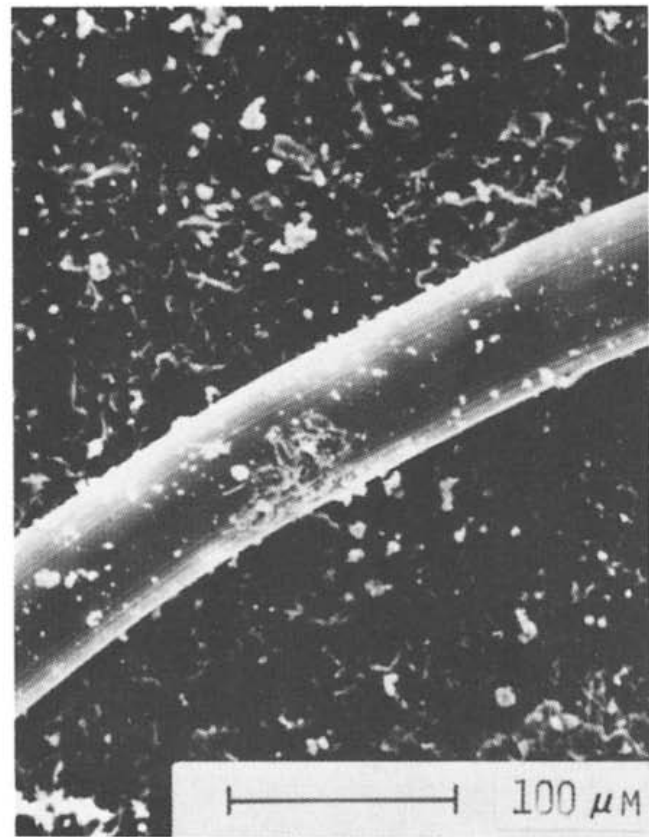
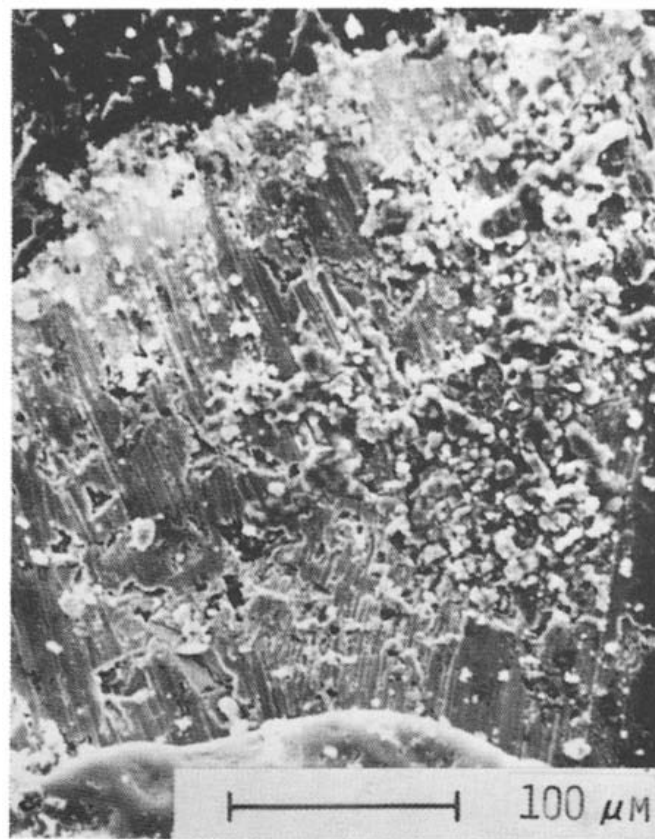
Fig. 6. SEM of electrode pins and bridgewire from a partially corroded igniter lot.

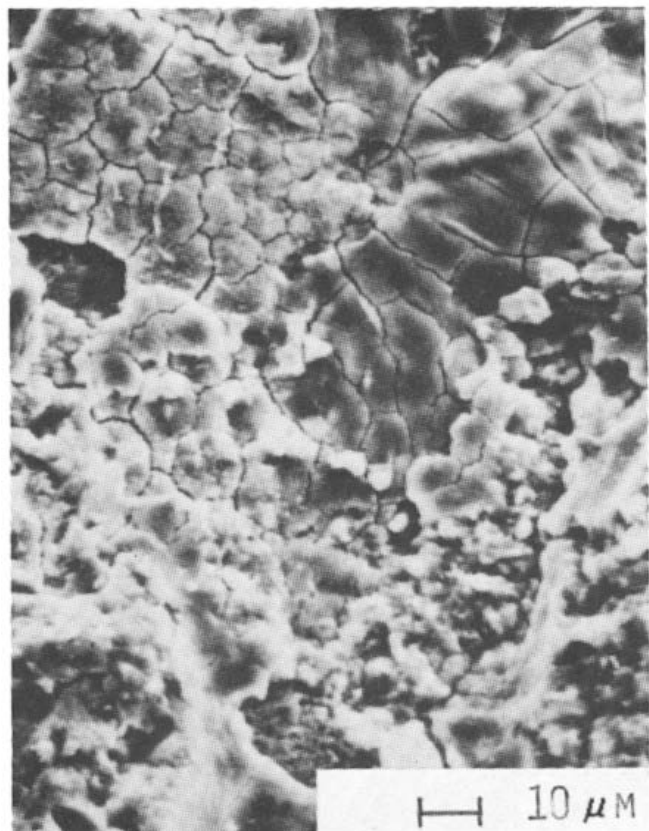
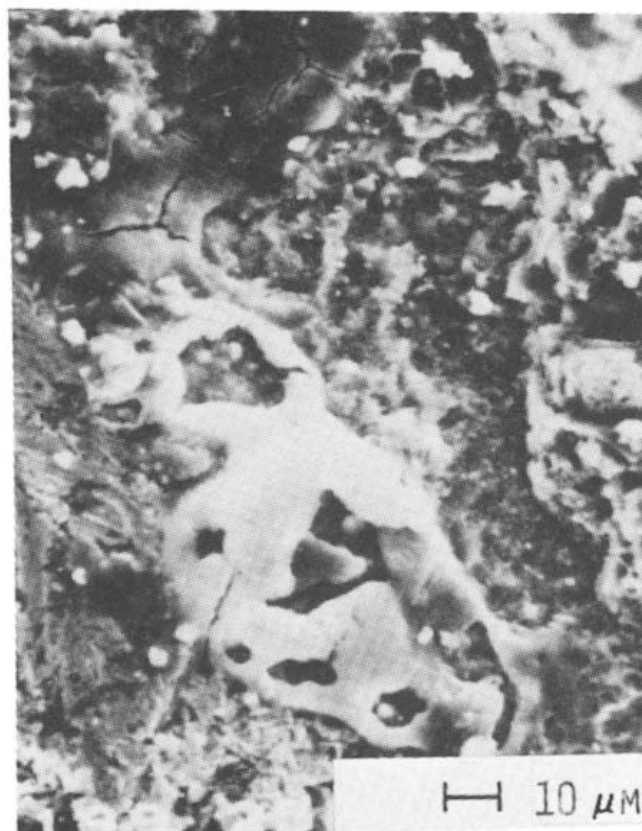
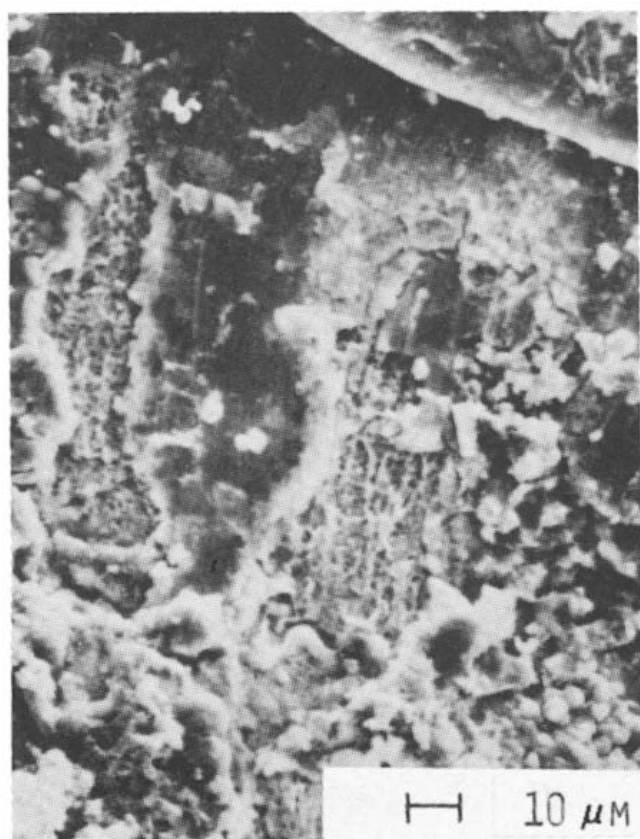
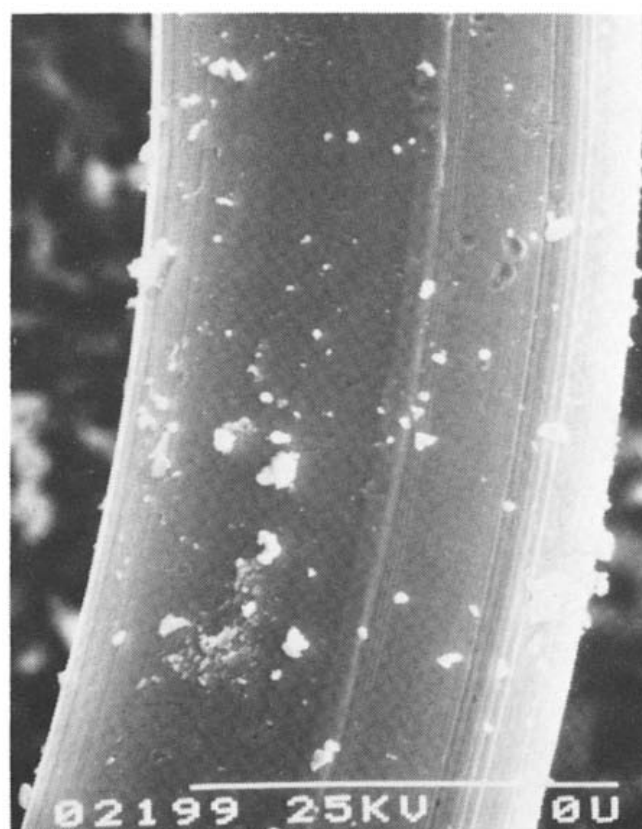
Disassembly and evaluation of the header revealed massive corrosion of the electrode pins (Figure 9). Nearly all of the surface was corroded. Either one or both of the bridgewire/pin welds were detached at the weld interface in one-half of the units evaluated. Optical and SEM examinations revealed similar corrosion of the electrode pins and weld areas as previously found for the thermal battery igniter. No bridgewire corrosion was observed. Similar units subjected to the same thermal cycle but without the humidity environment were found not to be corroded.

Fig. 9. SEM of electrode pins and bridgewire from piston motors exposed to humidity cycle.

A design change was necessary to eliminate the corrosion and stress corrosion cracking problems in the piston motor. A hermetically sealed version was designed and built for application with a humidity requirement. In units where the leak rate was less than  $10^{-8}$  atm cc/sec, either no corrosion or minimal corrosion was observed when

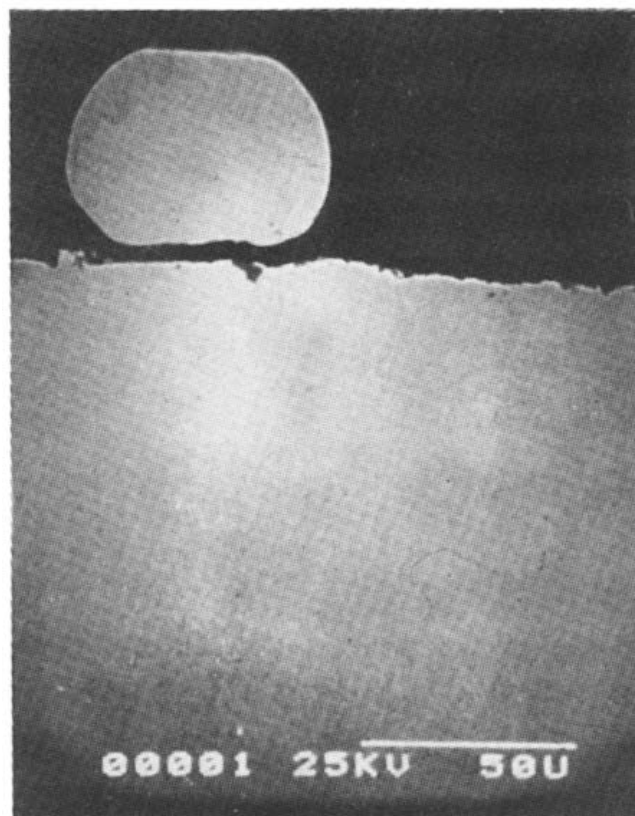
Thermal Cycle - No stress corrosion cracking

Fig. 10. SEM of cross-sectioned header pins from piston motor (thermal and humidity cycled).

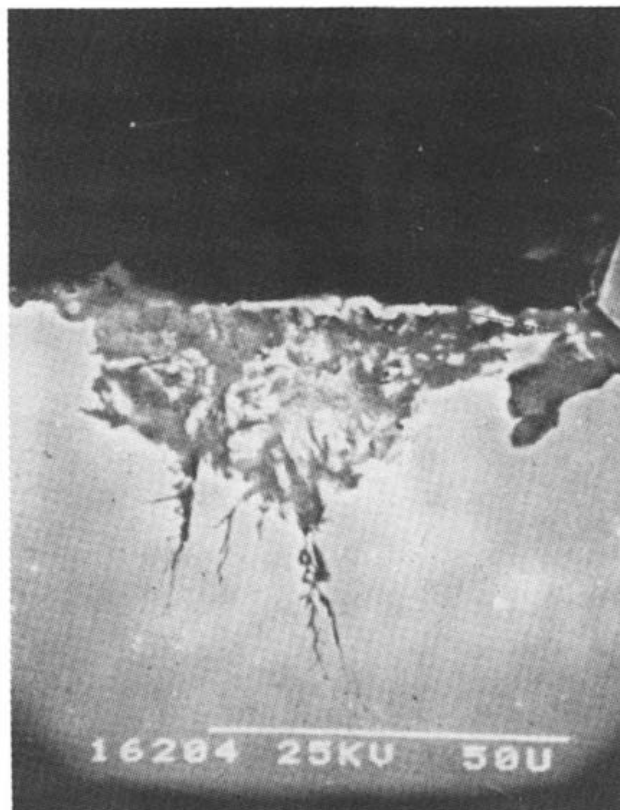
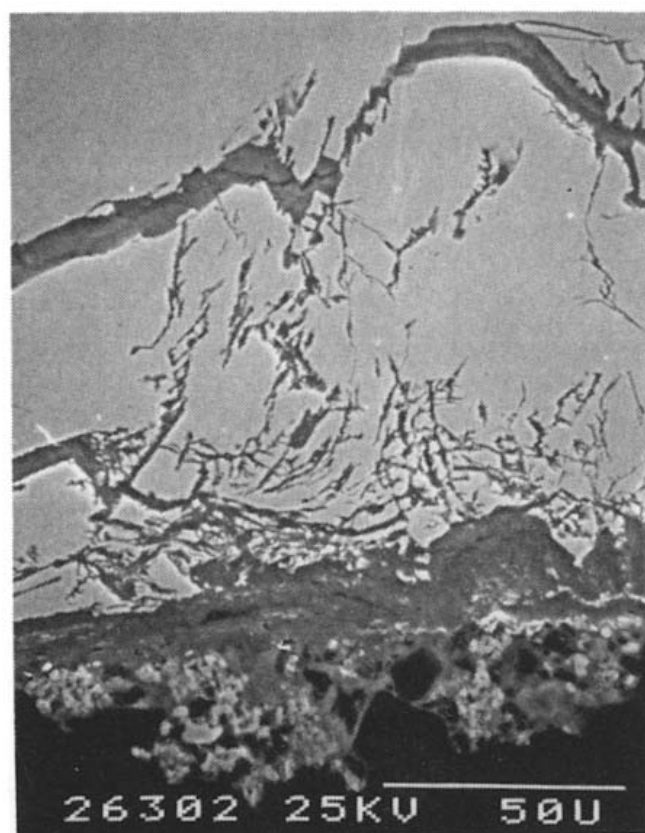
Corroded and uncorroded units were sectioned through the pins and weld area to determine the depth of the corrosion and also to determine the mechanism of the bridgewire/pin separation. Figure 10 shows examples of these sectioned units. The corrosion was over 100 μm deep, and sharp cracking of the Kovar pin was observed proceeding around the weld effected area. Energy dispersive x-ray analysis ( $Z \geq 11$ ) revealed the presence of chlorine in the surface corrosion product and also in the corrosion product within the cracks, even at the crack tip. Eventually this cracking coalesced and resulted in separation of the weld area from the pin. No surface corrosion or cracking was observed on those units previously identified as uncorroded.

Humidity Cycle - Showing Chloride assisted stress corrosion cracking
