THE DECONTAMINATION OF A DISUSED GAS WORKS SITE

A PARKER, K W PEARCE

S F FENNER and M S WRIGHT

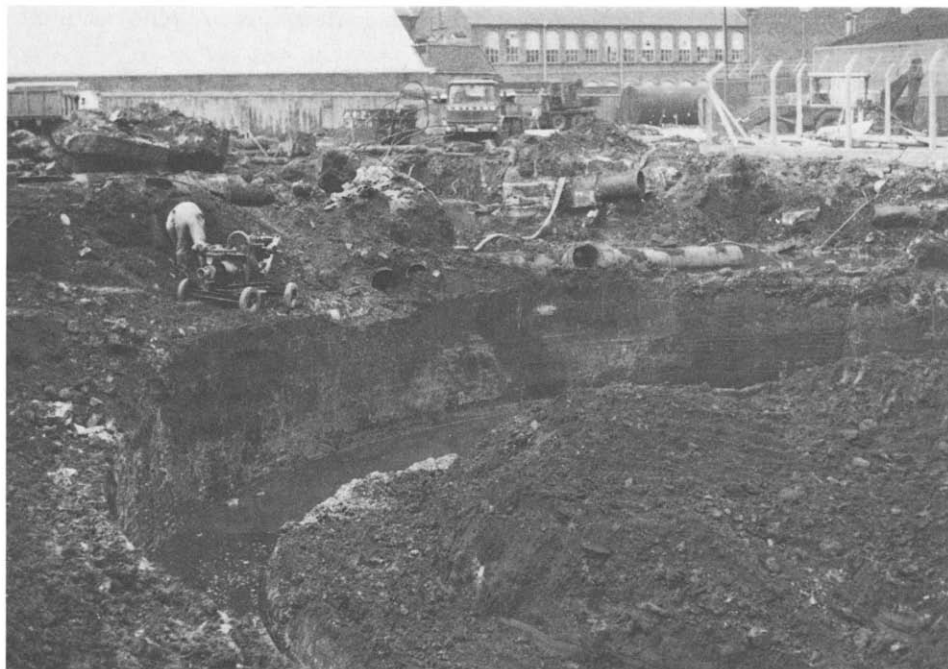
Fig 2 Excavated gas holders

A second Akerman excavator was brought in to work on the contaminated gas works area. It rapidly became apparent that contamination, mainly due to tar, was extensive, especially beneath the large cast iron pipes which had linked the ovens with the purifier and gas holders. The 20 m diameter holder mentioned previously was located and excavated. It was found to be approximately 6 m deep and had a domed base formed from the underlying clay which had then been covered by brickwork. The surrounding "ditch" contained narrow concrete buttresses to prevent the sides of the holder from penetrating into the clay (Fig 2). The water in the holder showed only fairly low levels of dissolved contaminants (TOC 35 mg/l, phenol 0.7 mg/l and ammonia 11 mg/l) but was covered by a thin layer of tar. The tar was removed by pumping the water into the second 20 m holder which still contained rubble and earth. Tar-free water could be removed from this to sewer by pumping from a sump dug in the rubble. This treatment also served to remove suspended solids from the water. Considerable quantities of tar which were present in the ditch at the base of the holder were removed by the excavator after adsorbing the tar on dry but contaminated solid material from elsewhere on the site. The holder was filled with crushed rock followed by sub-base.

The remaining 20 m diameter holder base was thoroughly cleaned out. The design was similar to the buried holder base which had earlier been excavated, being about 6 m in depth. Most of the water contained in it was pumped to sewer but the water at the base again had a high suspended solids content together with tar. Since no large convenient settling tank was available this was removed from the site by tanker by local waste disposal contractors. Approximately 60,000 l of contaminated liquid was removed in this manner.

The 34 m diameter gas holder base would be under the proposed car park so that complete removal of the contents were not considered to be necessary. After breaking down the retaining walls to 1 m below final level using a concrete breaker, 1 m of the rubble fill was removed and replaced by sub-base after lowering the water level in the holder by pumping to sewer.

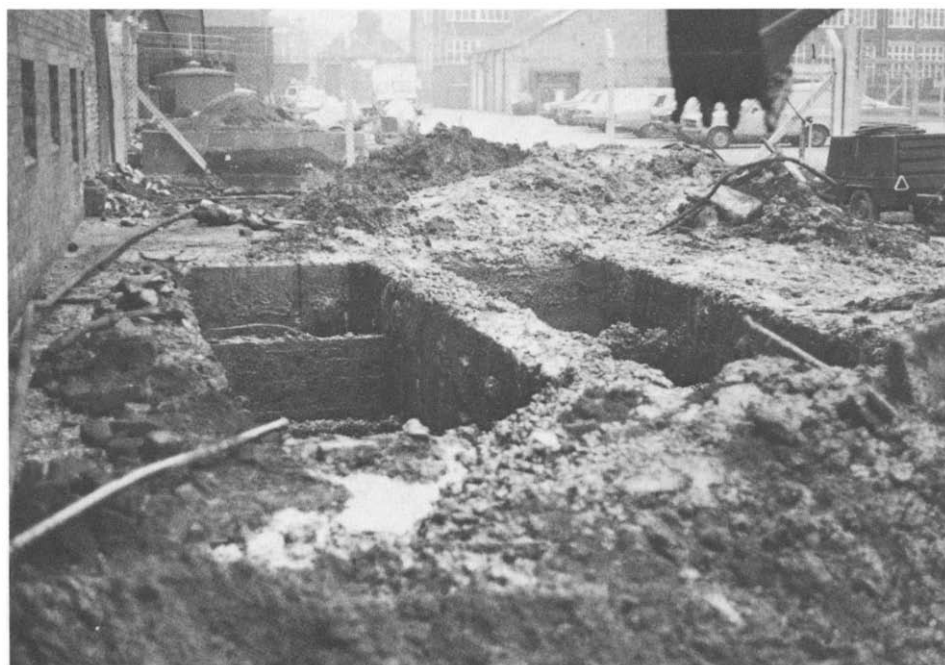
Fig 3 Tar tank

The concrete tar tank (Fig 3) on the northern boundary was then decontaminated. This structure consisted of several interconnected chambers having a total volume of about 60 m³. Two skips were originally filled with tar but these posed transport problems since the contents had a low viscosity. The remainder of the tar was therefore adsorbed on to contaminated solid material as above. A smaller tar well having a depth greater than 5 m and a buried 20 m³ steel tank containing tar were later found in this area of the site. They were decontaminated using the same method. Considerable care was needed not to fracture a "live" 200 mm high pressure gas main close to the tar tanks. Contaminated material from around this pipe was re-

4 The contents of tar tanks and well were adsorbed on dry, chemically contaminated solids present on the site, which were then transported by normal lorries to licensed landfill sites.
