DECONTAMINATION OF EXPLOSIVES BUILDINGS AND PLANT AT RO/XD BRIDGWATER*

G.A. TRIMM

Royal Ordnance Explosives Division, Bridgwater, Somerset TA7 8AD (Great Britain)

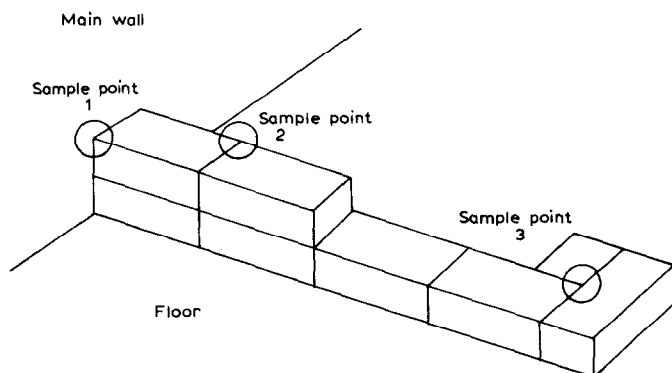
In early 1983, during the demolition by conventional means of a glazed brick partition wall in a process building, a small detonation occurred injuring a contractor. The building had been used for many years as an RDX boiling, oiling and waxing house and, although the surface of the wall had been cleaned, checked and wetted, it is suspected that a small amount of RDX had penetrated the mortar between the bricks.

The remains of the partition wall were thoroughly hosed and then submerged in water held by sand-bags for 48 h. The wall was of single thickness of glazed brick and extended $4\frac{1}{2}$ bricks deep into the building, being 2 bricks high for half its length and single brick high for the remainder. Three samples of mortar scrapings were taken from exposed surfaces and these were checked in the laboratory for RDX content — only a minute trace was indicated (Fig. A-1).

Fig. A-1. Remains of partition wall before final demolition showing sample points.

The requirement was to remove the remains of the partition wall and provide a rebate of about 25 mm below the floor surface. The method employed was to use a number of small charges and remove the wall incrementally. Small charges were used to avoid over-pressure in the building.

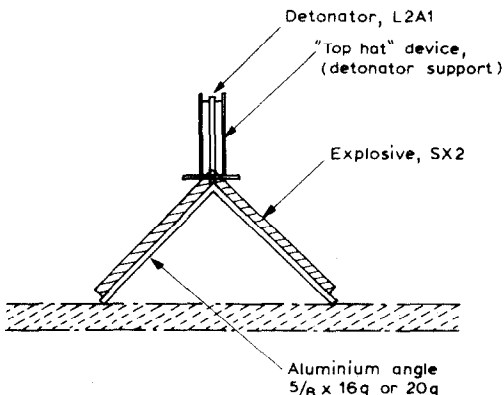
The charges used were made up from $\frac{1}{8}$ " thick strips of SX2 cut from sheets made in the factory. The strips were laid on $\frac{5}{8}$ " aluminium angle in the general configuration shown in Fig. A-2. The individual weights and length of charge varied according to the break-up of brickwork the Firing Officer considered it was advisable to produce at each firing.

Fig. A-2. Cross section of explosive charge and detonator.

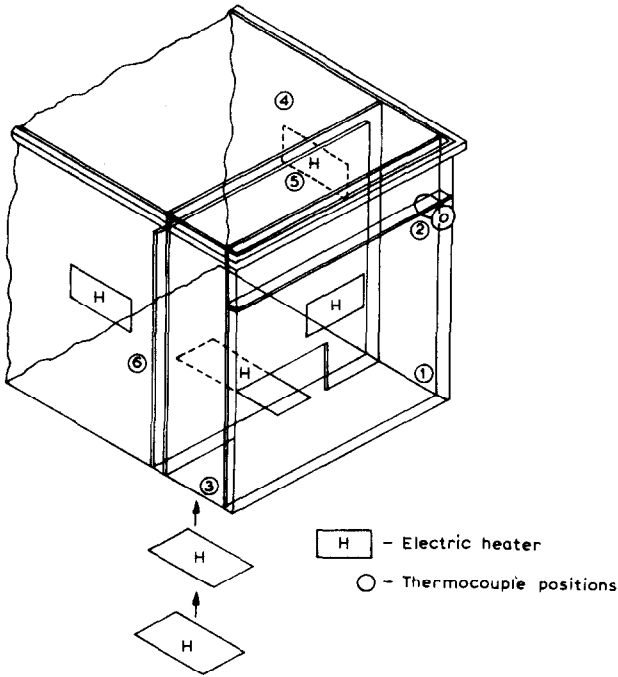
After completion of a production run in April 1982, inspection of the TNT Nitration Unit revealed a hole at one end of the vessel and also defects in some welds in the area.

Six electric heaters were positioned as shown in Fig. B-1 and spaced from the unit by firebricks. The heaters were secured in position by steel wire or, in the case of the 2 heaters under the floor of the unit, supported by scaffolding poles. The heaters were rated for a maximum of 13.2 kV A (13.2 kW) each (55 amp at 240 volt) and were wired in a "star" configuration, 2 heaters being connected in series to each phase of the 3 phase supply.

Fig. B-1. Arrangement of electric heaters (two heaters are placed underneath the floor of N8/T9).

The required programme was to allow the temperature to rise to 300°C uncontrolled and then to increase the temperature at a rate of 150°C per hour to the range 425°C to 450°C . The temperature was maintained in this range for 2 h after which the heaters were switched off and the unit allowed to cool in still air.
