ELECTROSTATIC SENSITIVITY OF CONSOLIDATED MAGNESIUM—TEFLON COMPOSITIONS*

B.V. DIERCKS

*Manufacturing Engineering, Morton Thiokol Inc./Longhorn Division, Marshall,
TX 75671 (U.S.A.)*

Summary

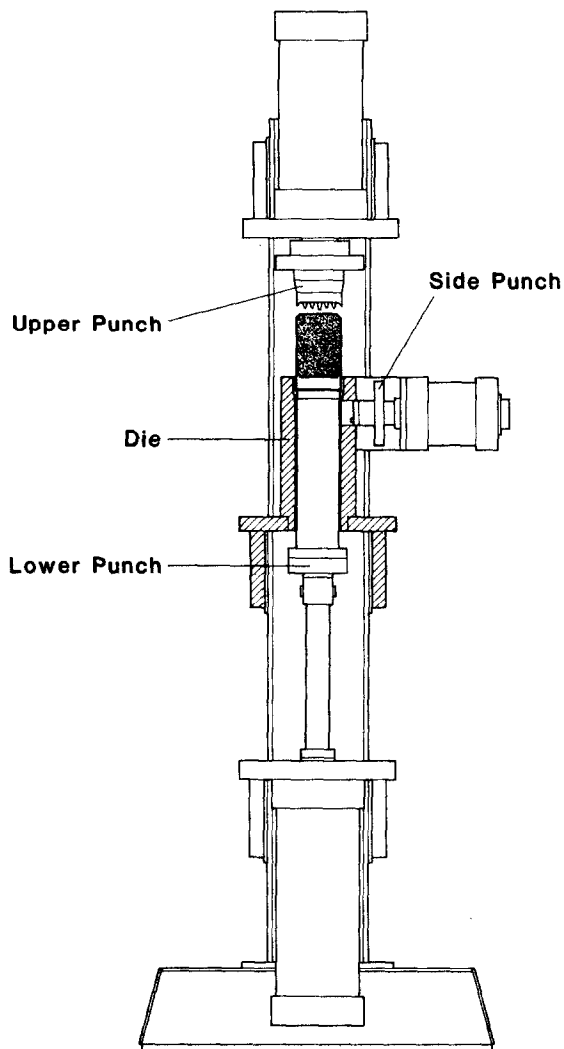
Fig. 5. Consolidation press for RR119/B pellet — Cross section of press with the consolidated pellet resting on the anvil (i.e., as presented to operator for removal from lower punch).

In both the July 26 and December 3, 1983 incidents, the operator was sure the pellets ignited on the bottom as they were removed from the lower punch. Using an electrostatic voltmeter, we measured voltages as high as 3600 volts on the top and sides of the pellet as it was ejected from the die cavity. This voltage slowly dissipated to the air.

were felt to have initiated when the pellet was removed from the lower punch. At this time, the negatively charged pellet can arc to the punch, through the flashing on the pellet, when an air gap between the two is generated. This same condition exists when the upper and side punches are withdrawn. No ignitions have occurred as a result of these separations, and if such did occur, it would happen while the pellet is in the die and behind the shield in the press, thereby protecting the operator from direct exposure. Allowing the press cycle to remove the lower punch from the pellet, while not altering the conditions for drawing an arc between the pellet and the punch, does have the pellet in the die and behind the shield in the event ignition occurs. By delaying the opening of the press shield door for 60 seconds after pellet/lower punch separation, then rubbing the top of the pellet with a grounded brass brush prior to pellet removal, the electrostatic charge decreased to a neutral or safe handling level. This operational procedure was instituted during the period of time we were obtaining the authorization to use ionizing air blowers.

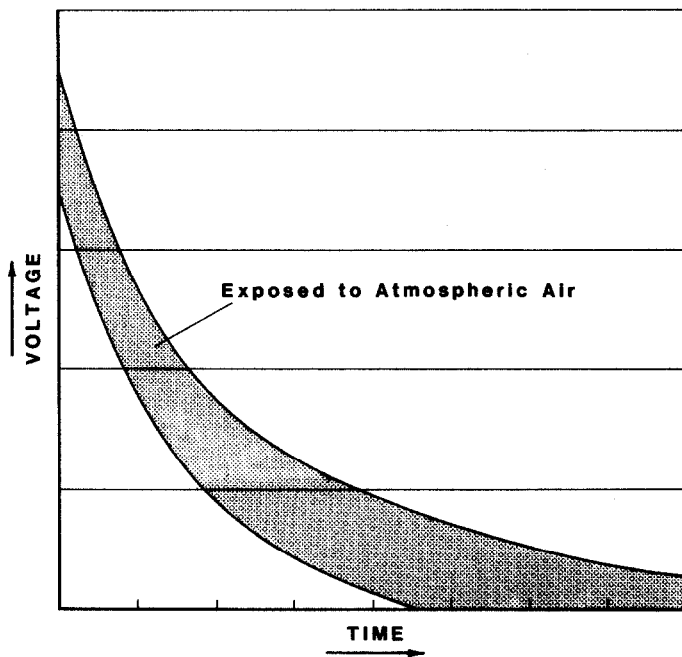
of the pellet after the top punch was withdrawn (the lower punch is in the "up" position with the pellet in place) ranged between 1200 and 3600 volts. This voltage decayed to between 200 and 1400 volts within 30 seconds (Fig. 6). The magnitude of the electrostatic voltage developed varied between mixes. Within a mix, the variation was smaller. The electrostatic voltage on the bottom of the pellet immediately after it was removed from the bottom punch ranged between 1400 and 1800 volts. This was essentially the same whether the pellet was removed immediately after ejection from the die cavity, or allowed to sit on the bottom punch for 60 seconds prior to removal (Fig. 7). Sixty seconds after removing the pellet from the lower punch, the voltage on the bottom had decayed to between 200 and 650 volts. Generally, the voltage reduced by one-half in the first 15 seconds after removal from the punch.

Fig. 6. Generalized voltage/time profile — Generalized graph of electrostatic voltage on pellet surfaces exposed to air as a function of time.

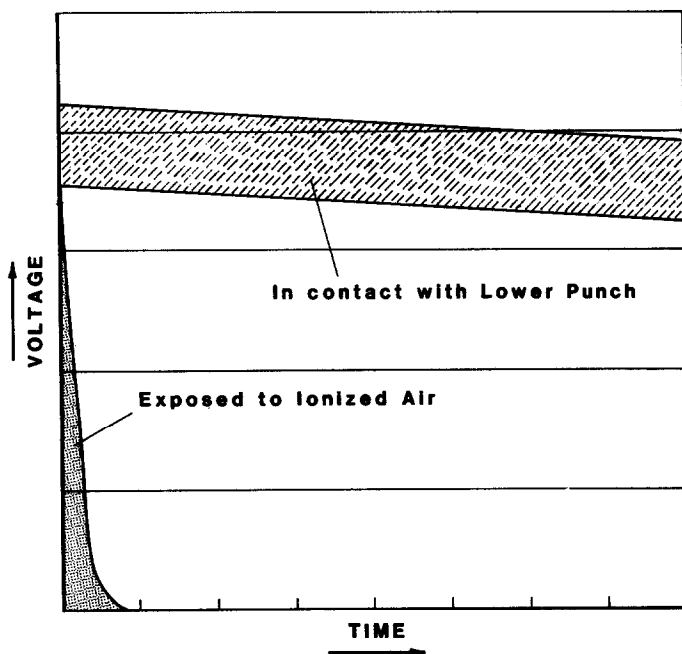
Fig. 7. Generalized voltage/time profile — Generalized graph of electrostatic voltage on pellet surface in contact with lower punch as a function of time and on pellet surfaces washed with ionized air as a function of time.

Tests were run using an ionizing air system to blow ionized air across the surface of the pellets after ejection. This method was very effective in reducing/removing the electrostatic voltage on the top and sides of the pellet in a very short period of time (Fig. 7). To be effective on the bottom of the pellet, it was necessary to expose the bottom of the pellet to the ionizing air stream. This was effected by using a probe on the end of an air-operated cylinder to roll the pellet off the lower punch.

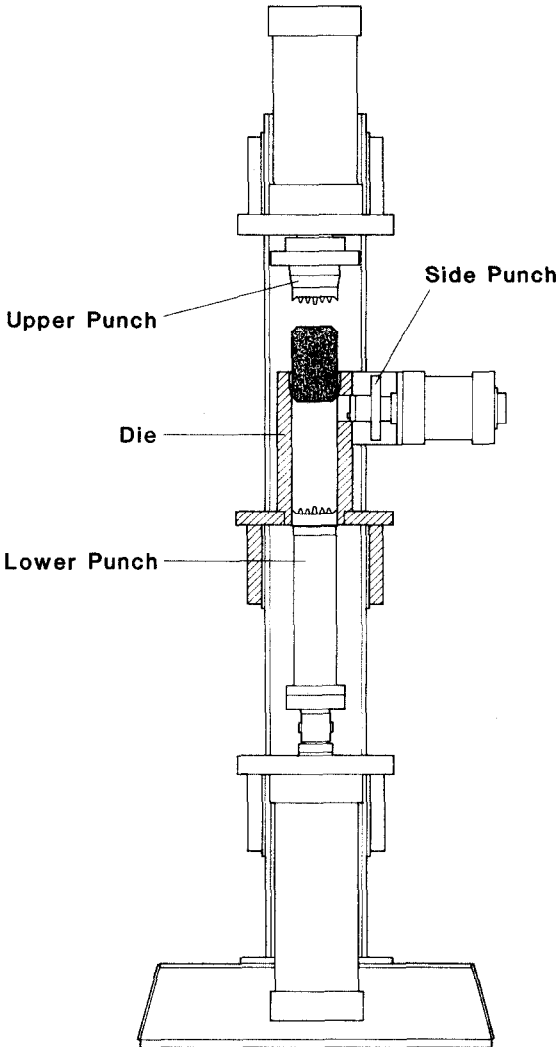
Fig. 8. Consolidation press for RR119/B pellet — Cross section of press showing pellet resting in die after lower punch has been separated.

The press was programmed to cycle such that the consolidated pellet was ejected from the die cavity. The lower punch was then retracted pulling the pellet back into the tapered part of the die cavity until it reached the smallest part of the die, at which time the punch separated from the pellet. In this condition, the pellet extended approximately $3/8$ inch above the top of the die (Fig. 8). When operating in this manner, the voltages on the bottom of the pellet 30 seconds after separating the lower punch, were between 200 and 1000 volts. Sixty seconds after separation, the voltages ranged between 0 and 500 volts.

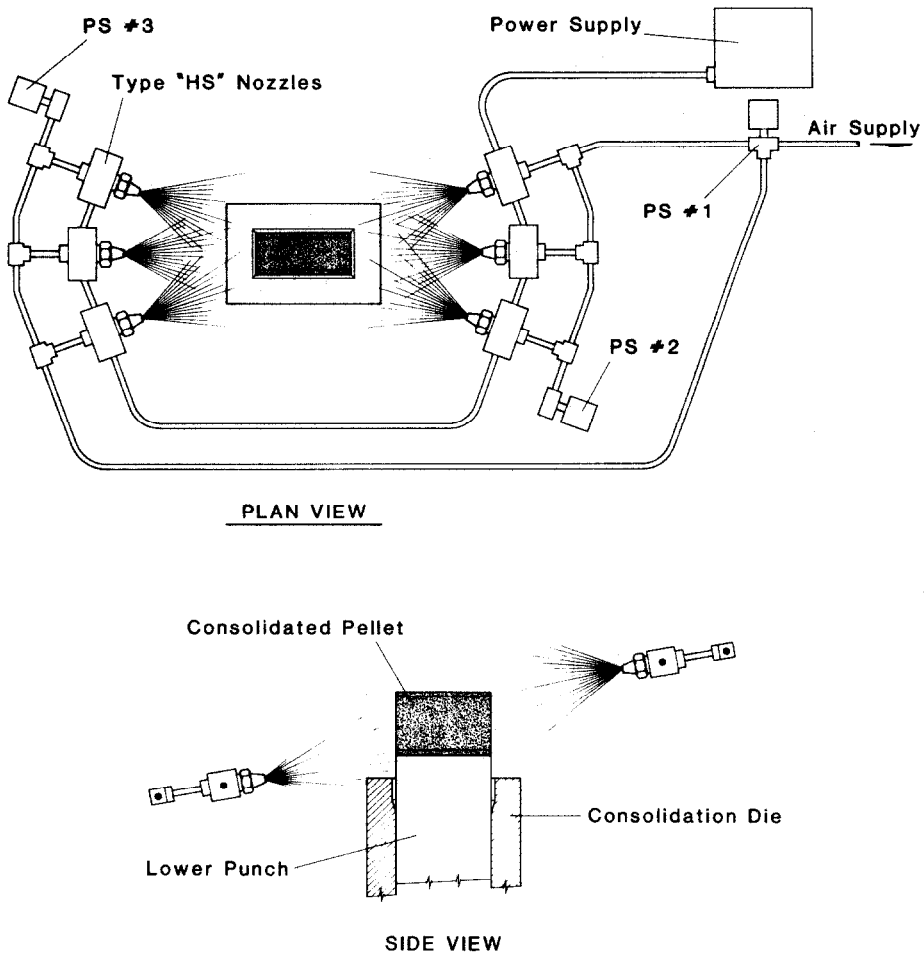
Fig. 9. Ionizing air nozzles — Depiction of the ionizing air nozzles washing the sides and ends of the consolidated pellet.

The biggest problem encountered with using ionized air was the Army Safety Manual DARCOM-R 385-100, which prohibited the use of ionizing air systems in hazardous environments [1]. To eliminate this as a problem, we developed a system which effectively removed the ionizing air system from the hazardous environment. Our particular situation was best solved by placing several Simco Company ionizing air nozzles fore and aft of the pellet as it sits in the raised position (Fig. 9). We essentially encapsulated the system by maintaining a positive air pressure at all times. This assures sufficient air velocity to prevent the ingress of gaseous or particulate matter around the ionizing electrodes. This system, while not much more effective than the interim procedure of separating the lower punch from the pellet while in the die and delaying the shield door opening 60 seconds, is a much more efficient and economical production approach.
