EXPLOSION HAZARDS OF CHLORINE DRYING TOWERS

YASUYUKI TABATA, TSUTOMU KODAMA and TAKASHI KOTOYORI

Research Institute of Industrial Safety, Ministry of Labour, 5-35-1 Shiba, Minato-ku, Tokyo 108 (Japan)

At 3.45 p.m. on July 18, 1975, three chlorine drying towers in a mercury amalgam cell chlorine plant (Ryohnichi Co., Ltd. near Okayama) exploded. One operator was killed and twelve seriously injured.

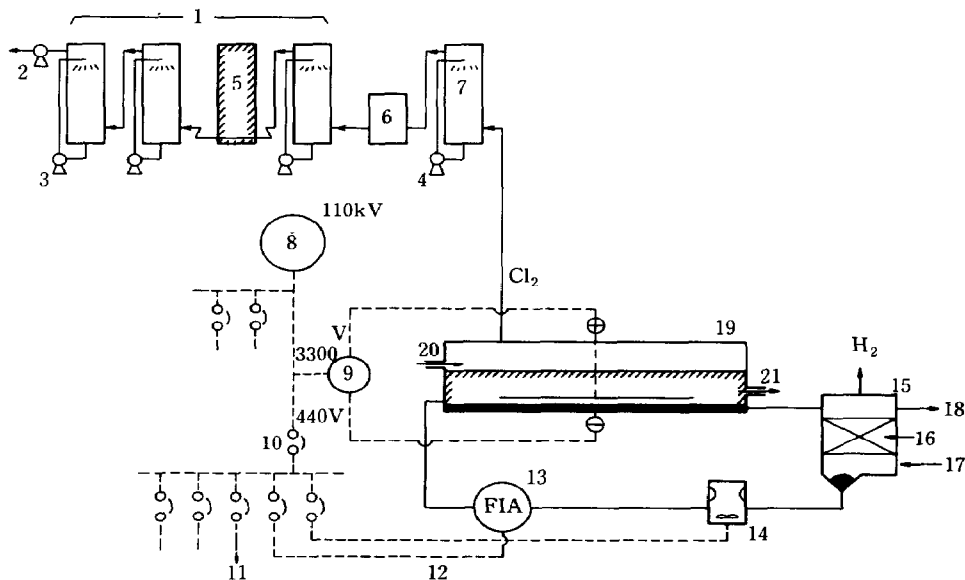
Fig. 2. Flowsheet of the mercury amalgam cell chlorine plant where the accident occurred. Key: 1, chlorine drying tower chain; 2, turboblower; 3, sulphuric acid pump; 4, water pump; 5, the 2nd tower, being under repairs; 6, mist separator; 7, cooler; 8, AC main power source; 9, rectifier; 10, no-fuse-breaker; 11, supply to an air dechlorination blower; 12, cell control and alarm system; 13, indicator and alarm for the flow state of mercury; 14, mercury pump; 15, decomposer; 16, graphite packings layer; 17, water inlet; 18, caustic outlet; 19, mercury amalgam cell; 20, concentrated brine inlet; 21, spent brine outlet.

The feature of this plant arrangement will be seen in the flowsheet. Input to the rectifier was taken from the AC main power source. Both the AC power

supply for the mercury pumps and that for the FIAs, which were installed to check the flow state of mercury, were taken from the load side of a no-fuse-breaker rated at 600 A (hereinafter referred to as the breaker indicated as 10 in Fig. 2). The system was, therefore, in such conditions that should the breaker trip for any reason, not only would the mercury pumps stop, but also the pump failure alarms would not work.

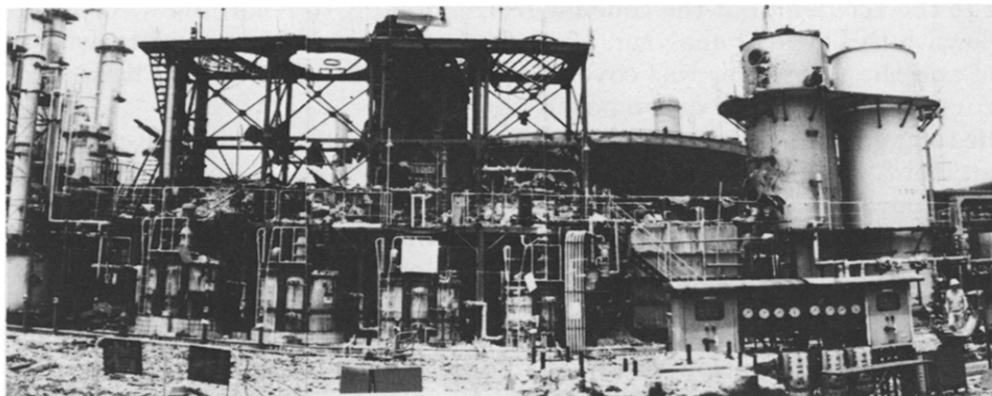
It was at the height of summer at about 3 p.m. when the highest temperature of 32.8°C was recorded at the Okayama meteorological observatory since the beginning of that year. The process variables were all kept within the set ranges at 3.30, as established by the inspection after the accident from the chart-strip recordings. At about 3.38 an operator, who was on duty at his post in the main control room, noticed that the DC current dropped suddenly from the set value of 205 to 195 kA. As the result, the shift foreman asked the operator, who was on duty in the sub-control room, situated beside the cell room, whether or not any abnormality had occurred around the cells. The operator replied by telephone "there is no specially abnormal situation". Judging from the facts established after the accident, however, there must have been some clearly abnormal state which should have been noticed by the operator. At about 3.40, that is, one or two minutes later, the DC current was restored to the original value of 205 kA by the automatic function of the current stabiliser installed on the rectifier. Although the operators in the main control room felt relieved for that matter, they then noticed that the hydrogen discharge pressure was decreasing from the set value of 0.34 to below 0.2 kgf/cm² (gauge pressure). The foreman instructed the operator in the sub-control room to check again the cells when the operator reported by telephone "all AC power supplies for mercury pumps and those for RICAs have been cut off!". Suspecting that some serious events were occurring in the plant, the foreman decided to carry out an emergency shutdown. Shortly afterwards, at 3.45, a violent explosion occurred in the chlorine drying towers. Three towers were completely destroyed, except for the bottom structures which were made of steel. Piping and Raschig rings in the towers, both made of PVC, were also ruptured and dispersed, some fragments being blown away up to 100 m (Fig. 3). Window glass in the plant was broken within 50 m. One operator was killed due to pulmonary edema and twelve seriously injured. They were all engaged in the repair work on the second tower.

Fig. 3. The scene after the accident.

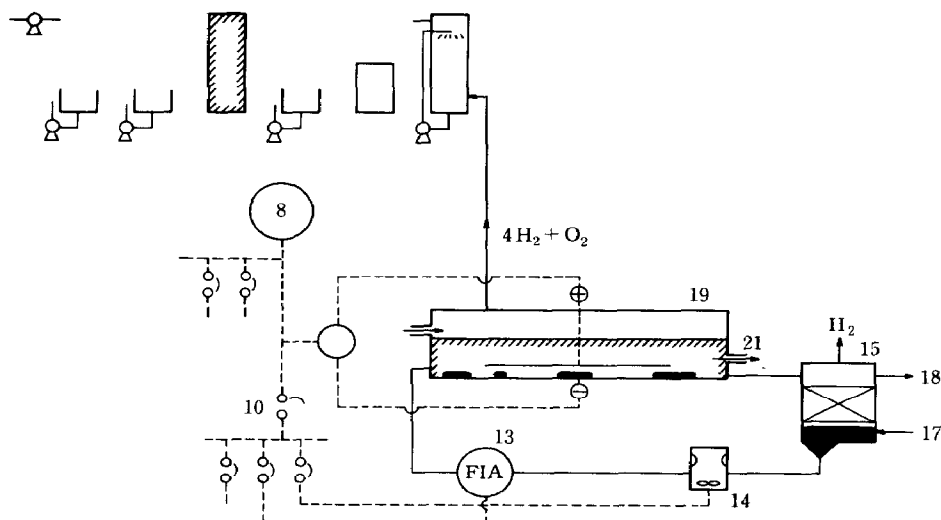
The position at the time of the accident is shown in Fig. 4.

The breaker tripped and when the mercury pumps stopped the alarm did not work since the AC power supply for FIAs was also cut off and so the operators

were not aware of the dangerous situation occurring in the plant. The DC power supply to the electrolytic process was on. Brine supply to the cells was not interrupted because of a separate AC power supply until the emergency shut-down immediately after the accident. Inspection of the continuous hydrogen analyser recordings revealed that the hydrogen concentration was 0.3 vol% just

Fig. 4. The position at the time of the accident. Flowsheet and numbering correspond to those of Fig. 2. Key: 8, gross power consumption increased by about 8 MW; 10, breaker tripped out; 13, alarm for mercury flow did not work; 14, mercury pump stopped; 15, the bulk of mercury drained into the decomposer; 17, flow rate of water lowered; 18, flow rate of hydrogen and caustic lowered; 19, steel bottom plate was exposed and a part of mercury remained; 21, temperature of spent brine rose to about 100°C.

prior to the accident, but the time lag from sampling to recording was considerable with this type of analyser. Some 20% of the steel bottom plate was exposed and the remainder was covered with a thin mercury film. The bulk of mercury drained into the decomposer.

The temperature of the spent brine rose to about 100°C immediately before the accident, while its usual value was approximately 85°C. In the meantime, the gross power consumption of this factory increased to about 40 MW for 5–7 min before the accident, while its usual value was approximately 32 MW. The increment of 8 MW could be explained as follows: $37 \text{ cells} \times 205 \text{ kA} \times 1 \text{ V} \cong 8 \text{ MW}$, if it is assumed that there was an increase of about 1 V across each cell due to some increase in distance between electrodes accompanied by the outflow of mercury. In addition, the unusual rise in temperature of the spent brine could also be calculated, assuming that the energy increment of 8 MW would have been converted to heat ultimately.

(1) Install a current breaker of sufficient capacity to deal with an abnormal load.

(2) The AC power supply for control, measuring and alarm system should be taken from separate sources other than that for the mercury pumps of the DC power supply. The control, measuring and alarm systems must be capable of operating during a plant failure. A emergency power supply for this purpose should be considered.

(3) The continuous hydrogen analysers should be installed on the chlorine outlets of each cell to enable it to monitor any change of hydrogen concentration within as short a time as possible.

(4) Install an interlock system between the DC power supply to the cells

and the AC power supply to the mercury pumps, and so also between the DC power supply and the continuous hydrogen analysers, so that an interruption of the power supply or an abnormal sudden increase of hydrogen concentration would shut down the entire plant.

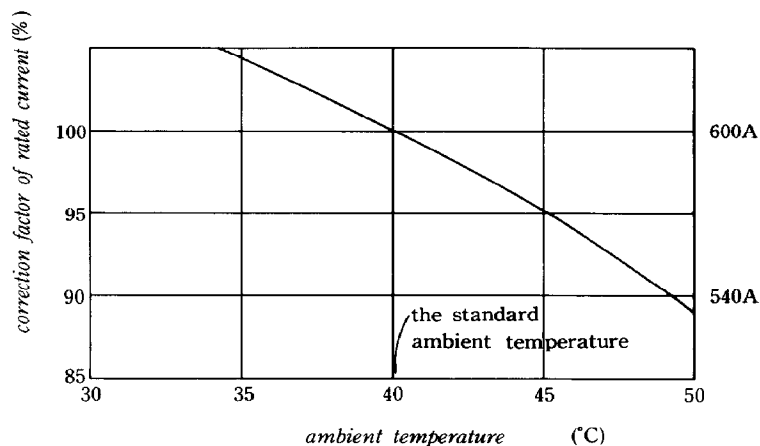
The gross load current on the breaker at the time of the accident was about 530 A because an air dechlorination blower consuming ca. 40 A was temporarily in operation on that day. The normal load current was about 490 A. Incidentally, the capacity of the breaker falls when the ambient temperature rises (Fig. 5). According to Fig. 5, should the ambient temperature reach 50°C, the gross load current of 530 A would have attained to cut-off level of the breaker. The switch room, where the breaker was located, was a single-store room made of reinforced concrete and was situated alongside the plant building exposed directly to the afternoon sun. Furthermore, the switch room contained additional 325 breakers, so that the temperature inside would have been further increased by the heat generated from these electrical appliances. Thus, it was presumed that high ambient temperature was responsible for the breaker to trip out eventually.

Fig. 5. Effect of ambient temperature on the capacity of the breaker.

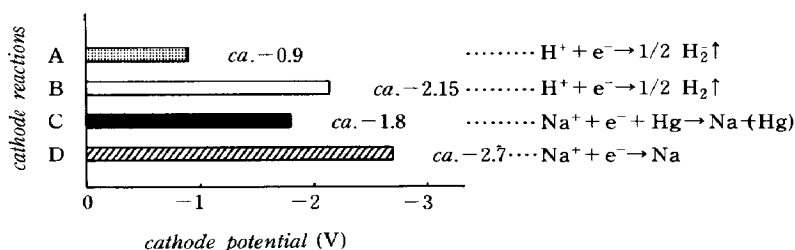
On the basis of the standard hydrogen electrode, the likely reactions which might occur on the exposed steel bottom plate or on the remaining thin mercury film and their corresponding cathode potentials are shown in Fig. 6. Although the normal cathode reaction is C in Fig. 6, hydrogen would begin to generate at once on the exposed steel cathode because of its lower reduction potential [eqns. A in Fig. 6 and (1)]. The remaining mercury film would be saturated with sodium within one minute, changing into a butter-like substance. Similarly, hydrogen would begin to generate on its surface according to eqn. B in Fig. 6. Meanwhile, at the anode the successive stages of the reaction would eventually lead to the generation of oxygen according to eqns. (2), (3) and (4). On balance, hydrogen and oxygen would be formed at a theoretical mole ratio of 4:1 under the abnormal situations in the cells.

Fig. 6. Cathode reactions and their corresponding electrode potentials: A, hydrogen formation on iron plate; B, hydrogen formation on saturated Na-amalgam; C, reduction and amalgamation of sodium ion; D, deposition of metallic sodium.

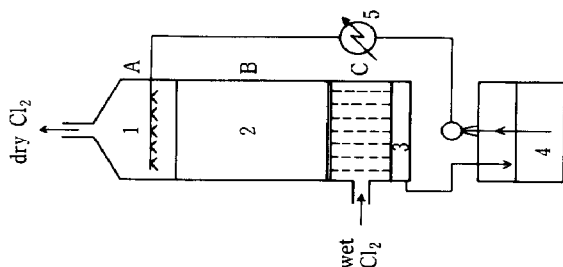
Fig. 7. A diagram of a chlorine drying tower. Key: 1, sulphuric acid distribution tray; 2, Raschig ring layer; 3 and 4, sulphuric acid sink; 5, cooler.

Measurement of the actually charging state of a chlorine drying tower, made of PVC, was carried out in the Tsurumi Soda Co., Ltd. near Yokohama on October 15, 1975 (Fig. 7).

(1) Electrostatic potentials of about plus 100 V were detected around the tower top A using an electrostatic radioisotope-type potentiometer. Comparable potentials were also detected on the side wall of the space below the Raschig ring layer C. But, no charge was detected on the side wall of the Raschig ring layer B. The pointer of the potentiometer showed such a behaviour on the dial plate that, as the probe approached the tower wall, it drifted gradually from zero position towards the positive side and then returned suddenly to zero, when the probe came at a certain distance away from the tower wall.

(2) Noises in the high frequency band, caused by the electrostatic discharge in the tower, were detected using an amplifier modulation radioset. More frequent noises were clearly heard at C than at A. No noises were heard at B.

(4) It was observed that a large portion of sulphuric acid flowed down below the Raschig ring layer as liquid columns, but at the same time the space was filled with a mist of sulphuric acid. Electrostatic potentials of about minus 5 kV were repeatedly detected whenever the probe of the potentiometer was inserted from the outside into a hole which was drilled in the side wall.

(5) As for the shape of the towers, each chlorine gas outlet should be placed at the highest point of a tower, and not at its side wall. A conical, not a cylindrical, shape is desirable for the top part of the tower to eliminate any dead pockets where hydrogen gas could accumulate.

(6) An acidproof and conductive material should be adopted for the construction of the towers, so that the tower structure can be held at the earth potential, with sulphuric acid, to eliminate completely the electrostatically charging phenomena.

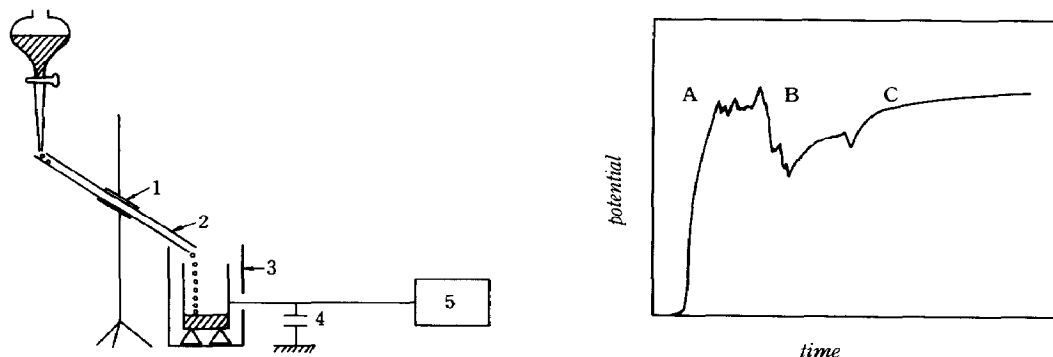
Fig. 9. An experimental set-up on electrostatically charging phenomena of sulphuric acid when flowing down from a PVC pipe. Mean weight per droplet was about 0.056 g. Key: 1, teflon sheet; 2, PVC pipe, 1 in. in diameter, 1 m long; 3, Faraday cage; 4, condenser, 490 pF; 5, electrometer and recorder.

Sulphuric acid (98%) becomes charged positively when dripping down from a PVC pipe, which is charged negatively (Fig. 9). The electrostatic charge per droplet showed a constant value of ca. 8×10^{-12} C, irrespective of the rate of dripping. This corresponds to a potential rise per droplet of 0.017 V with the above experimental set-up. It was also observed that the charged sulphuric acid droplets dispersed as mist just after having separated from the PVC pipe.
