## ANALYSIS OF THE LPG-DISASTER IN MEXICO CITY

C.M. PIETERSEN

Department of Industrial Safety, TNO, Apeldoorn, The Netherlands

In November, 1984, an enormous disaster involving an LPG installation occurred in Mexico City and resulted in the deaths of over 500 people. A TNO team went to Mexico shortly afterwards to conduct an investigation. This article reflects on their findings and draws some preliminary conclusions.

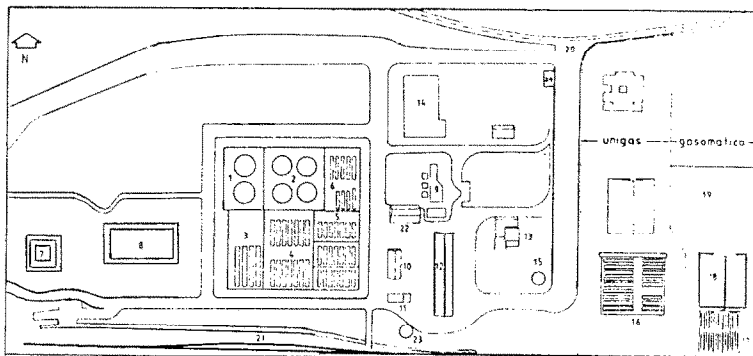
The lay-out of the Pemex LPG-storage and distribution centre is given in Fig. 1. The storage consisted of four spheres with a volume of  $1,600 \text{ m}^3$  and two spheres of  $2,400 \text{ m}^3$ . There were an additional 48 horizontal cylinders of various dimensions present (Fig. 1). At the time of the

Figure 1. PEMEX LPG installation, San Juan Ixhuatepec, Mexico City.  
Scale 1:2200

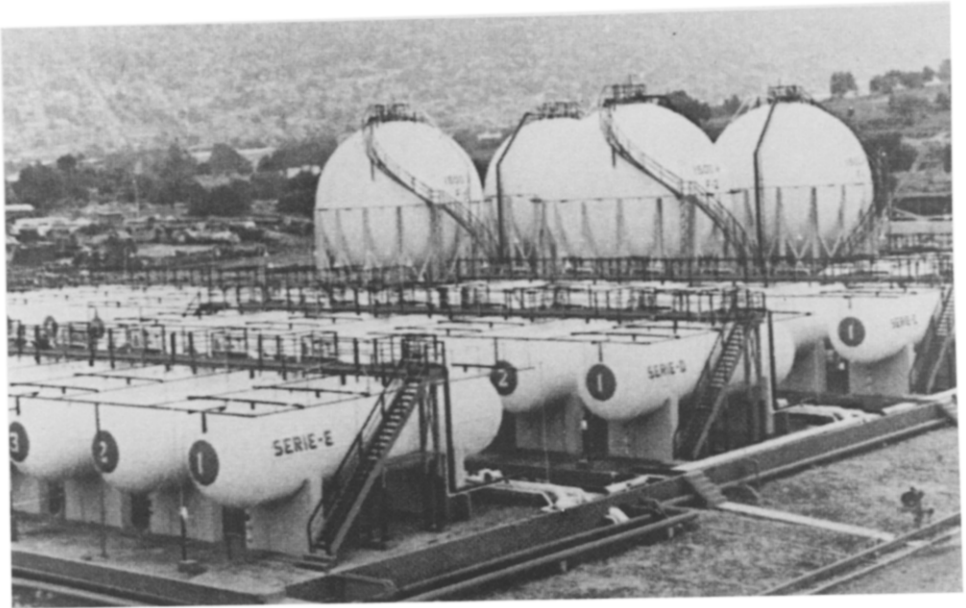
disaster the complete storage may have contained 11,000-12,000 m<sup>3</sup> of LPG. According to Pemex the set pressure of the pressure relief valves amounted to approximately 10.3 bar. The wall thickness of the larger spheres was 37 mm. The wall thickness of the cylinder that was actually measured by the team was found to be approximately 28 mm. The storage location was divided into separate sections through concrete walls about 1 m high (Fig. 2).

Figure 2. Storage tanks before the disaster took place.

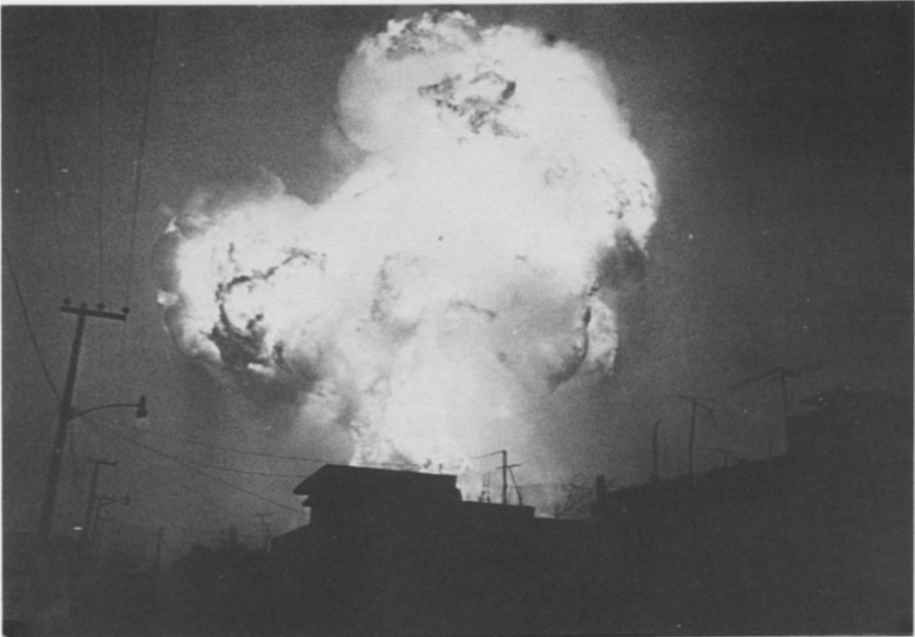
Figure 3. A "BLEVE"

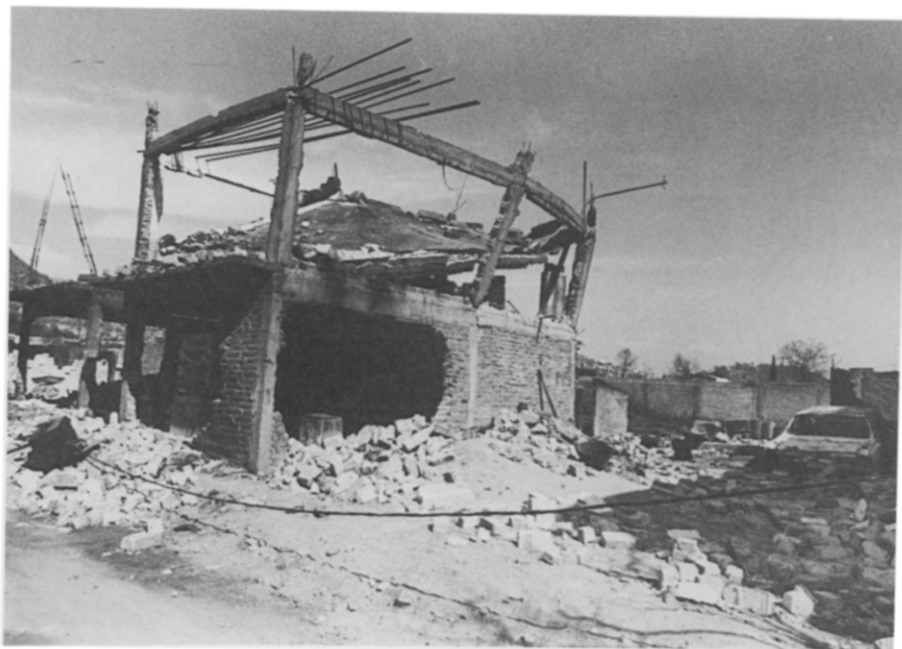
On the basis of a number of reflections, it appears to be an impossibility that tanks were already thrown off their supports at this time. The vapour cloud is assumed to have penetrated houses which were consequently destroyed through internal explosion (Fig. 4).

Figure 4. Devastated house.

Ignition of a vapour cloud inside a building is bound to cause extensive damage to that building. Internal explosions appear to have occurred in many damaged buildings. A number of these explosions probably took place at the time of the initial vapour cloud explosion. Internal explosions may also have occurred later, on penetration of partly unburnt LPG that was dispersed by the physical explosions of one or more larger storage tanks (BLEVEs). Case histories supply examples hereof which have been included in the report. People inside an igniting vapour cloud stand only a small chance of survival (case history). Direct flame contact, the intense heat and lack of oxygen see to this. Accounts from people at distances of over 300 m at the time of ignition indicate that ignitions took place locally, although only at small heights (< 1 m), which enabled these people to survive.

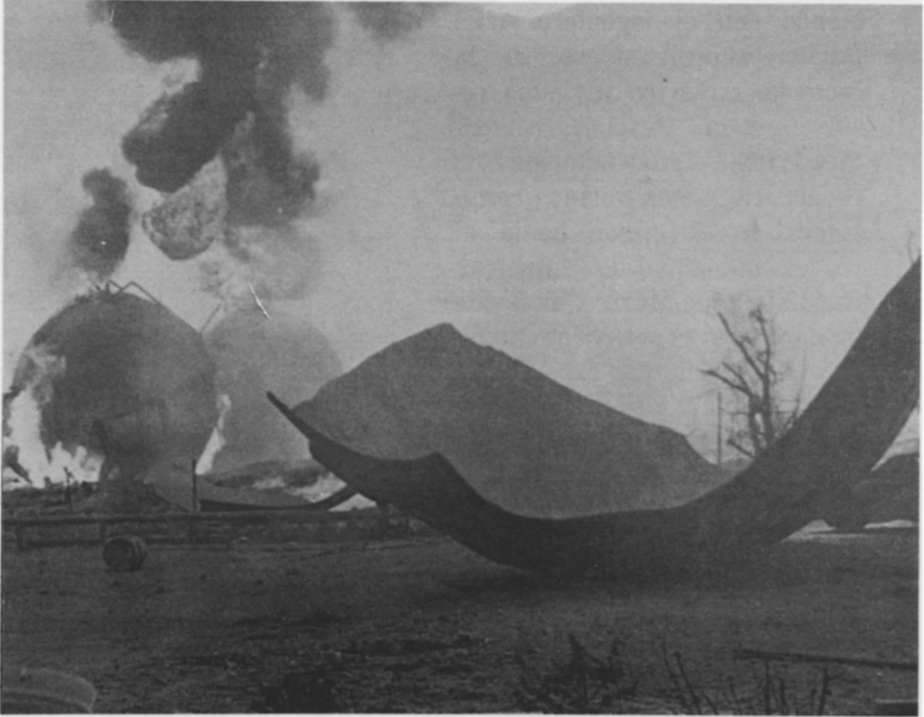
The four smaller spheres were completely destroyed, their fragments scattered about the area. The largest spheres remained intact although their legs had buckled from the heat, which caused them to fall to the ground (Fig. 5). Four out of 48 cylinders were left on their original concrete supports. Twelve cylinders came down at distances of over 100 m. The greatest measured distance amounted to 1,200 m. Forty-four out of 48 cylinders were located by the team. The remained four fragmented into smaller parts.

Figure 5. Fragment of a small sphere and 2 large spheres on fire.

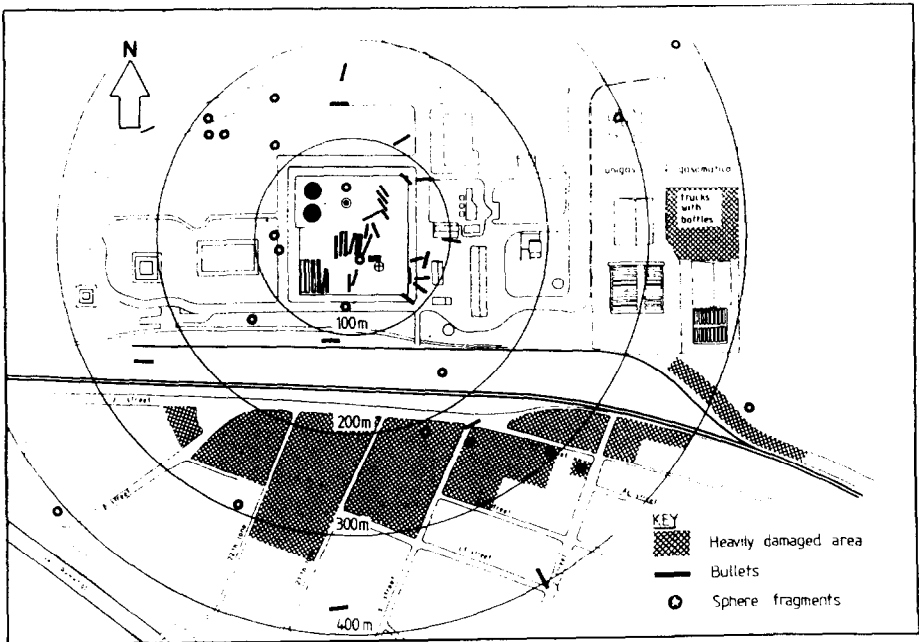
hoping to obtain additional information in this respect. However, our own observations, video tapes, conversations, etc., enabled us to establish quite accurately the area in which housing was for the greater part destroyed. The majority of casualties occurred within this area which stretches out to roughly a distance of 300 m away from the centre of the storage location.

Figure 6. Reproduction of the area in which damage occurred.

which also gives the positions of the various cylinders after the disaster, except for the couple that came down at distances of over 1,000 m and the one sphere fragment that landed at a distance of about 700 m. The cylinder at the corner of J. Street and LT. Street (a distance of 400 m) is given in Fig. 7.

In the case of cylindrical tanks, the amount is a great deal less. Energy released upon rupture of an LPG-tank is partly (60% according to the TNO "Yellow Book" (ref. 5) converted into kinetic energy of the fragments. As a result the fragments may be scattered about over great distances. Fig. 6 shows the positions of the larger fragments up to distances of about 400 m. At least four large fragments came down at even greater distances of 600, 750, 1,100 and 1,200 m.

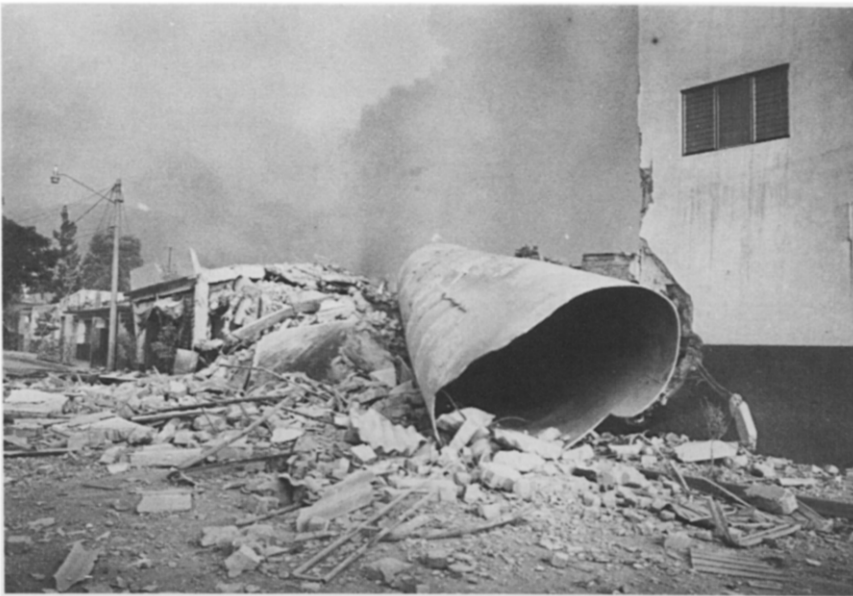
Figure 7. "End tub" crashed at a distance of about 400 m.

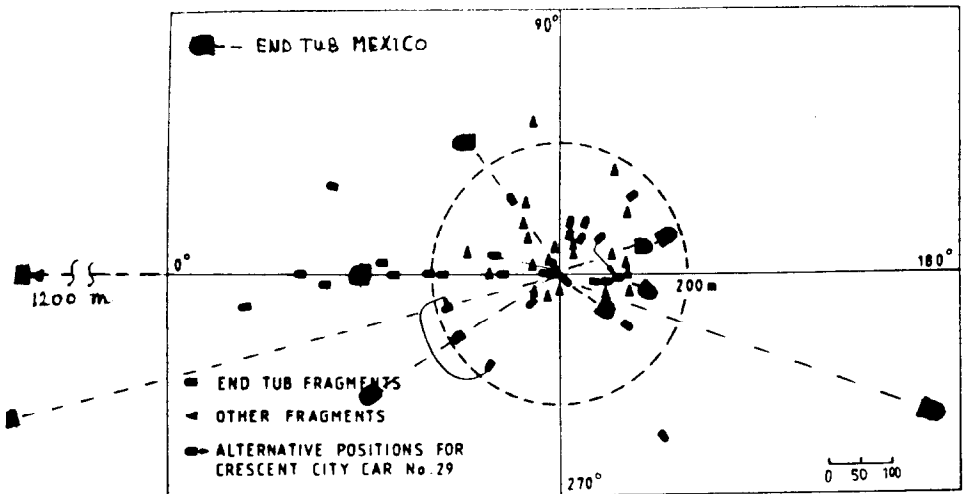
A preferential direction can be detected from the way the cylinders are positioned. These "fragments" are so-called "end tubs". They were predominantly launched in a southward direction, a fact caused by the original

south-north positioning and the pipeline connection north of the tanks. A fire resulting from a split or a leak of the pipeline connection initiates a circumferential rupture of the tank, its spherical front bursts off in a northerly direction, whereas the major part of the cylinder will be jettisoned southward.

This particular directionality is also found in case histories (ref. 6). Fig. 8 indicates this effect in the case of the San Juan Ixhuatepec disaster.

Figure 8. Reproduction of the directional preference.
