APPROACH TO A LEAK ON AN LNG TANK BOTTOM

Z. MERATLA

Summary

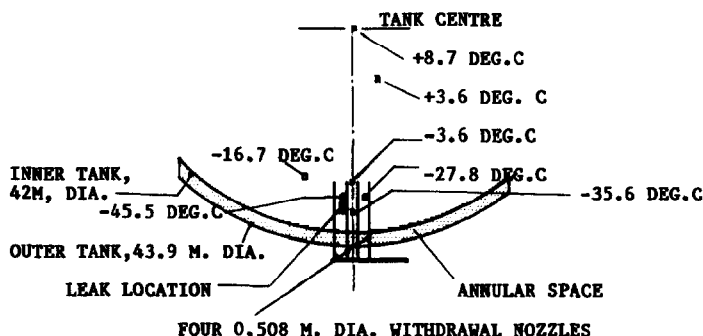
The nature of the problem did not lend itself to pinpointing the leak point. However, from the foundation temperature measurements shown in Fig. 2, it was determined that the problem was confined to the bottom discharge nozzles area.

Fig. 2. Sample point temperature readings in foundations and on outer tank bottom (□) as a result of an inner tank floor weld repair failure; (■) leak location after tank entry.

The LNG tank operated without any problems for approximately 12 years. After this period the foundation thermocouples began indicating low temperature readings under the discharge nozzles. The temperature dropped as low as -79°C . A sample temperature record is shown in Fig. 2. Externally, there was no evidence of any problem. A survey around the tank outer ringwall and at the entry/exit of the heating and thermocouple cable conduits indicated there was no flammable gas present.

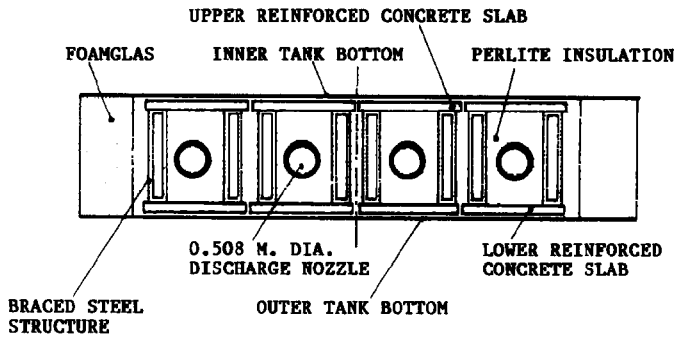
Fig. 3. Discharge nozzles - cross-sectional view.

- (a) One of the fabricated discharge nozzles shown on Figs. 2 and 3 developed a crack.
- (b) The nozzle to inner tank floor weld failed.
- (c) The perlite insulation within the nozzle's pit settled.
- (d) The inner tank floor plate or lap joints developed a crack.
- (e) The heating system failed or was inadequate.
- (f) Because of the bottom fill line penetration through the annular space, condensation of heavy ends may have formed on the outer tank bottom.

- (a) Removal of the inner tank bottom plates over the affected area to gain access into the nozzles pit shown in Fig. 3.
- (b) Removal of the upper concrete slabs over the bracing in the nozzles pit.

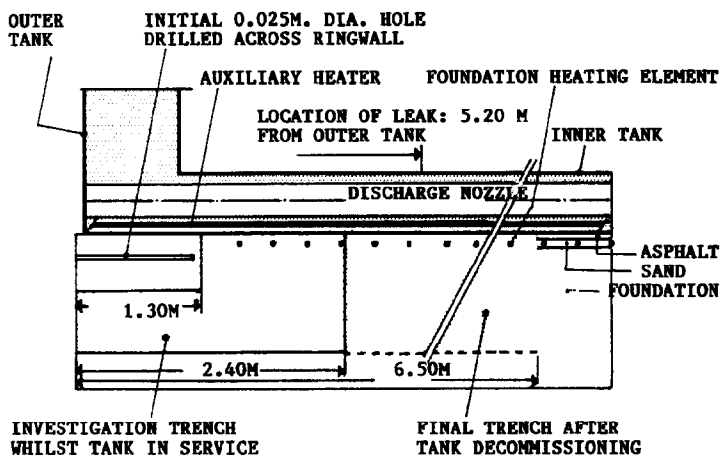
Fig. 4. Foundation investigation.

(a) A 25-mm diameter hole was drilled to over 90% of the depth of the outer ringwall as shown on Fig. 4. The temperature was found to decrease with depth. At 1.10 m depth the temperature was -2.5°C

(b) Due to the rebar steel reinforcement in the outer ringwall, the drilling was terminated and a trench 1 m deep by 1 m wide was carefully dug under the ringwall. The tank foundations, consisting of a sandy substrate, were found to be frozen inside the ringwall, but there was no evidence of any free ice formation or other indication of frost heave.

The trench was terminated at approximately 2.4 m from the outer tank shell, as shown in Fig. 4. The exposed heating conduits were found to be completely corroded. The absence of any flammable gas suggested that the outer tank bottom was not breached.

A 0.90 m deep hole was drilled into the foundations, at the furthest point of the trench, indicated a temperature of -5.5°C at 0.50 m below the tank bottom. A thermocouple was installed in this hole, so that the foundation temperature can be monitored during tank warm-up. The trench was temporarily backfilled.

To test for the possibility of an outer tank bottom leak, the trench under the tank was extended beyond the leak point as shown in Fig. 4. The sand and asphalt underlays beneath the outer tank bottom were removed, and the bottom sandblasted. Dye Penetrant, Soap Tests and visual inspection did not show any defects. Also the bottom plates were not corroded.

The confined space within the trench did not allow the backfill to be compacted. A multi-section, double-layered concrete backfill was used, as it met the following criteria:

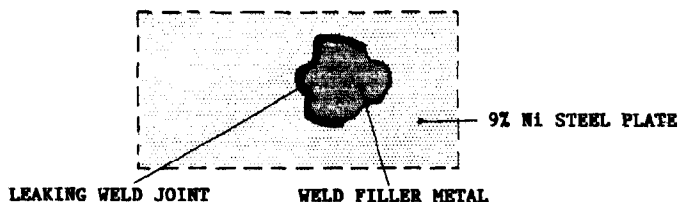
Because the problem area was fairly well defined, the leak point was identified almost immediately with the Vacuum Box: A weld repair of approximately 25 mm dia, on a floor plate was found to be the cause of the problem. Non-Destructive Testing over the affected area showed no other major defects or failures. The discharged nozzles were checked internally with Liquid Penetrant and pressure tested to the equivalent of the maximum liquid level. All were found to be free of any defects.

The leak was due to an inadequate weld repair in the middle of a floor plate between the nozzle openings and the inner shell. This location was remote from the high stress area of the footer plate to shell weld-joint. The 2.28 m \times 6.3 mm thick plate was made of 9% Ni, Double Normalized and Tempered steel. The crack was confined to the periphery of the weld filler metal as shown in Fig. 5. During the first 12 years of operation, the low temperature problem was not evident, suggesting that the crack developed fully at a later date.

The bevelling of the plate surface preparation prior to weld repair is believed to account for crack closure with increasing liquid head, hence minimizing the effect of the hydrostatic head on leakage rate. Thus, temperature variations with increasing LNG level were not detected. Also, the leak point was located away from the joints of the concrete slabs above and under the bracing of the nozzles pit, resulting in the small quantity of leaked LNG being spread over a large area. This may have accounted for the outer tank bottom plate not being breached.

Fig. 5. Inside-tank view of a weld repair leakage line.
