The investigation of a devastating accident — An accidental explosion of 40 tons of TNT

Guo-Shun Zhang^a and Ming-Jun Tang^{b,*}

Abstract

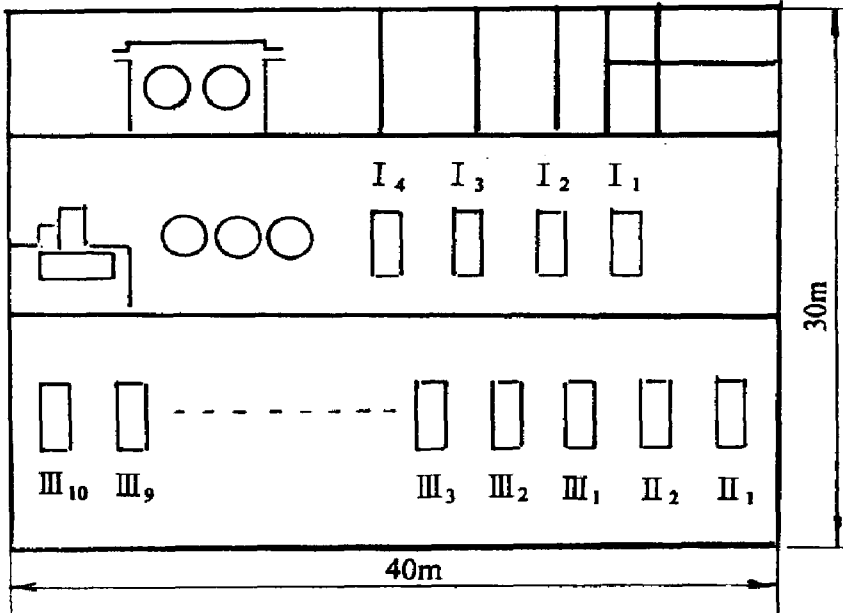
Fig. 1. Schematic of TNT production line.

On February 9, 1991 at 7.30 p.m., a massive and devastating explosive accident occurred in the TNT production line of a factory in Liaoning province, China. Seventeen workers were killed and 107 injured, among them 13 in critical condition. Buildings of an area of 50,000 m² were totally demolished, 58,000 m² were seriously destroyed and 176,000 m² were damaged. 951 pieces of process equipment were completely destroyed. Direct property damage was 22.66 million RMB (ca. \$5 million) and indirect property loss due to the interruption and rebuilding of this and neighboring production lines was enormous. The schematic of the production process is shown in Fig. 1.

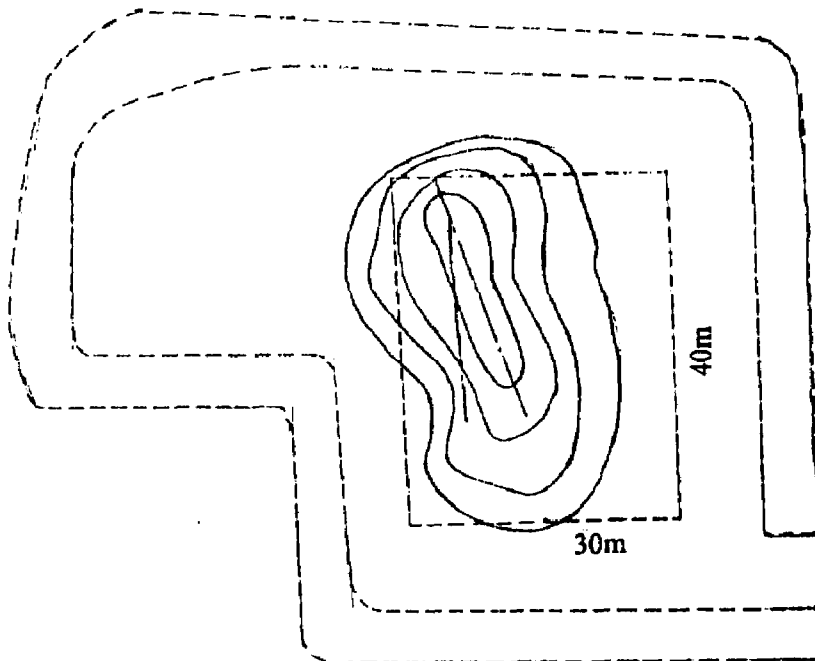
The nitrating workshop, where the explosion occurred, consisted of three connected buildings. In the middle there was a three-layer, reinforced concrete building with the dimensions 9 × 40 × 15 m³ and an arched roof. The side buildings east and west of the central building were 8 × 40 m² and 12 × 40 m², respectively. Most nitrating reactors were placed in the west building and the laboratory for physical and chemical analysis was in the east building. The three buildings were surrounded by a soil barricade of 3 m in height. The entrance to the workshop was through culverts which penetrated the barricade. After the explosion, the workshop was completely eliminated leaving a huge crater of 40 m in diameter and 7 m in depth (Fig. 2).

Fig. 2. Schematic of the crater. (—) Isohypers of the crater, (---) locations of the nitrating buildings and the barricades before the accident, and (- - -) symmetry line of the crater or the reactors before the explosion.

(3) Crater analysis. The ground mapping showed that there was an angle of 5° between the main axis of the crater and the axis of the original location of nitrating reactors. These data indicated that the explosion originated in the first few reactors, which is in agreement with witness testimony that smoke and fire were first observed in the No. 2 reactor. After the first explosion, displacement of other reactors resulted due to the shock waves produced by the explosion of No. 2 reactor. Then sympathetic detonations followed. Different displacements of each reactor before sympathetic detonation resulted in a tilt between the axes of the crater and the location of reactors before the incident.

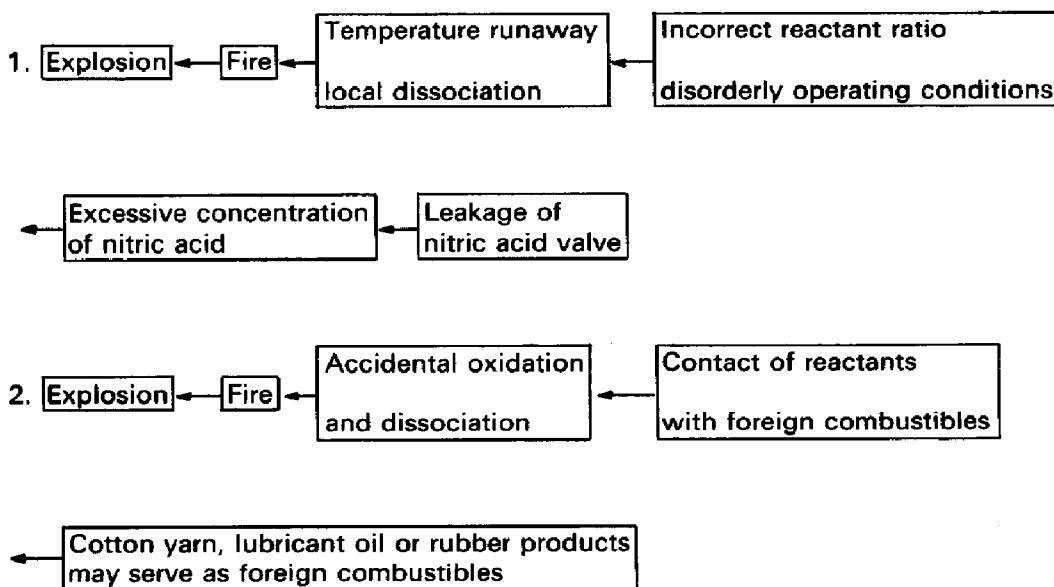
In the analysis non-relevant factors such as: leakage of cooling water, interruption or insufficient supply of cooling water, stirrer problems, breakdown of instrumentation and the presence of foreign matters in raw materials, etc. were eliminated. Then, two “cause-result chains” were formed from the few relevant factors, as shown in Fig. 3.

In the first “cause–result chain”, the key is “incorrect reactant ratio and off-specification operating conditions”, which were the result of “excessive concentration of nitric acid”. Due to the violent reaction, the contents in the reactor flowed to the separator where they continued reacting violently. However, there were no cooling tubes or stirrer in the separator where local overheating might easily develop into dissociation and combustion. It was found during the investigation that the off-specification operating conditions were present prior to the accident. On the day shift of February 9, nitric acid valves of No. 6 and No. 7 reactors were found to be leaking. After the next shift took over at 4.30 p.m. maintenance workers repaired the valves at 5.00 p.m. Nevertheless, the leakage already resulted in an excessive concentration of nitric acid in the nitrating system. For instance, the nitric acid concentration in the No. 2 reactor reached 7.09%, which is two or three times above the concentration of No. 1 reactor – 3.5% according to the standard operating procedures manuals.

In the second “cause–result chain”, the key is “contact of reactants with foreign combustibles”, since combustibles such as cotton yarn, lubricant oil, rubber gloves or rubber spacer, etc. will react violently with nitric acid and the

Fig. 3. Cause–result chains for a 40 tons TNT accidental explosion.

oxidation reaction may result in smoking or even fire. In the investigation, no foreign combustibles were determined to have entered the reactor before the explosion. However, it was discovered by further investigation that unapproved asbestos cord was used as the filler between the top of the separator and its upper lid. This asbestos cord might have served as the igniter of the fire when contacting nitro-sulfuric acid of high temperature and high concentration. Particularly, a large amount of concentrated sulphuric acid had been added into No. 2 reactor as a safety measure. In contrast with the original attempt, the addition of sulfuric acid would increase the chance for interaction between the asbestos cord and the concentrated nitro-sulfuric acid.

The incident started as a result of the leakage of nitric acid valves on No. 6 and No. 7 reactors, which lead to excessive concentrations of nitric acid in the nitrating system and brought forward the lowest melting point in the reactor system. Then, a violent reaction and the generation of a large amount of smoke in the No. 2 reactor resulted. The interaction of unacceptable asbestos cord containing a large percentage of combustible fiber and grease with

nitric acid of high concentration and high temperature provided the ignition source. Another source of ignition might be dissociation and ignition of nitro-compounds due to local overheating resulted from violent reaction in No. 2 separator. Finally, the fire was able to transit to detonation because of the lack of automatic dumping device and the failure of the operators to manually dump the reactor.
